Strengthening, Restoration and Rehabilitation of the Greek Orthodox Church of Saint George - Old Cairo

Dr. Hanan H. Eltobgy¹

¹ Associate Professor, Faculty of Engineering, Benha University, Cairo, Egypt

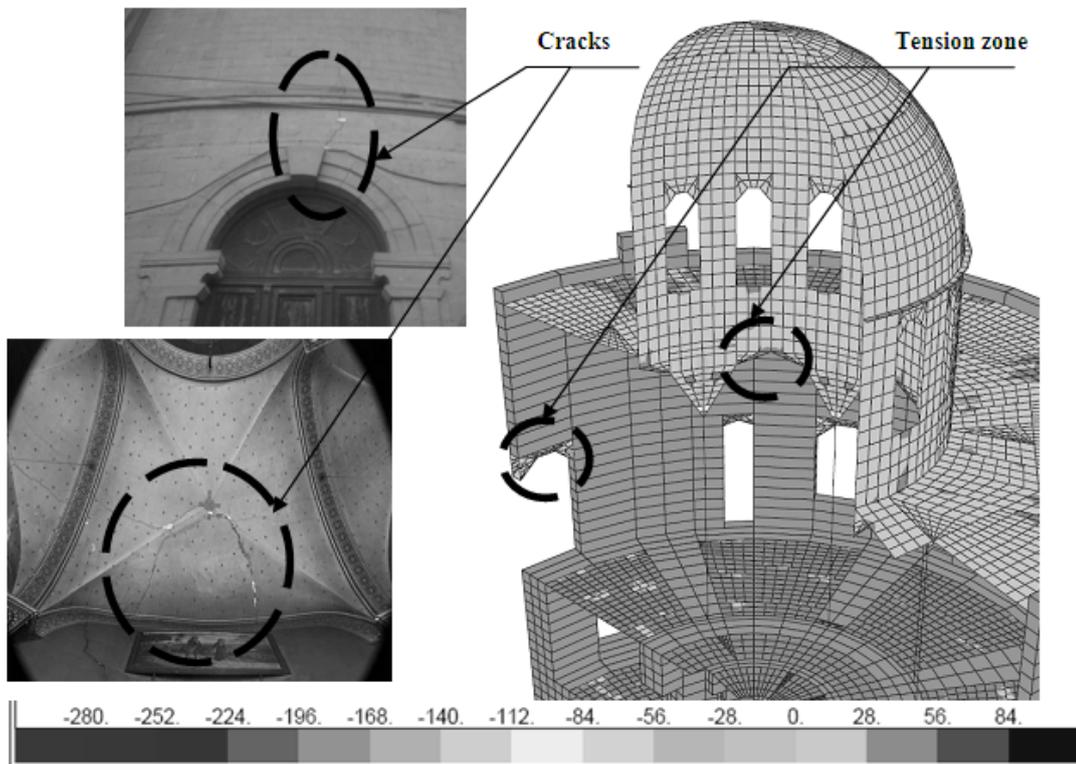
Figure 3. High Tension Stresses in the Arches and around the Openings

The structural characteristics of the building are analyzed on the basis of linear-elastic analysis. A comparative analysis of results obtained from the model and the presence of the major cracks can easily be predicted. The stress distribution represents the zones of the large tensile stresses. The cracks are assumed to occur when the tensile principle stresses exceed the tensile ultimate strength of the material. The direction of the crack is perpendicular to the direction of the tensile principal stress. The comparative analysis of the results presents a clear explanation for the position of the cracks, as shown on figure 3.

- The loss of integrity of the structural system due to the low tensile capacity of masonry, occurrence of cracks at each storey level and separation of the massive walls from the rigid parts of the structure. These cracks are concentrated around the openings (windows and doors) where the stresses from the model proved the presence of high tensile where the main cracks were found.
- Failure or damage to the secondary decorating elements (gypsum plaster for the inside of roof slab) due to amplified effects and low bearing capacity.
- The differential settlement widened the existed cracks and initiated new cracks.
- Shear failure of walls or the upper parts due to the poor quality of mortar and low shear force resistance.
- The dynamic analysis of modes of failure and the dynamic characteristics proved that the structure is sensitive towards the expected possible earthquakes.

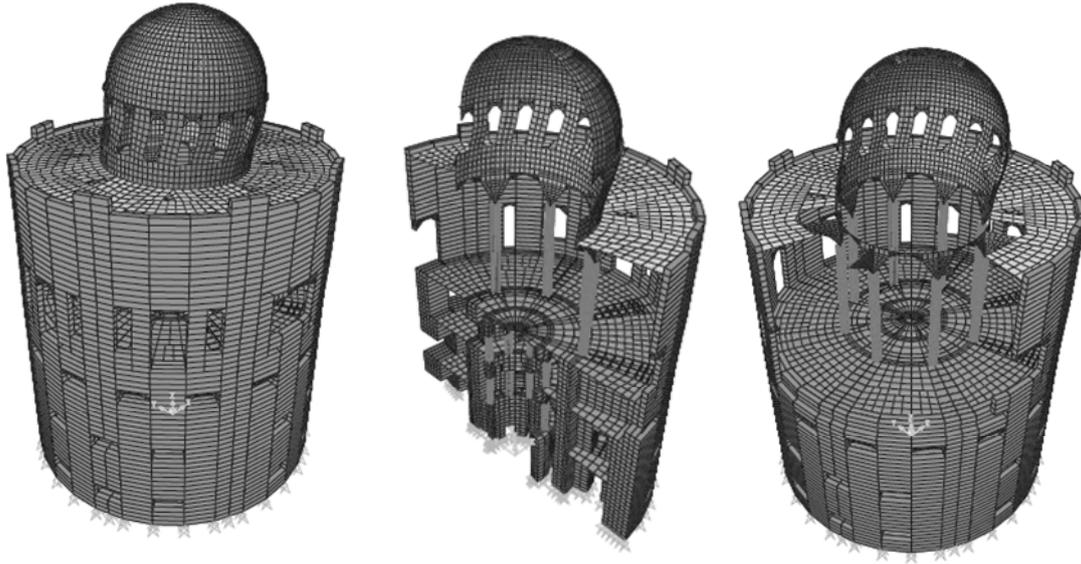
Figure 4. Mode Shape Number 1 Time period (0.46797 second)

The Dynamic characteristics of the structure have been made based on the modal analysis. The analysis determines the un-damped free vibration mode shapes and frequencies of the system. Six modal analyses have been considered however the first mode shape is sufficient as it is the lowest-frequency mode (Longest period). Figure 4 shows the modal shape number 1.
