## Condition assessment of a damaged reinforced concrete building according to Fib Model Code 2010

**ABSTRACT:** The Model Code 2010 treats the problem of structural conservation by defining the activities aimed at maintaining a structure to a state which satisfies the defined performance requirements. The approach recommended in the Model Code 2010 has been applied to a damaged reinforced concrete building, built in the fifties and now owned by the public administration, devoid of a Condition Control Plan in place. Following the Model Code suggested procedure, a diagnostic campaign, including several non destructive investigations such as visual inspection, magnetic bearing of reinforcement, sonic tests, rebound hammer test, has been carried out on a significant and safe sample of structural elements. Strategies adopted for building conservation and assessment are illustrated and discussed, along with outcomes of the diagnostic campaign.

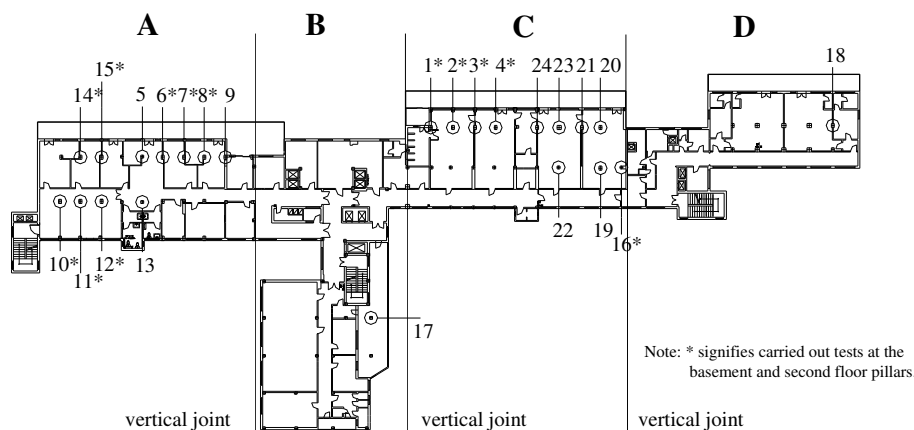
Figure 1. Horizontal plane section of a generic level, with vertical joints and tested pillars reported.

The structure consists of four building bodies connected by three vertical joints (Figure 1). The building has 1,307 pillars distributed as follows: 194 in the first five levels (basement, ground floor, first, second, third floor), 179 on the sixth level (fourth floor) and 168 on the seventh level (fifth floor). The very high number of pillars has led to the selection of a significant, safe and representative sample of them, respecting, when possible, the facilities of the building.

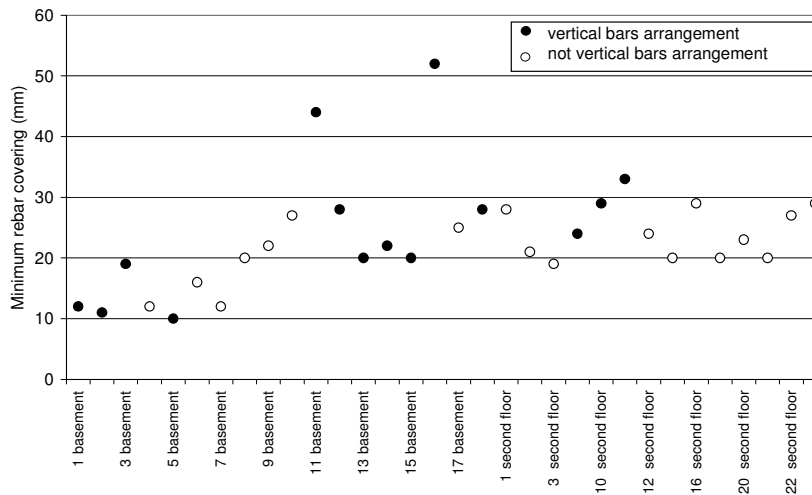
The electromagnetic rebar location showed the number and the diameter of longitudinal bars, confirmed by some low-invasive samples, as well as the distance between stirrups and the reinforcement covering thickness. Results showed that longitudinal bars were not perfectly vertical, therefore covering thickness was not constant either (Figure 4). This might be due to both the pressure exerted by the casting of the fluid concrete and by the concrete vibration. These outcomes were very useful to evaluate the covering thickness and to define the kind of restoration required on bars and pillars.

Figure 4. Minimum rebar covering for each pillar.

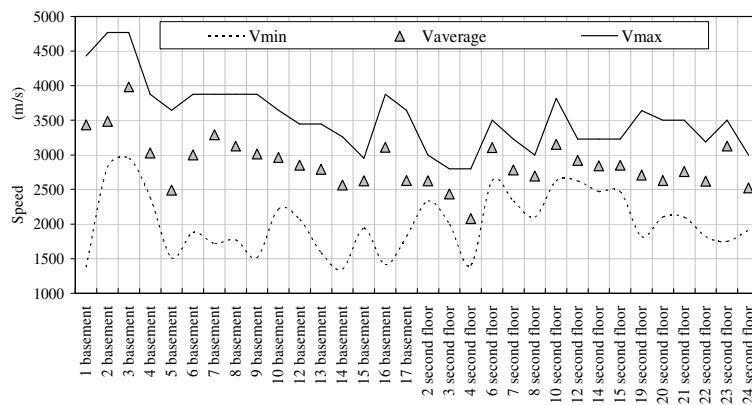
Sonic tests performed on the basement pillars showed uniform results; the average velocity value was about 3,000 m/s, thus matching with the concretes fairly good elastic-mechanic characteristics, Popovics (2003). Some pillars showed lower velocity in restricted regions of the investigated surfaces; in these areas the hammer produced a dull noise and the waveform was very jagged, due to the vibration of the hit material. This occurrence indicated the external covering detachment, due to the lack of adhesion between plaster and concrete and between bars and covering. Tiled pillars showed higher velocity, as if the covering had protected the material against environmental attack. Pillars located on the second floor showed a very uniform behavior, the average velocity being about 3,000 m/s and the lowest value about 2,000 m/s. Figure 5 shows average, maximum and minimum sonic velocity of pillars.

Figure 5. Average maximum and minimum sonic velocity.

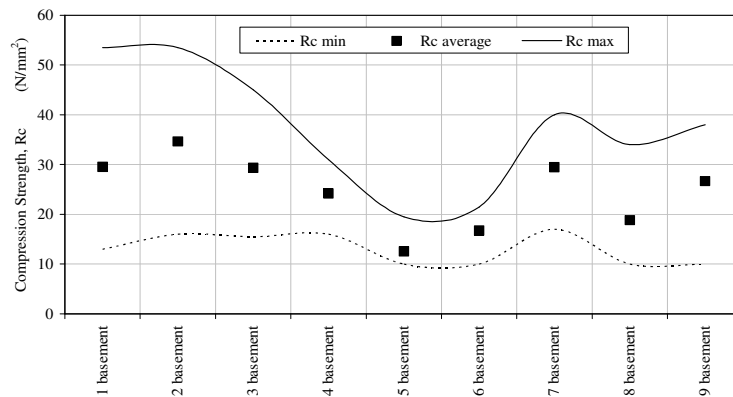
Average concrete strength value estimated by the rebound test hammer was high, but the results were considerably scattered and the range between maximum and minimum strength values was about 76%. This occurrence depends on the poor quality of the external concrete and on the detachment between bars and covering, which strongly affect the test. Figure 6 shows average, maximum and minimum strength for each pillar. Rebound hammer data is highly affected by the condition of the external concrete, while sonic data depends on the inner material condition. Thus, the two tests comparative evaluation strongly reinforced that the pillars core was in fairly good condition, and the damage was mainly reserved to the concrete covering.

Figure 6. Compression strength estimated by the rebound hammer test.

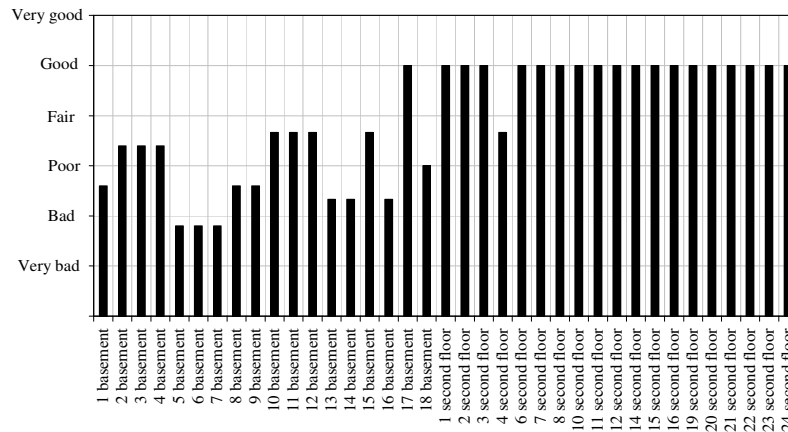
After considering outcomes of the survey on the whole, the absence of damage due to excessive load was confirmed. Results suggested that damage was primarily due to the physical-chemical degradation process. When the relative humidity ranges between 50% and 80%, concrete being porous and permeable the corrosion speed is particularly high and thus it is essential to recreate bars passivity, even of those ones not highly damaged yet. On the basis of the tested sample (3.5% of buildings pillars) it could be affirmed that the 50% of pillars were not damaged and did not need any kind of restoration, 20% needed to recreate the passivity of bars in order to stop corrosion, and 30% needed a more intensive action because of the relevant corrosion and the concrete damage. Figure 7 summarizes the pillars conditions resulting from the tests.

Figure 7. Pillars condition resulting from NDT.

In order to reduce the humidity level, a large-scale intervention is needed. Pipes should be checked, laundry steam channelized, air circulation increased and solutions for soil capillarity effects avoiding adopted. Walls, partitions and pillars should be dehumidified by creating a chemical barrier with hydro-repulsive abilities but assuring perspiration: in this way pores are modified and lose the tendency of absorbing soil water. A macro porous and anti-moisture plaster is also necessary, at least up to 1.5 m from the floor. The diagnostic campaign highlighted that pillars restoration should be targeted depending on a pillar's individual damage. This would allow a correct restoration plan to be programmed and a realistic restoration cost to be estimated. The main goal is the reinforcements restoration, that should be achieved by

removing any damaged concrete covering and by cleaning bars carefully through brushing and sand blasting. All operations should be done manually, not producing excessive vibrations and not damaging healthy concrete either. Next, bars should be treated with an appropriate product in order to restore their passive layer. After this, the concrete pillar transversal section should be restored by adopting different tactics depending on bars diameter reduction.
