Reinforcement Corrosion of a Post-Tensioned Steam Cured Concrete Jetty in the Persian Gulf Region

Masoud Moradian¹, Mahdi Chini², and Mohammad Shekarchi³

¹ Researcher, Construction Materials Institute (CMI), Tehran, Iran

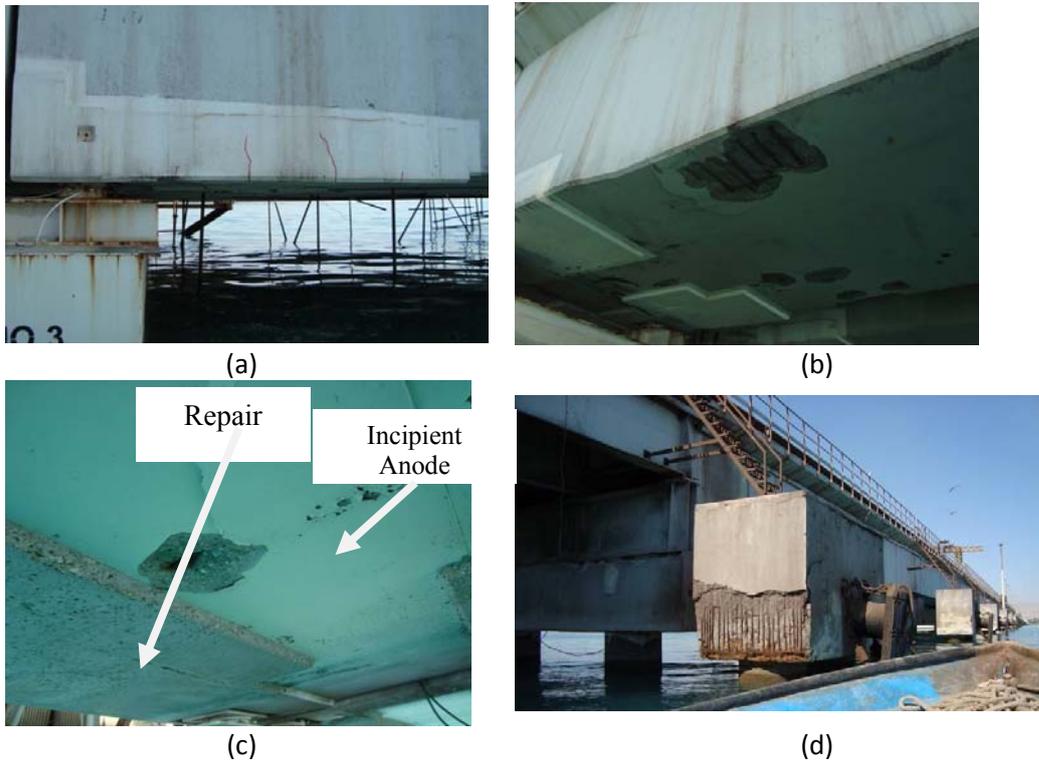
2-Most of the repair works were unsuccessful and cracks were visible in surrounding areas. It seems that the most important cause of this phenomenon is incompatibility between repair and base concrete. Moreover, a structural weakness is possible near the supporting points where the shear forces are maximal (Figure 2-a).

3-Extensive reinforcement corrosion was visible in the bottom of channel bridge (Figure 2-b). Low concrete cover thickness, high humidity under the jetty and possible splashing of seawater could be the main causes.

4-Patch repair works caused the formation of incipient anode in vicinity areas which is the sign of electrochemical incompatibility (Figure 2-c).

5-High rate of corrosion was visible in fenders and some other areas near the seawater (Figure 2-d).

Figure 2- a) Crack occurrence in supporting points b) reinforcement corrosion under Channel bridge c) formation of incipient anode d) corrosion in fenders

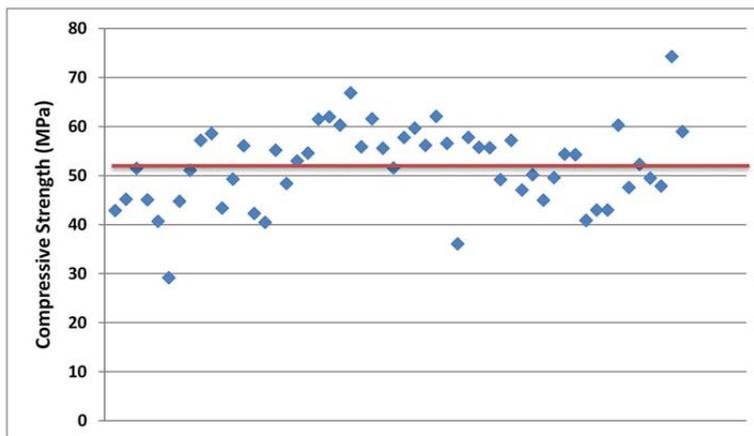
Concrete cores were drilled from different parts of the jetty for determination of compressive strength and water absorption according to ASTM C 42 and BS 1881-122, respectively. Figure 3 illustrates compressive strength of more than 50 obtained cores. The average value is more than 50 MPa with a standard deviation of 8.1 MPa which implies suitable mechanical properties of the concrete. High value of compressive strength was expected based on the mentioned mix design; results of tests on concrete cores confirm appropriate casting and curing procedure. This is very good compared with other structures that have been built in Iran. It is mentioned that the minimum water-to-cement ratio recommended by ACI 357 (ACI 1997) in a marine environment is 0.4 for the splash zone, and the minimum recommended compressive strength is 35 MPa. Thus, the mechanical quality of the used concrete was in accordance with common standard codes.

Figure 3. Compressive Strength in different parts of the jetty

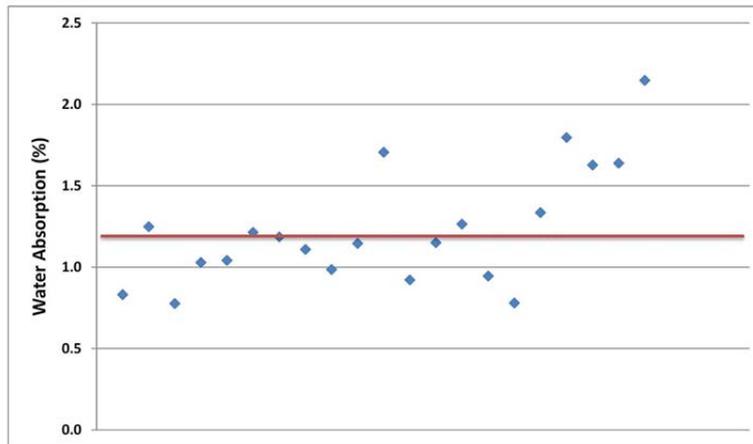
Figure 4 also shows 30 minutes water absorption test on 21 concrete cores. The average is about 1.2% which indicates high quality of the concrete. There is no significant standard that provides a criterion for the water absorption or void content value because these parameters depend on various conditions such as aggregate type. However, the Iranian national code of practice for concrete durability in the Persian Gulf and the Sea of Oman (BHRC 2005) has limited 30-min water absorption to 2% for severe conditions. Therefore, almost all of the samples were acceptable according to this standard. Based on the results of compressive strength and water absorption, the quality of concrete used in construction of the jetty seems to be above the acceptable values in references. Further tests were performed to confirm this idea. The results of electrical resistivity test on concrete cores are presented in the next part.

Figure 4. 30 minutes water absorption in different parts of the jetty

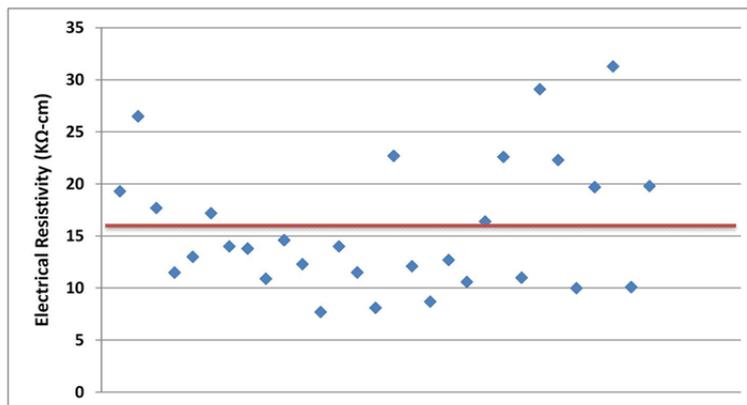
The average electrical resistivity of the concrete is about 15.7 K Ω -cm. The ACI 222R-01 code provides some ranges in which the concrete resistivity and corrosion rate may be related. Based on this reference, the rate of corrosion is low which means high quality of the used concrete.

Figure 5. Electrical resistivity of concrete cores in different parts of the jetty

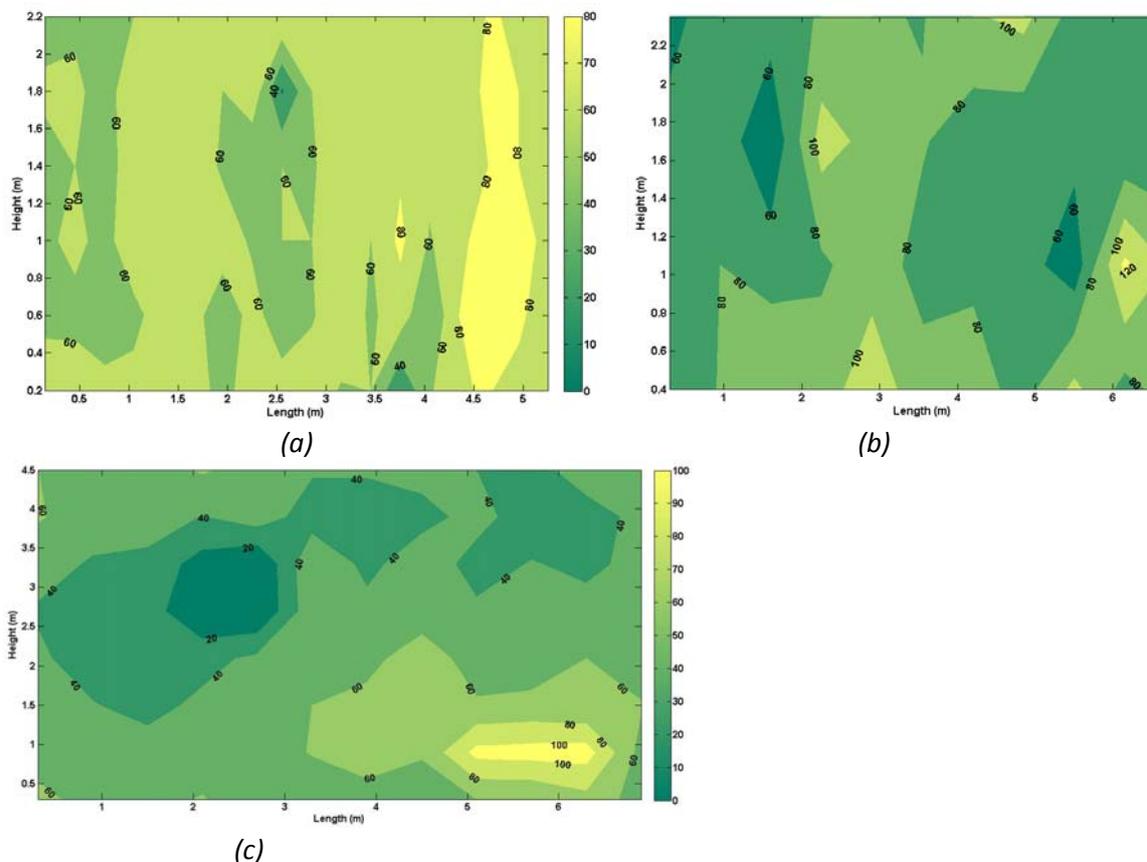
Concrete cover is the main protective layer against weather and other aggressive effects, and the time to corrosion initiation for conventional carbon steel is most sensitive to its cover depth (Zhang et. al.). The concrete cover for steel reinforcement was measured, and the results indicate that the cover thickness varies in different parts of the jetty. Figure 6-a, 6-b, and 6-c illustrate the cover thickness in bottom of a beam near the coast, an area on channel bridge and uploading pier, respectively. As can be seen in the figures, the cover thickness in (a) and (c) is less than (b). However, in most areas of (a) and (b), the cover thickness is more than 50 mm. For splash and atmospheric zone exposure conditions, a minimum concrete cover of 90 mm should be used American Concrete Institute (ACI) 357R-84. It is noteworthy that there were

some areas in bottom of channel bridge with a cover thickness of less than 20 mm (Figure 2-c). Though, access to those areas was not possible and visual inspection adopted for investigation.

Fig. 6. Cover thickness (mm) in a) bottom of a beam near the coast, b) an area on channel bridge, c) an area on unloading pier

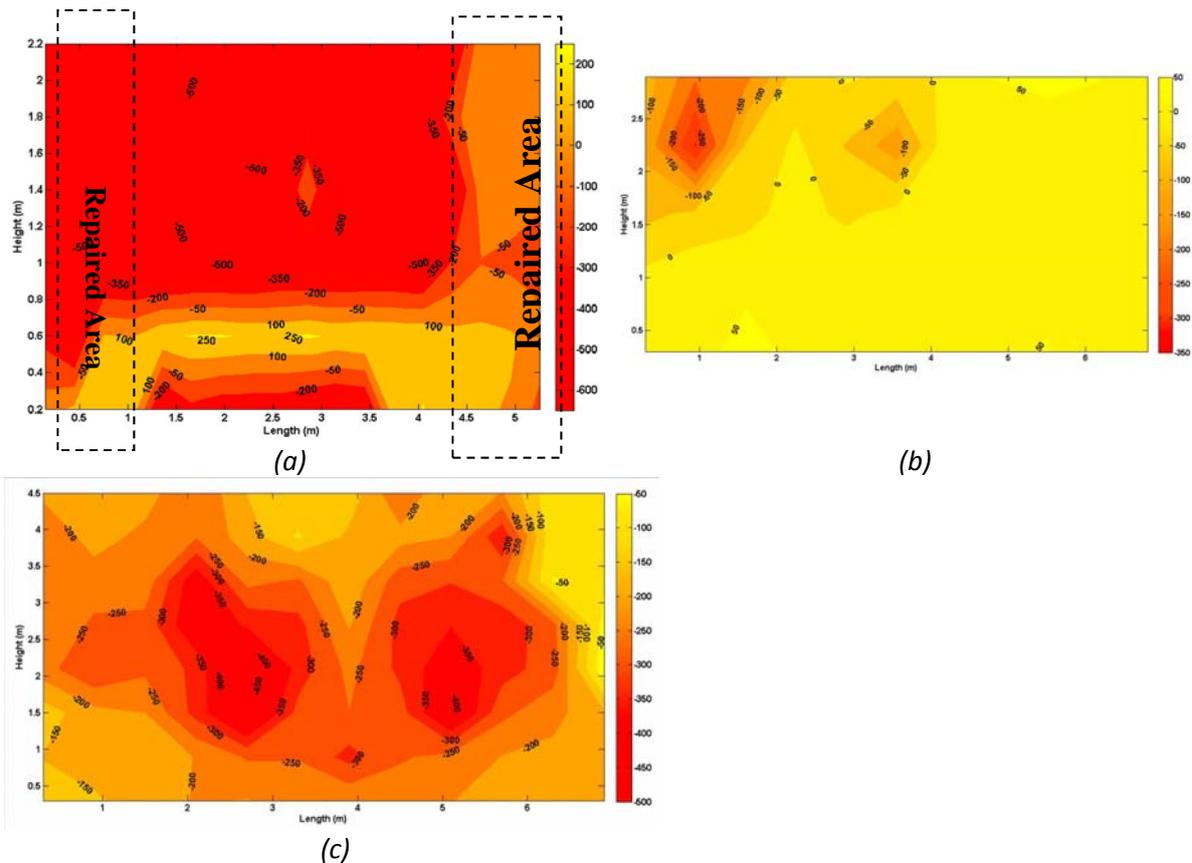
The half-cell potential contours in different parts of the jetty are presented in Figure 7. Repaired areas is shown in Fig 7-a. Based on the ASTM C876, the probability of corrosion is more than 90% in most areas of this surface. The repaired areas have become a cathode which accelerates the corrosion in neighborhoods. In addition, repaired areas themselves have critical potentials as well. Thus, the patch repair work seems to be unsuccessful in this case. The reasons could be

insufficient cover thickness, humidity of this part of the jetty, possibility of splashing of the seawater, and hot climate of the region. Wet surface of this part was visible in visual inspection. In spite of high rate of corrosion in (a), the process of deterioration in upper and inner sides seem to be substantially lower or negligible. Only some local corrosion occurrences were detected in channel bridge (Figure 7-b). The test was performed on several other areas of this element of the jetty. High quality of concrete and adequate cover thickness could be the reasons for lower corrosion. However, the corrosion rate was higher in uploading pier (Figure 7-c). Lower cover thickness and position of this part in the sea could be some possible causes.

Figure 7. Half-cell potential contours (mV) in a) bottom of a beam near the coast, b) an area on channel bridge, c) an area on uploading pier

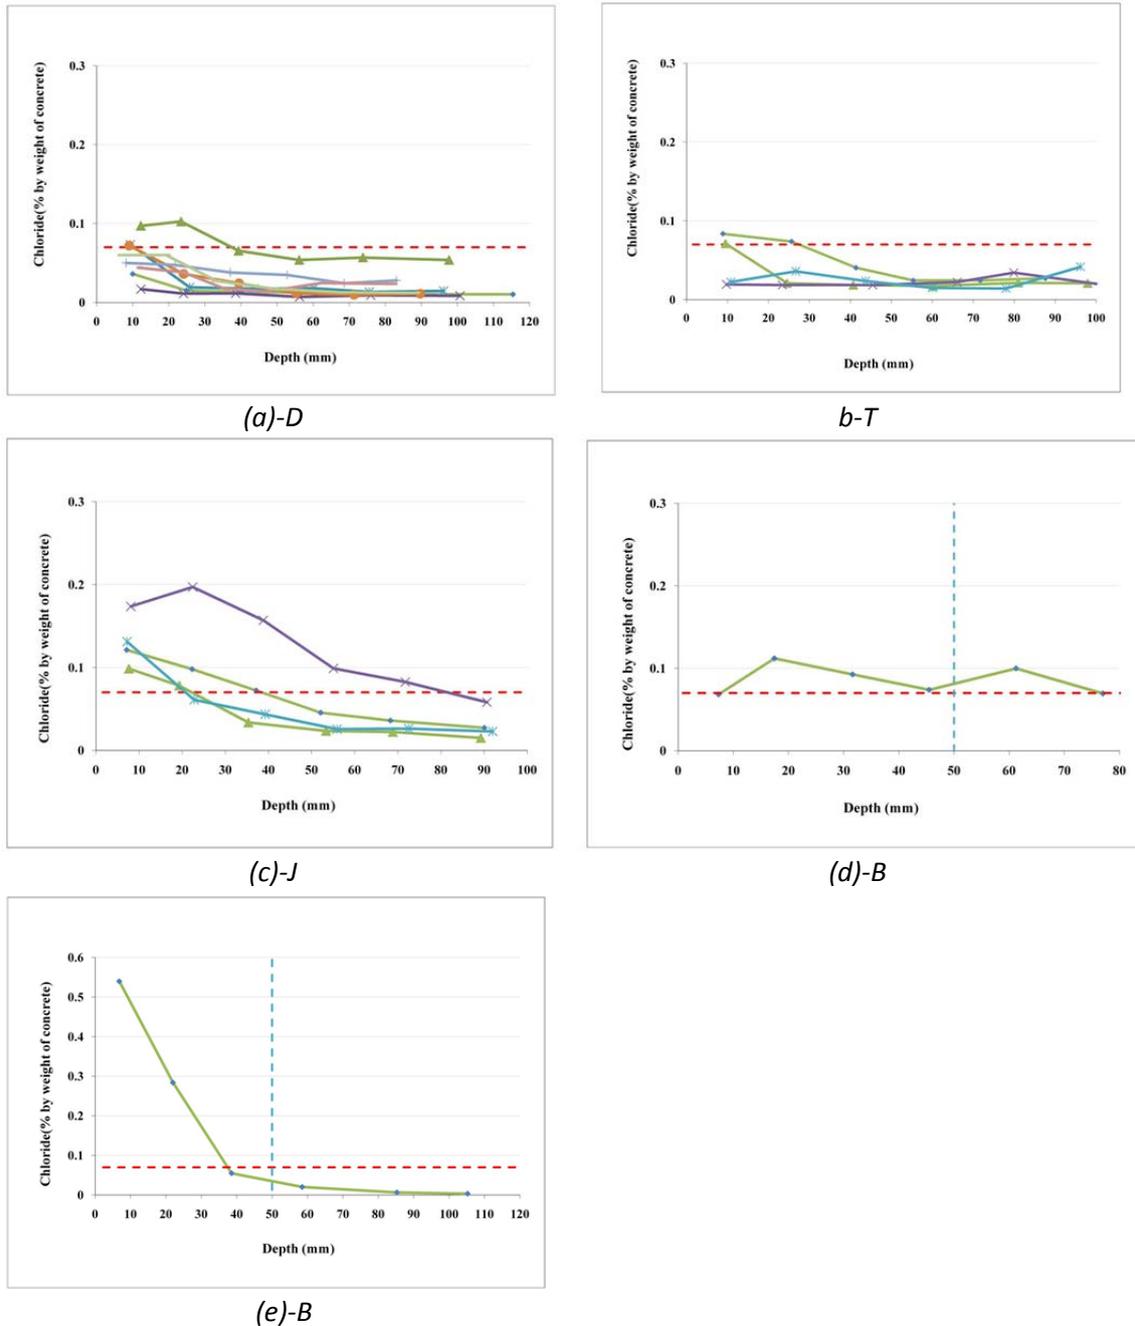
This test was performed on powder samples obtained from the selected structural members at different depths of the concrete. The chloride content measurement was carried out in the laboratory according to ASTM C114 and results are presented in Figure 8. According to report of Angst et al. the chloride threshold value for corrosion initiation of reinforcement considered between 0.015 to 0.3 percent by concrete weight. BS 8110, recommends 0.4% chloride content by weight of cement as the threshold value. The chloride content on top of channel bridge and inner surface of beams was low (Figure 8-a and 8-b). Minor signs of corrosion were visible on these areas. However, chloride penetration in uploading pier was higher comparing to mentioned parts (Figure 8-c). Chloride ions have penetrated to some concrete surfaces near the seawater (Figure 8-d).

Effectiveness of repair works was examined in one location near the coast by measuring chloride penetration as well (Figure 8-e). It seems that the applied repair was not useful and chloride ions penetrate into the concrete. Meanwhile, carbonation test was performed on several points of the jetty using the traditional RILEM CPC-18 method and a negligible depth of carbonation was observed. It is known that high humidity and salt crystallization on the surface of concrete elements in marine structures usually prevent CO₂ diffusion as a protection against carbonation (Castro & AlKhaiat).

Figure 8. Chloride profiles a) on top of channel bridge b) inner parts of Channel bridge c) in uploading pier d) in a surface near the seawater e) in a repaired point

Considering great economic and strategic importance of the jetty, it should be repaired without substantial disruption in operation. The repair methodology adopted consisted of the total removal of the superficial layer of deteriorated and chloride-contaminated concrete in bottom of channel bridge to a depth beyond the reinforcing bars, and replacement by a new high-quality concrete. Several bars were corroded and they must be replaced with new ones. Repair concrete must be compatible with substrate and durable with a sufficient cover thickness. Concrete mix properties like low w/c ratio or admixture addition could substantially affect the durability of concrete in the marine environment. Using concrete with lower w/c ratio including pozzolanic admixtures especially silica fume, improves the permeability and resistance to chloride diffusion into concrete structures in marine environment. It must be noticed that dimensional compatibility between substrate and repair concrete must be considered. Dimensional and electrochemical incompatibility between repair and substrate concrete causes further corrosion in repaired areas. Eventually, use of proper type of available coatings on the new casted concrete repair could increase the life time of the structures (Shekarchi et al.).
