Sustainable Rehabilitation of Corroded Bridge Columns

Shamim A. Sheikh¹ and James Liu¹

¹ Department of Civil Engineering, University of Toronto, Toronto, Canada

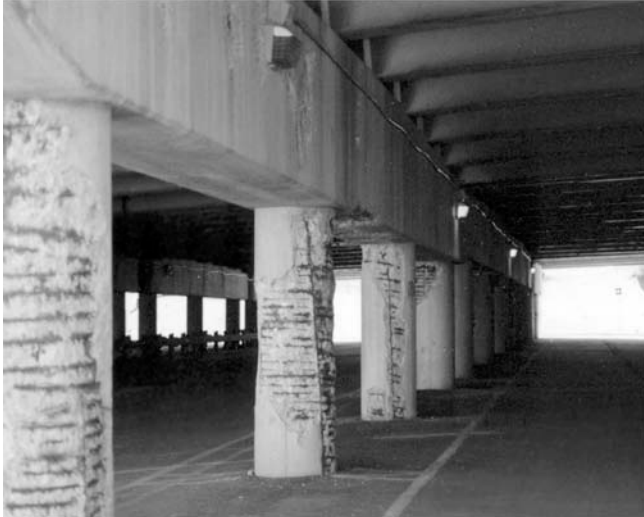
Environmental effects, ageing, overloading and updated stricter code provisions make numerous structures deficient. One of the most serious conditions under which the steel-reinforced concrete structures are damaged is the use of de-icing salts combined with cycles of freezing and thawing. A case study involving highway bridge columns that were damaged by corrosion of steel due to the application of de-icing salt and extreme weather conditions is presented here. Figure 1 shows the conditions of the bridge columns before repair. These columns are about 800 mm in diameter and the bridge was built in 1960s. The concrete cover was completely spalled off and the effectiveness of spiral steel had diminished significantly. The traditional repair techniques for corroded structures generally last only a few years before a repeat of repair is needed. These techniques are cumbersome and in most cases need closure of structures for long periods of time. An innovative and durable solution that involved the use of expansive or non-shrink grout and GFRP wraps was developed during this research leading up to the repair of field columns. The idea behind this technique was to seal the structure such that the corrosion process is starved of its essential ingredients such as moisture and air and the corroded lateral steel is compensated with GFRP. This would eliminate the need for removing the contaminated concrete and steel thus substantially reducing the cost of repair.

Figure 1. Corrosively damaged bridge columns.

Columns in the damaged bridge, as shown in Figure 1, were repaired using the techniques discussed above without the plastic sheet. Four of the columns with three different repair schemes were monitored for several years.

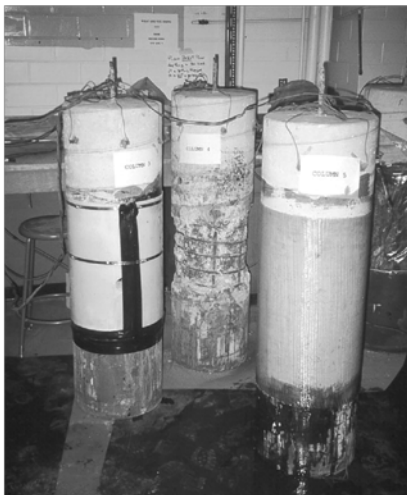
As noted above, a laboratory-based research program was carried out to investigate the feasibility of the proposed repair technique. In the first test series, half-scale specimens of bridge columns were constructed and tested under axial load. Five 406 mm diameter \times 1.37 m long columns were constructed with 6-20M longitudinal steel bars and a 10M steel spiral with 75 mm pitch. Thirty four days after casting, four of these column specimens were subjected to accelerated corrosion to cause damage similar to that observed in the field. Figure 2 shows the damaged columns in different stages of repair. Three corroded columns were repaired using various retrofitting procedures. The un-repaired column damaged by corrosion acted as control specimen along with the un-corroded healthy column. The repair schemes were designed to minimize the costly fieldwork. Therefore, the corroded steel and the contaminated concrete were not removed from the damaged columns.

Figure 2. Simulated corrosion damage of columns and repair schemes.

One damaged column was built back to original shape with a commercially available rheoplastic, shrinkage-compensated mortar called Emaco. This cement-based mixture contained propylene fibres and silica fume. After 24 hours of curing, the column was wrapped with two layers of GFRP. The second column was repaired with grout based on expansive cement especially developed for high expansive potential (Sheikh et al 1994). A 3 mm thick polymer sheet reinforced with polyethylene fibres was wrapped around the damaged area of the column and held in place with five clamps so as to act as a formwork for the expansive cement mortar. Four hours after grouting, the column was wrapped with two layers of GFRP on top of the polymer sheet which acted as a barrier between fresh grout and the GFRP wrap. The third column was repaired in a similar manner using non-shrink cement known as Type K. The columns were stored in the lab at 23°C temperature and about 50% relative humidity for three months before they were tested under axial load for their short-term mechanical behaviour. The results from the tests on four columns are presented here in Figure 3 along with the tested columns.

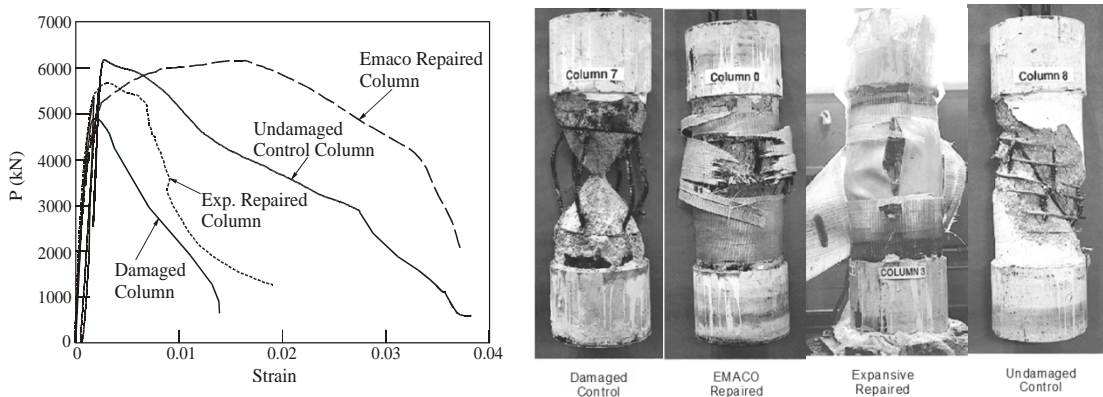
The corrosion in the lab specimens was limited to spirals as was the case in the columns of the bridge and caused about 20% reduction in strength and much larger reductions in ductility and energy dissipating capacities of the column (Figure 3). Pitting corrosion of spiral reduced area of steel drastically making it ineffective for confinement and caused its rupture at relatively small column strains. Repair improved the behaviour of damaged columns significantly. The axial load carrying capacity of the Emaco-repaired specimen was as large as that of the undamaged control column and its ductility and energy dissipation capacity were substantially better. The columns repaired with Type K and expansive cements behaved similarly and did not display good performance due to the fact that at large strains the plastic sheet of the formwork used in these columns opened out and engaged the fibre wrap at both ends, causing large local strain and premature failure of the wrap and the column. Uomoto and Nishimura (1999) had reported based on lab studies in which fibres alone were immersed in sodium hydroxide solution, that alkalis adversely affected the properties of glass fibres. The plastic sheet in the two columns was used to separate the GFRP wraps from the fresh cement and concrete products. In other repaired columns, the repair patches were covered with a protective epoxy coating to avoid direct contact between the new cementitious material and GFRP.

Figure 3. Response of columns under axial load and columns at the end of test.

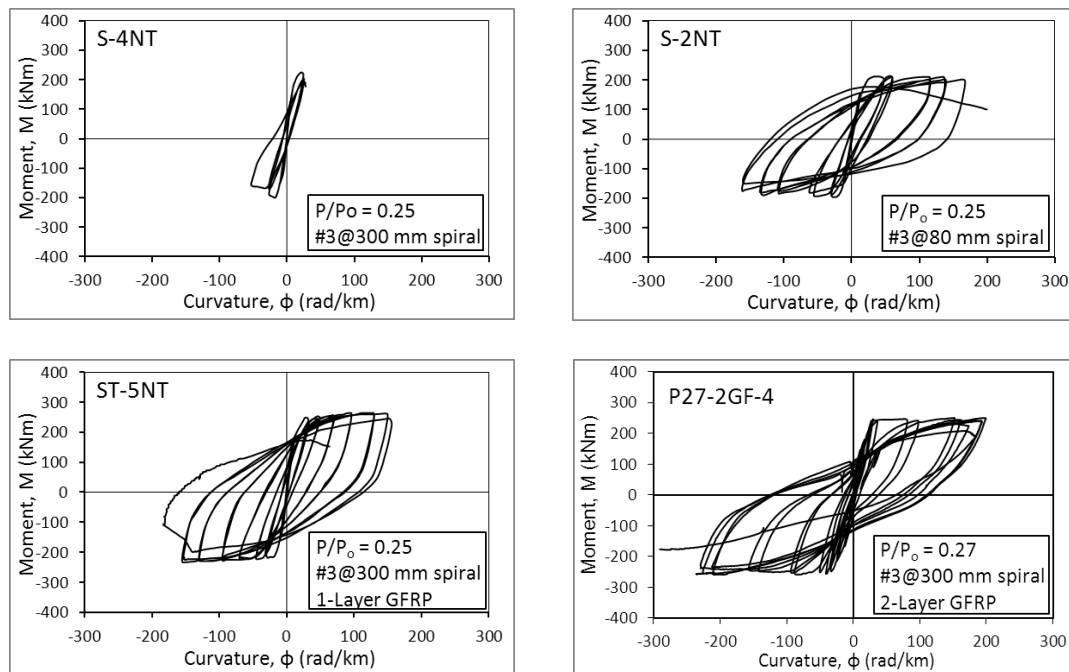
Figure 4 shows the moment vs. curvature responses at the critical sections of these specimens. It is obvious from the figure that the control specimen S-4NT failed in the 4th lateral displacement cycle in a brittle manner indicating that the confinement provided by this kind of widely spaced spirals was almost negligible. Columns with deficient lateral confinement have very low ductility and energy dissipation capacities which may lead to brittle collapse of structures.

Figure 4. Moment vs. curvature responses of four circular columns.

Comparing the behaviour of columns S-4NT, SN-5NT and P27-2GF-4, it was concluded that substandard concrete columns were effectively retrofitted by externally bonded GFRP wrapping, which could significantly improve the seismic performance of columns and resulted in a remarkable increase of ductility and energy dissipation capacity. Furthermore, the behaviour of GFRP-retrofitted columns SN-5NT and P27-2GF-4 under simulated seismic loading exceeded the seismic performance of the conventional steel-confined column S-2NT which was designed in accordance with the seismic provisions of ACI 318-95. Columns retrofitted by FRP wrapping showed little degradation of flexural strength with the increase of lateral displacement excursion, which was distinguished from the seismic behaviour of conventional steel-confined columns. The experimental results showed that substandard columns with deficient lateral confinement can be effectively retrofitted by externally bonded FRP wrapping with relative ease to improve the seismic resistance of columns.

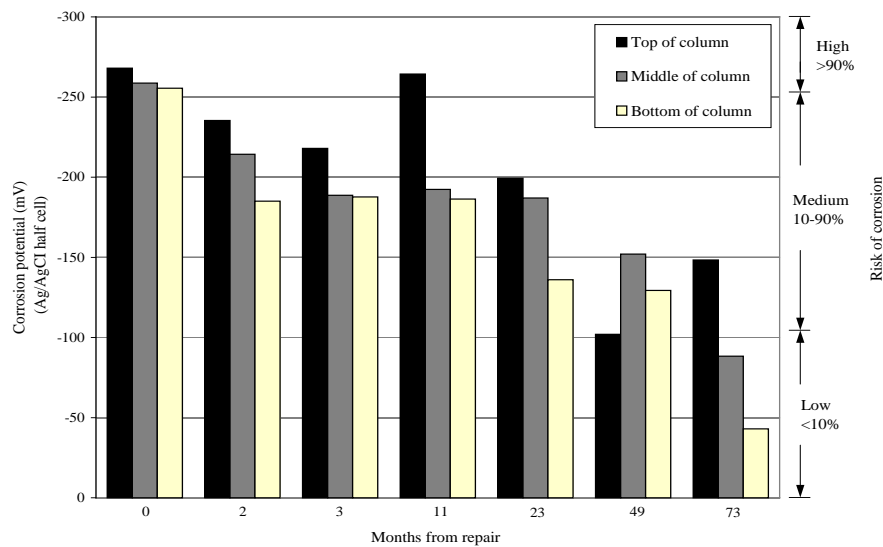
The corrosion activity was measured by embedding three half-cells in each of the four columns. The cells were placed at the top, middle and bottom of the columns. Table 1 shows the data from these cells for over nine years. Figure 5 shows the average corrosion activity and the related risk of corrosion in the four columns reduced continuously over the years. The GFRP wraps seem to have starved the corrosion process of essential ingredients of oxygen and water. It can be seen from Figure 6 that the repaired columns have been performing in an excellent manner over the last 15 years of service under severe weather conditions. Unlike the traditionally repaired structures these columns did not need any repeat of repairs.

Figure 5. Corrosion potential and risk in repaired bridge columns.

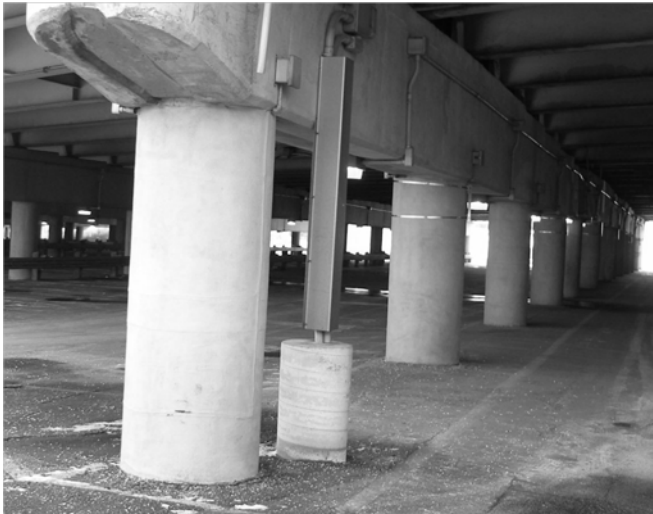
Figure 6. Repaired columns after fifteen years of service.

In addition to visually monitoring all the repaired columns for soundness, data from the four instrumented columns was recorded regularly for over 10 years. The FRP-repaired columns have been in service for more than fifteen years and have displayed excellent performance without requiring any additional repair work. In the procedure used for repair, the corroded steel and the contaminated concrete were not removed from the structure and even then the corrosion activity and risk of corrosion in the columns reduced significantly with time. Columns strain data indicated no impending deterioration. Based on the laboratory studies and field monitoring, it was concluded that the repaired field columns have load-carrying capacities of at least equal to that of the originally designed columns and significantly higher ductility and energy dissipation capacity. This study combined the laboratory research with field applications and long-term monitoring of structures. Results from this work show that monitoring of a representative number of field elements can provide an economical, valuable and often an essential source of information for designing the laboratory specimens and for evaluating the health of a structure.
