## Integrated approach for rapid seismic assessment of the existing building stock

Roberta Apostolska<sup>1</sup>, Golubka Necevska-Cvetanovska<sup>1</sup>, Veronika Sendova<sup>1</sup> and Julijana Bojadjieva<sup>1</sup>

<sup>1</sup> Institute of Earthquake Engineering and Engineering Seismology, Skopje, Republic of Macedonia

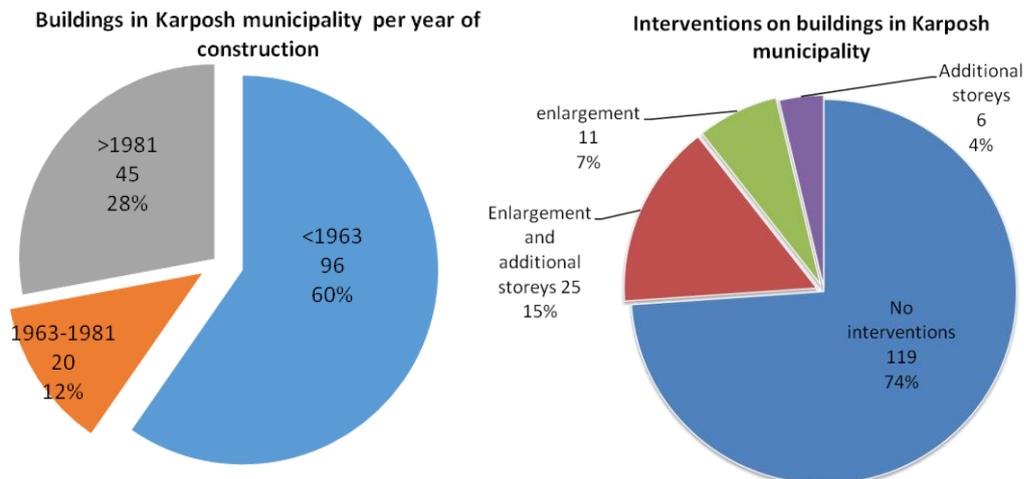
Figure 3. Review of structures in Karposh municipality classified according to: a) year of construction and b) number of interventions.

It obvious that more than half of the inspected structures are older than 50 years and were build prior enforcement of the seismic design codes (Fig. 3a) which emphasis the need of their maintenance and/or retrofitting. An increasing trend of building of different structural interventions on existing structures, is also present (Fig. 3b) thus inevitably arises the question about the seismic stability and safety of such new “hybrid” structures. This is even more

complicated because in most of the cases, the existing structures represent masonry structures which are design as non- seismic resistant structures.

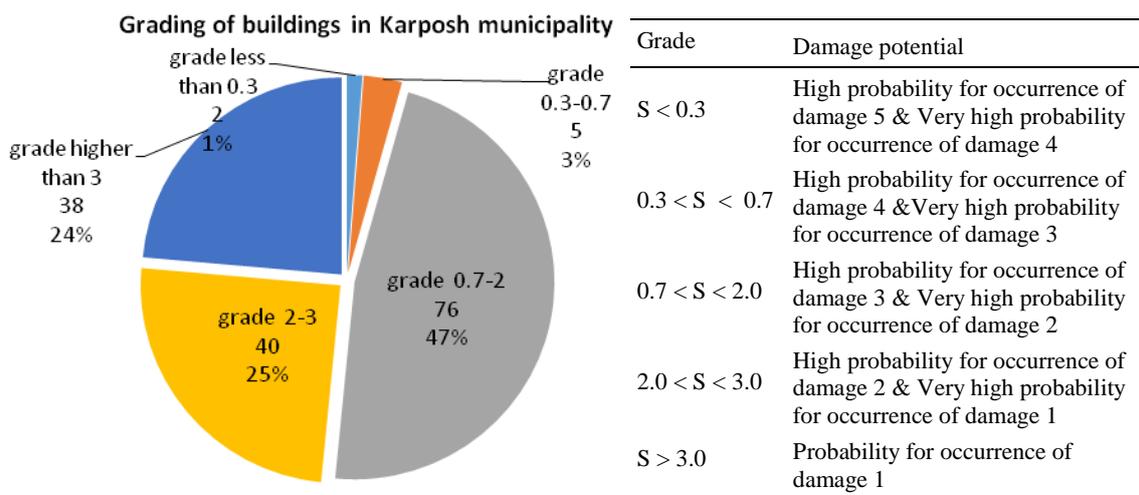
Figure 4. Review of structures in Karposh municipality classified according to grades obtained from the visual inspection.

Expected damage potential for the building evaluated according to the rapid visual inspection methodology presented in this paper is presented in Fig. 4. Based on these findings more than 50% of the inspected buildings (whose grades are less than 2) will need further more detailed evaluation.

It should be noted that obtained grades and damage classification levels corresponding to FEMA (2002) methodology.

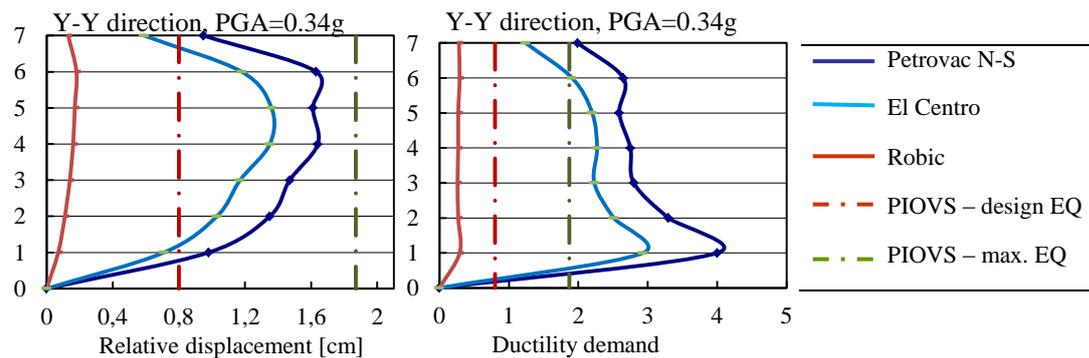
Figure 5. Relative displacement and ductility demands in Y-Y direction.

Figure 5 show the relative story displacements and ductility demand in y-y direction for maximum expected earthquake ( $a_{max}=0.34g$ ) at the considered location. Ductility capacities are defined using the methodology and a corresponding package of computer programmes for optimal design of new and performance evaluation of existing structures, (UNDP/UNIDO Project 1984, Necevska-Cvetanovska et al. 2000).

The presented results show that the ductility demands are higher than the traditional ones, Apostolska et al. (2012).

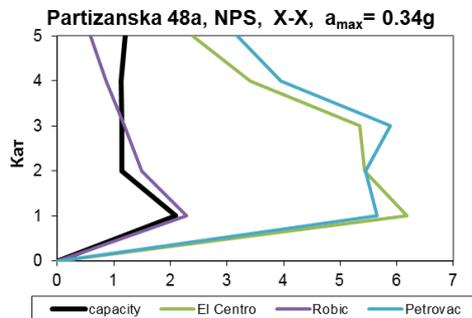
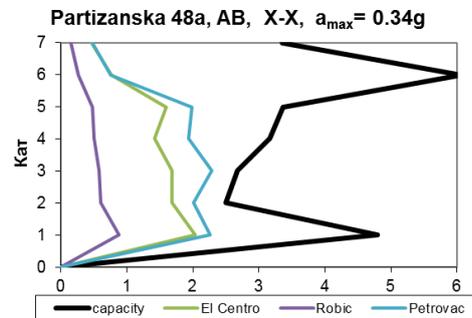
Figure 6 show the comparison between the ductility demand versus capacity for actual earthquake effects with intensity of  $a_{max}=0.34g$ , for each of the orthogonal directions and for both structures taken separately, Sendova et al (2012).

It could be seen that the ductility capacity of the masonry structure is considerably lower and vice versa, the ductility capacity of the newly constructed structure is considerably greater than ductility demand. This fact points to a considerably different behavior of both structures under the same earthquake intensity, i.e. different level of seismic protection.
