Rehabilitation of reinforced concrete gerber bridges

Stefan Kun¹, Dr. Rudolf Vogt², Oliver Leuenberger³

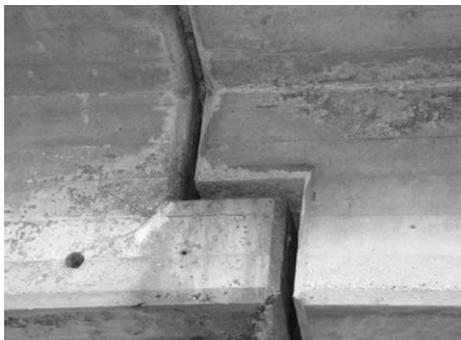
Traces of sintering on the visible joint surfaces and the concrete spalling and/or corrosion of the reinforcement were detected and evaluated in the main inspection reports every 5 years. In most cases, due to the restricted access to the interior of the joints it was impossible to obtain unequivocal findings regarding the condition of the reinforcement. In these cases, an assessment was carried out regarding the risk of corrosion of the reinforcement within the joints.

Fig. 1: Permeable joint and traces of sintering

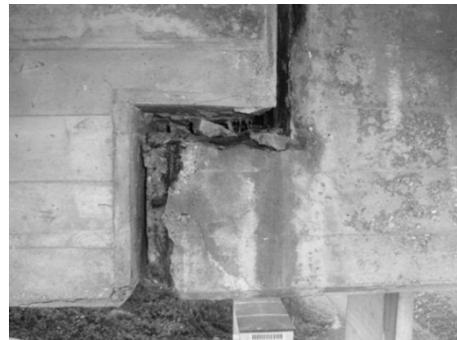
Fig. 2: Damaged hinge with spalling concrete and corroded rebars

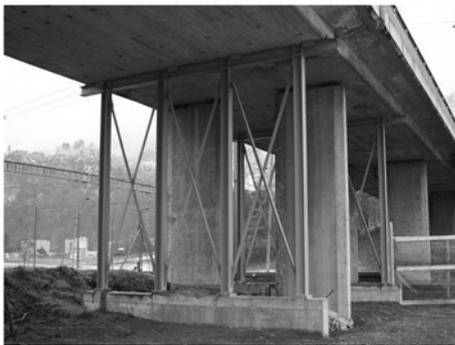
Fig. 3: Steel yokes beneath the suspended girder

In view of the alarming condition of the Gerber hinges, in 2008 steel yokes and/or support steel structures were installed under the hinges as an emergency measure (cf. Fig. 3). The steel yokes were installed directly beneath the Gerber hinges, as well as in the neighbouring midspan, since in the event of a failure of the hinges the bending moment at midspan would have exceeded the maximum permissible level.

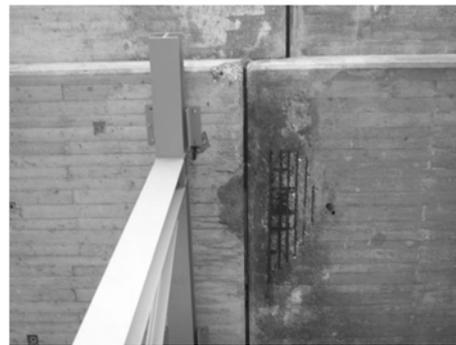
Fig. 4: View of the underside of the bridge deck

The suspended girders showed signs of significant tilting in some places, which had negative impacts on the adjacent constructions. The tilting in the vicinity of the hinges caused the concrete to break away from the bearing brackets so that some of the reinforcement was entirely or partially exposed (cf. Fig. 4). The suspended girders displayed major damage in the hinges. Some of the bearing brackets were partially deteriorated (cf. Fig. 2). Water containing chloride was able to penetrate into the open joints and carriageway expansion joints, thus giving rise to pitting and corrosion of the rebars.

This situation had to be regarded as extremely critical, since a failure of the bearing brackets of the hinge would have caused the bridge (or at least some parts of it) to collapse.

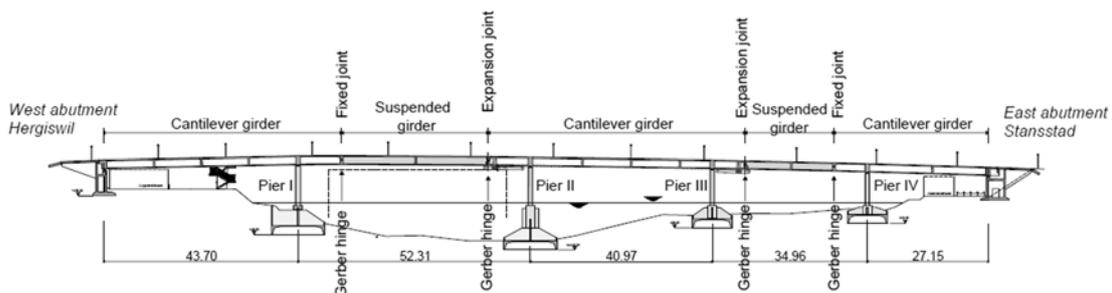
The inspections revealed that the bridge has suffered damage and needs to be repaired. The Gerber hinges and their surroundings were found to be in very poor condition as a result of the penetration of salty water containing chloride into open deck expansion joints over a long period of time.

Fig. 5: Longitudinal profile of the Acheregg bridge

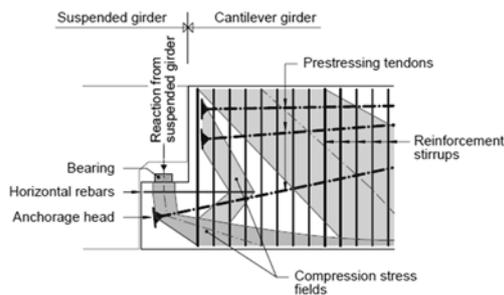
A detailed static calculation was carried out as part of this examination. For this purpose, the bridge was modelled as a three-dimensional girder grid in order to precisely calculate the distribution of loads over the four longitudinal girders. Based on standard methods of verification, it was not possible to produce evidence of adequate structural load bearing capacity in the vicinity of the Gerber hinges. In view of this, more refined calculation methods were used that incorporated truss models and tension fields (cf. Fig. 6). With the aid of this method, for the original condition of the bridge, i.e. without taking corrosion-related cross-section losses into account, it was possible to demonstrate a barely sufficient load bearing capacity for most of the bearing brackets at the Gerber hinges.

Fig. 6: Truss model for estimating the load carrying capacity of the brackets

As already noted, the corrosion of both the tendons and the statically relevant rebars could not be ruled out and it had to be assumed that the available load bearing capacity of the brackets is lower than nominally calculated.

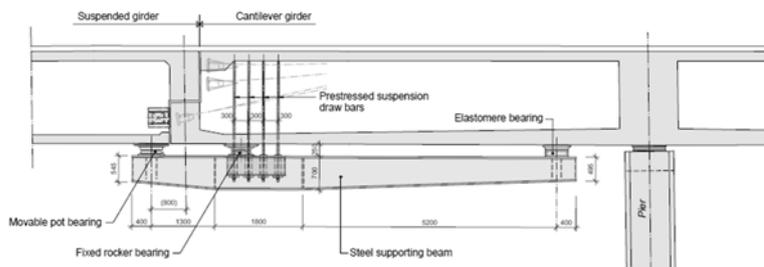
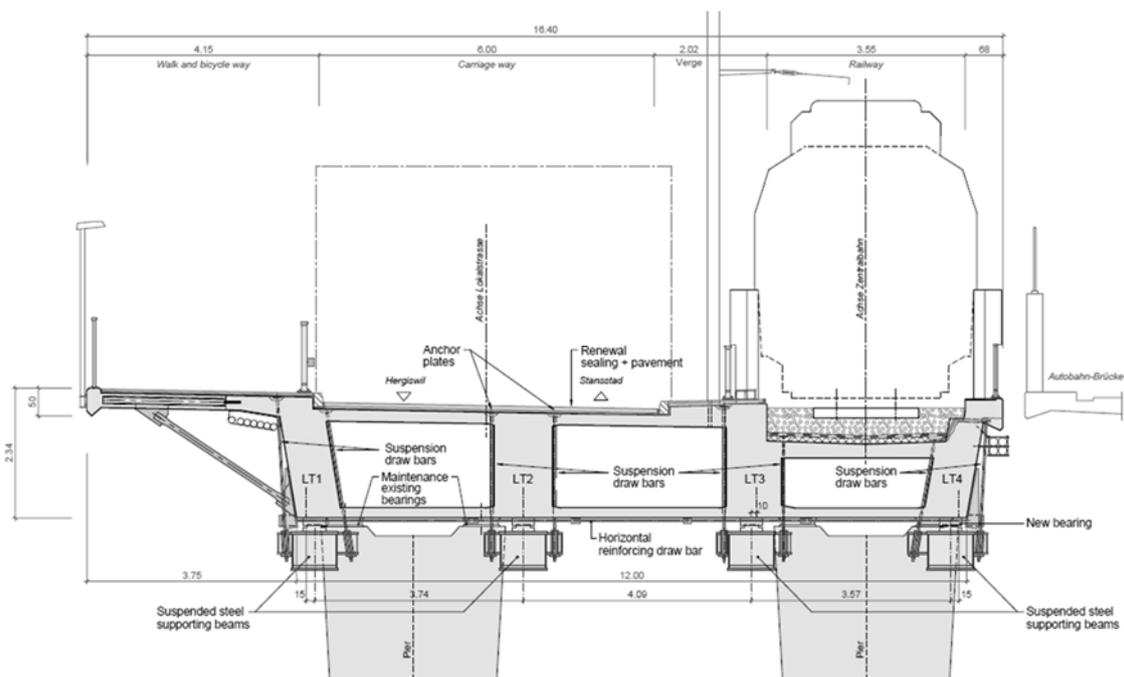
Fig. 7: Strengthening with steel cantilever beams beneath the bridge

Fig. 8: Cross section of the bridge after rehabilitation

The loads of the suspended girder from the central span will be carried by steel structures located under the 4 vertical webs of the cantilever box girder of the bridge. The tensile forces are suspended with prestressed drawbars into the bridge deck and transferred through the deck into

the webs of the cantilever box girder (cf. Figs. 7 and 8). Since the drawbars run outside the vertical webs of the longitudinal box girder, the upper slab of the box girder has to be strengthened to enable the force transfer. For this purpose, additional reinforcement bars are slotted transversally into the bridge deck.

As already noted, the status of corrosion of the tendons was unclear, and for the design of the supporting steel structures it was assumed that 50 percent of the prestressed tendons were completely corroded at the anchor head.

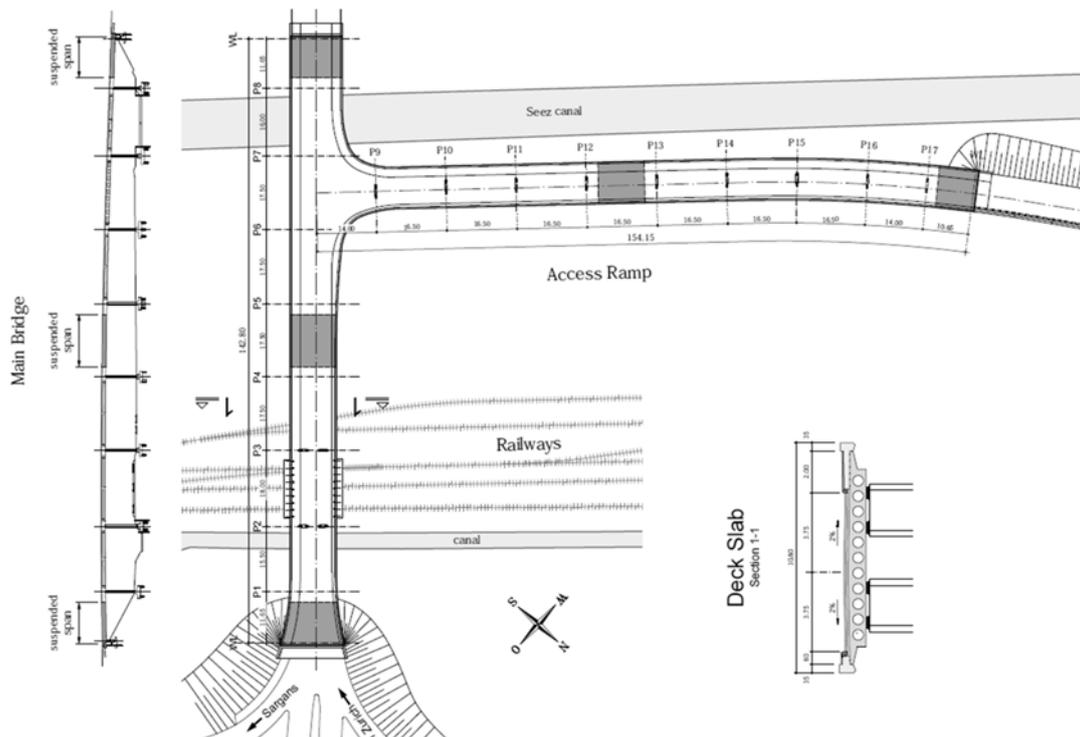
Fig. 9: Plan of the bridge over the SBB facilities and the river Seez, with the position of the old suspended girders shown in solid grey.

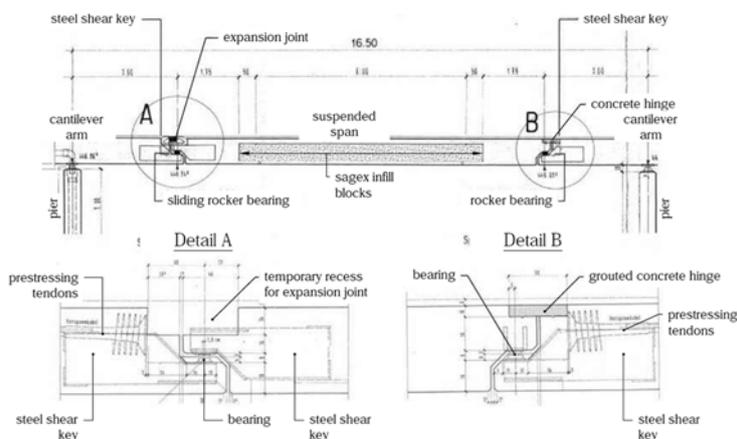
The suspended girders from the central spans were connected to the continuous girders using Gerber hinges, in some cases with steel shear keys incorporated into the concrete structure and standard reinforcements (cf. Figs. 10 and 13). The approximately 150-metre long ramp is also constructed as a continuous girder with 2 suspended beams, which are installed in the centre of the bridge and in front of the abutment.

Fig. 10: Suspended girders and diagram of joint with steel shear keys

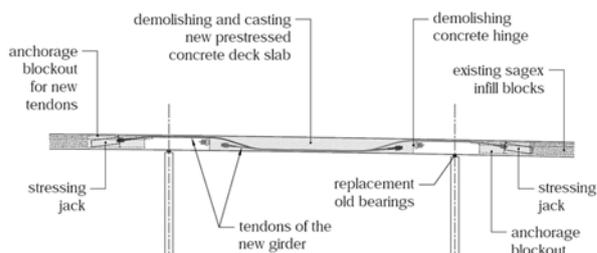
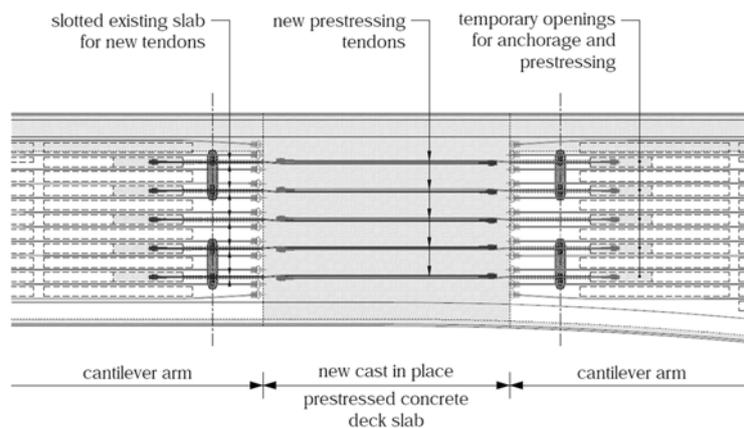
Fig. 11: Longitudinal profile of the post-tensioning tendons

Fig. 12: Layout of tendons in the new bridge deck

Since in the existing circumstances it was not possible to carry out a durable rehabilitation of the hinges, the suspended girders were dismantled and the newly constructed bridge decks were joined monolithically to the remaining bridge structure (cf. Figs. 11 and 12). The new deck elements took the form of post-tensioned solid concrete slabs. Anchorages were placed both at the connection area to the existing bridge deck, and in the recesses at the location of the infill foam blocks behind the pier. For this purpose, the infill foam blocks were partially dismantled. Following the replacement of the suspension girders, the bridge was turned into a continuous monolithic construction (cf. Fig. 9) and the structural bearing concept was adapted accordingly.

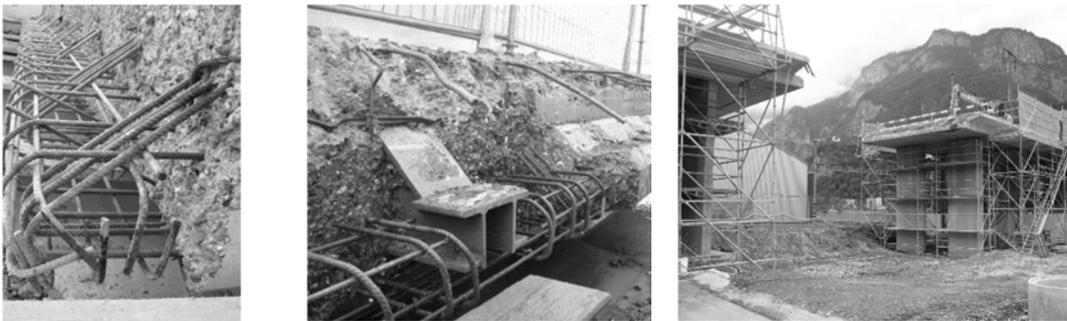
During the dismantling procedure, the condition of the Gerber hinges was examined (cf. Fig. 13) and documented. Significant damage was detected (including corroded bearings, rebar corrosion with signs of pitting and cross-section losses, and incorrectly inserted reinforcement

Fig. 13: Gerber hinge with rebars and steel shear key after dismantling
