Upgrade of seismic safety evaluation considering dispersion of R/C column's shear strength

Kenji Kabayama¹, Tetsuro Baba², and Atsushi Kobayashi¹

ABSTRACT: Two R/C school buildings in Ibaraki Prefecture, Japan were damaged by 2011 Tohoku Pacific Earthquake. Dynamic response analyses with the 3-D model of those buildings were carried out applying several input ground motions. Obtained analytical response showed consistency with inspected earthquake damage of buildings. The seismic index; I_S conducted from the current method for the Seismic Safety Evaluation had difference with the analytical response. The modified seismic index; I_{Sb} was proposed in order to consider dispersion of R/C column's shear strength for upgrading the Seismic Safety Evaluation. It was confirmed that I_{Sb} was more suitable than I_S for expressing the seismic performance of the objective buildings.

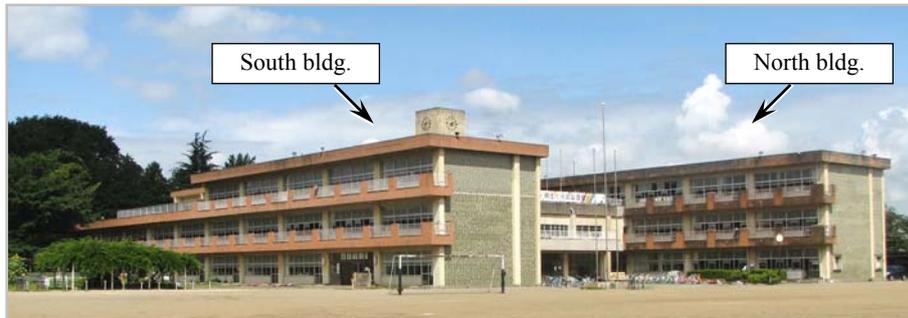
Figure 2. Objective R/C buildings of the elementary school viewed from southeast

Two R/C school buildings, The North bldg. and the South bldg. shown in the Figure 1 and Figure 2 were investigated by authors. Those buildings were connected by corridors installed expansion joints. Both buildings' data are summarized in Table 1.

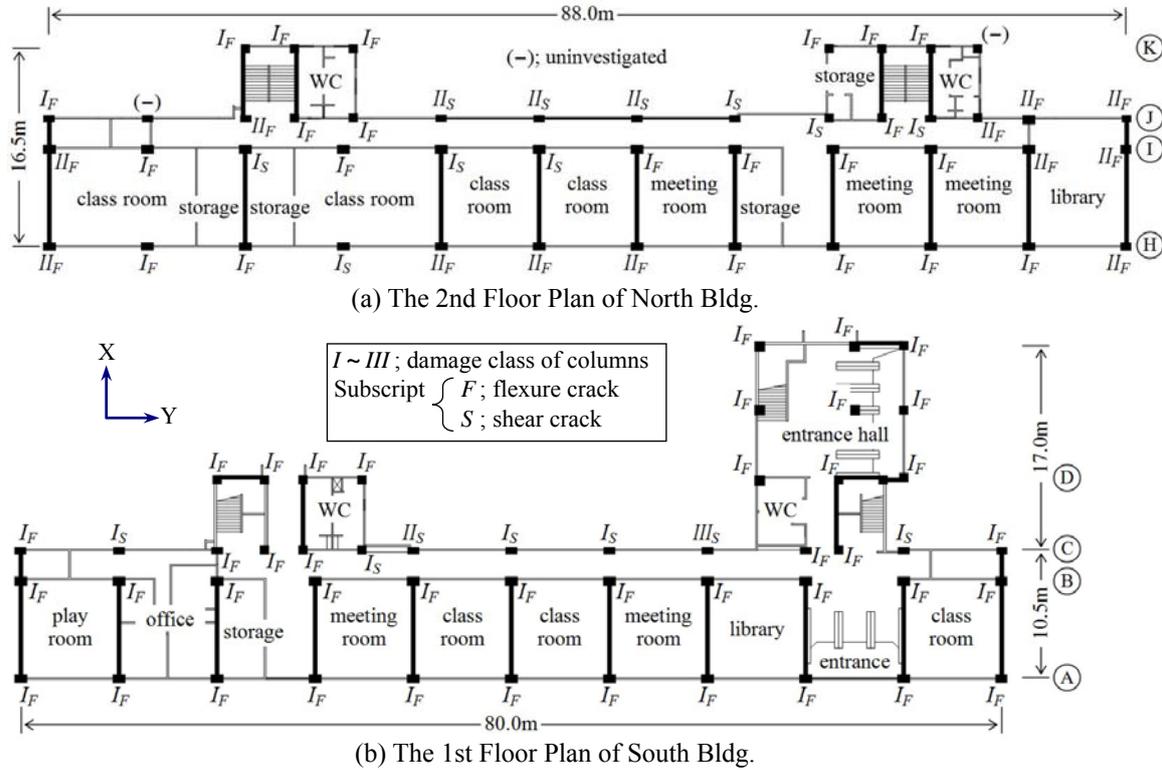
Figure 3. Floor plan of buildings and damage class of columns

The 2nd floor plan of the North bldg. and the 1st floor plan of the South bldg. were shown in Figure 3 with the damage class of each column. Each building had remarkable damages in the X direction on the floor drawn in the figure. Several short columns had serious shear cracks in the X direction at the frame J of the North bldg. and at the frame C of the South bldg. Residual

Seismic Capacity; R and the damage level in the X direction of each building were shown in Table 4. Both of them were judged as the minor damage in the X direction.

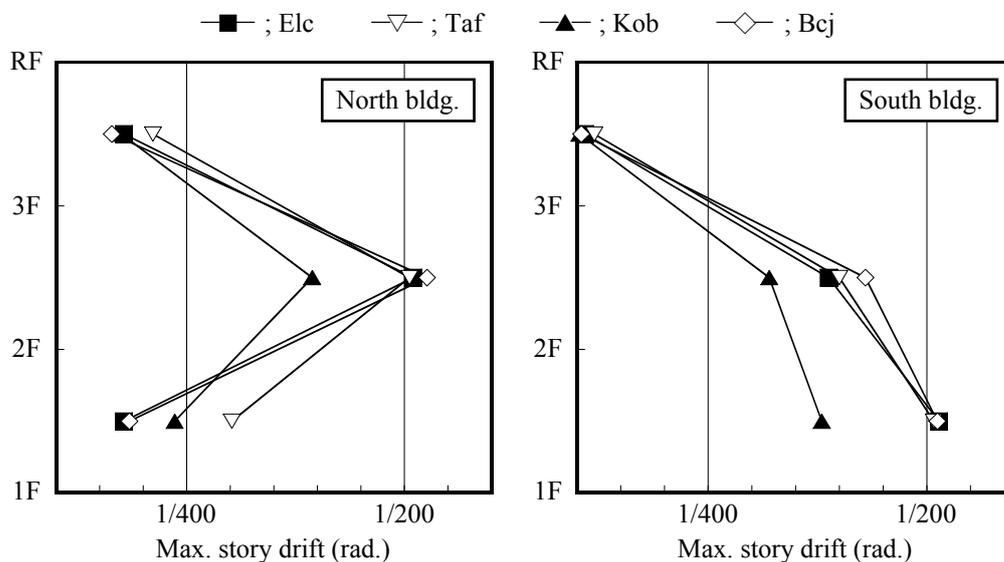
Figure 6. Maximum story drift during each earthquake response

Elasto-plastic behavior of building models during severe earthquakes were obtained by the analyses. The maximum story drift was shown in Figure 6 as an example of analytical results. It was confirmed that the 2nd story of the North bldg. and the 1st story of the South bldg. were the most injured story of each building, corresponding to the minimum R -values in Table 4.

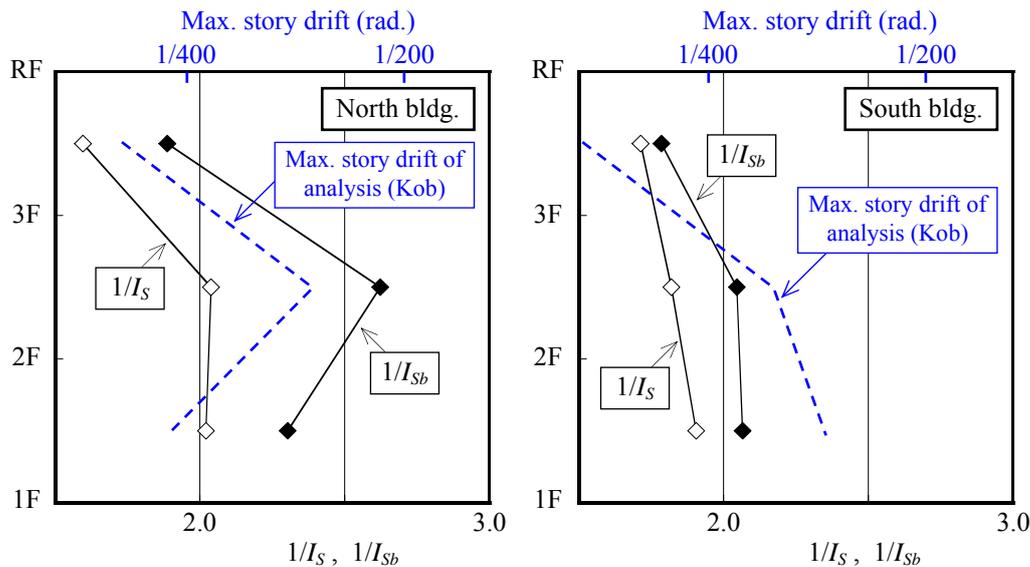
Figure 8. Distribution of reciprocal of I_S and I_{sb} with max. story drift of analysis

- ▷ As an analytical result, 2nd story of the North bldg. and the 1st story of the South bldg. were the most injured story of each building, corresponding to the inspected earthquake damage.
- ▷ For upgrading the Seismic Safety Evaluation, the modified seismic index; I_{sb} was proposed in order to consider dispersion of R/C column's shear strength.
- ▷ Proposed I_{sb} was more suitable than the ordinary seismic index; I_S for expressing the seismic performance of the objective buildings.
