Crack monitoring in the Baptistery of the Euphrasian Basilica in Poreč

Davor GRANDIĆ¹, Paulo ŠĆULAC¹, Igor RUŽIĆ¹, Nino KRVAVICA¹

¹ University of Rijeka, Faculty of Civil Engineering, Rijeka, Croatia

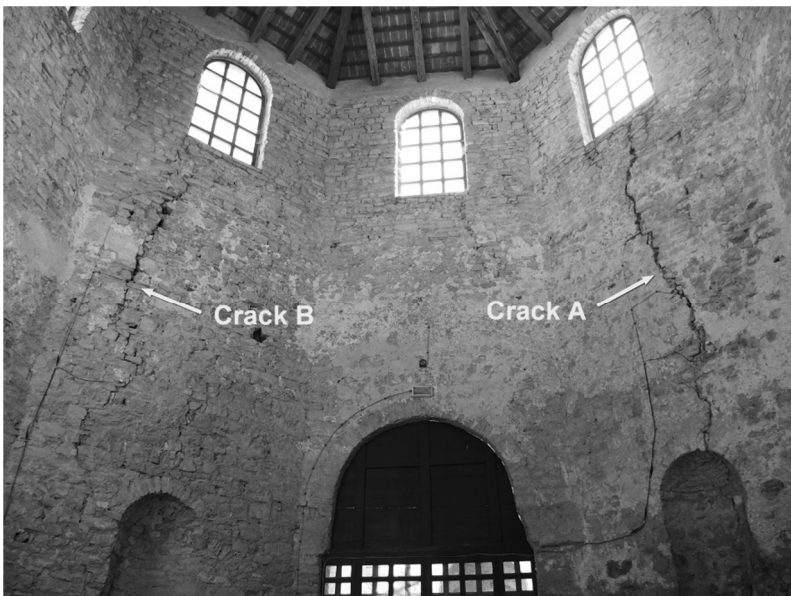
Figure 2. Two wide and long cracks in the Baptistery.

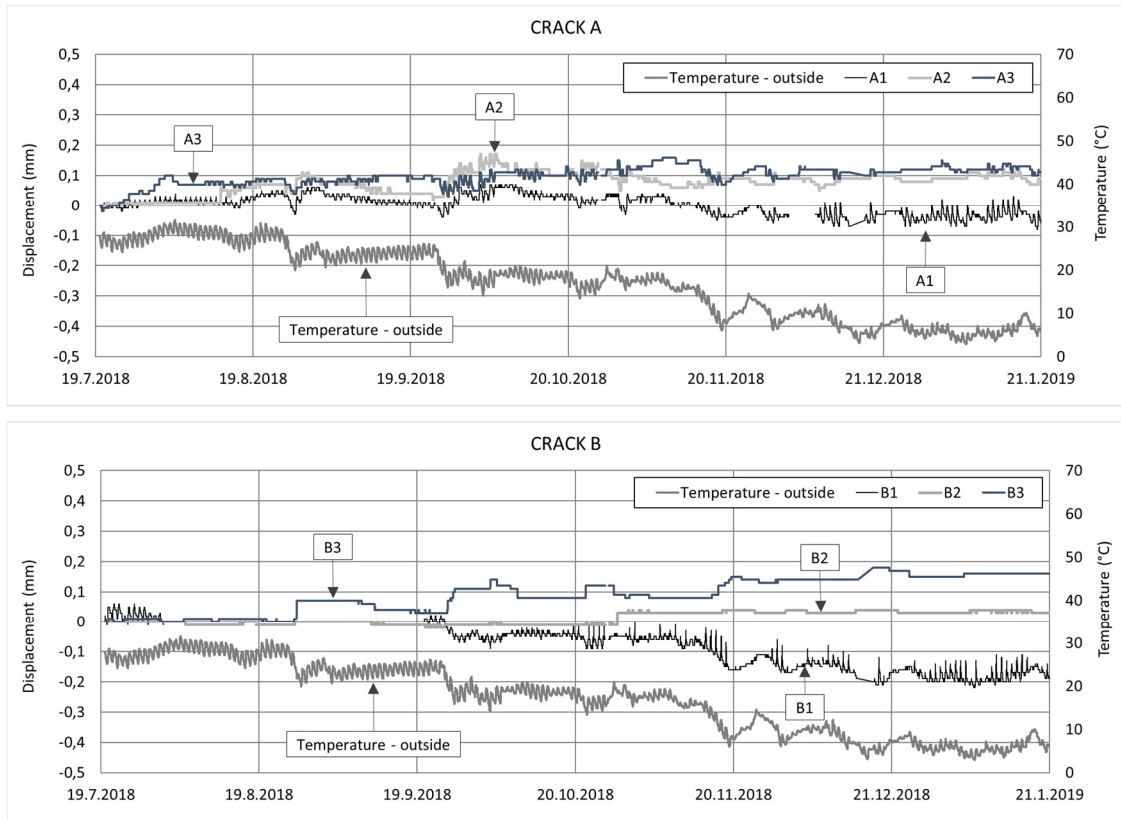
Figure 8 presents crack width changes (displacement) related to the outside temperature for the considered six-month period. Note that the measured crack width changes are extremely small in size: width of crack A is within 0.15 mm, while width of crack B is within 0.2 mm.

From Figure 8 we may establish a correlation between the crack width change and temperature, especially for measuring point A1 and B1: with the temperature decrease the crack width decreases, i.e. the cracks close. We expect the crack widths would return to previous measured values with temperature increase in the next six-month period.

Figure 8. Crack width in relation to outside temperature.

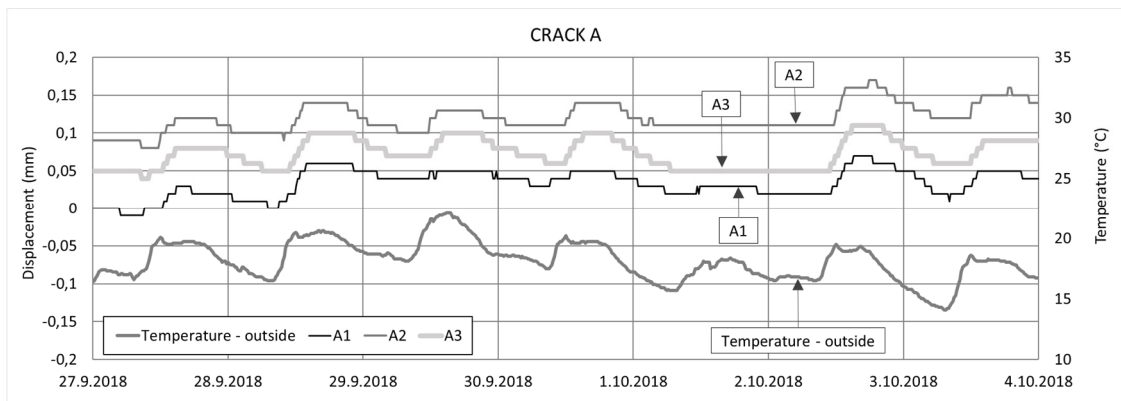
The correlation between the crack width A change and the temperature is better investigated in Figure 9, where the results are compared for the period from 27th September till 4th October. It may be clearly noticed that daily temperature fluctuations cause the crack width change accordingly (for all three measuring points). This is something that happens on daily basis due to the whole day exposure of the south wall (where crack A is located) to direct sunlight. This was not observed for crack B since that wall is not exposed to direct sunlight.

Figure 9. Crack width A in relation to outside temperature from 27th September till 4th October.

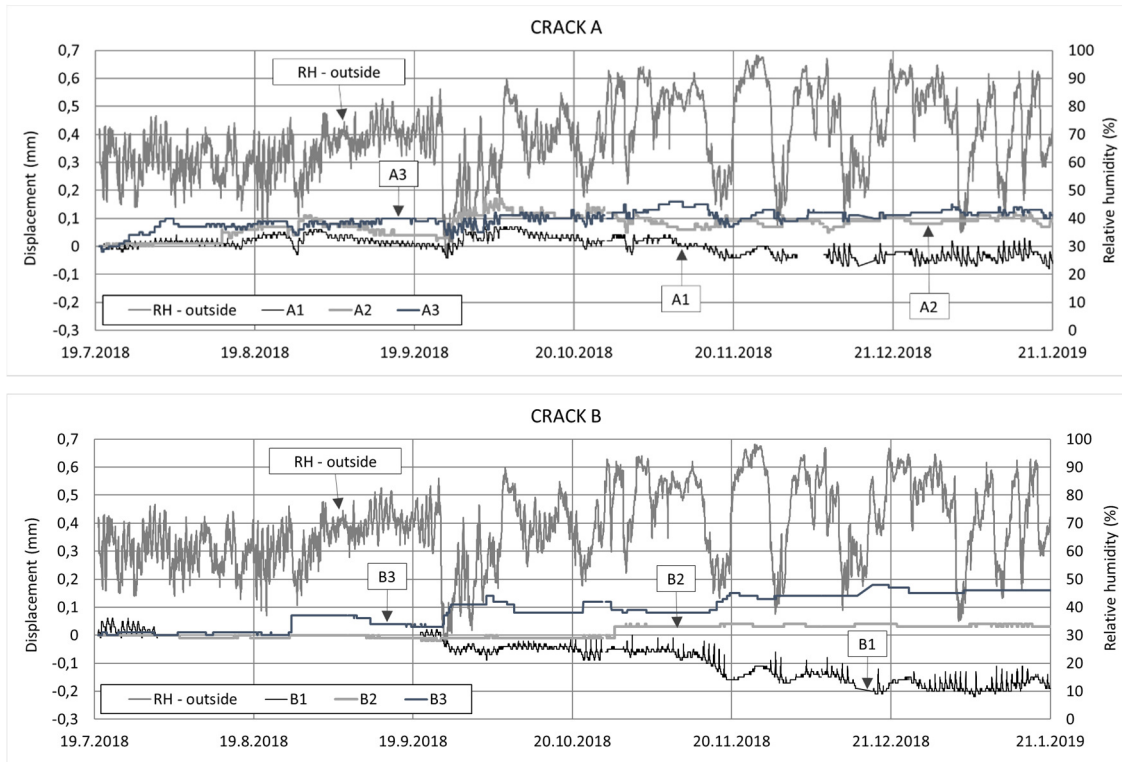
Figure 10 shows the crack width change in relation to relative humidity, where no significant correlation has been observed.

Figure 10. Crack width in relation to relative humidity.

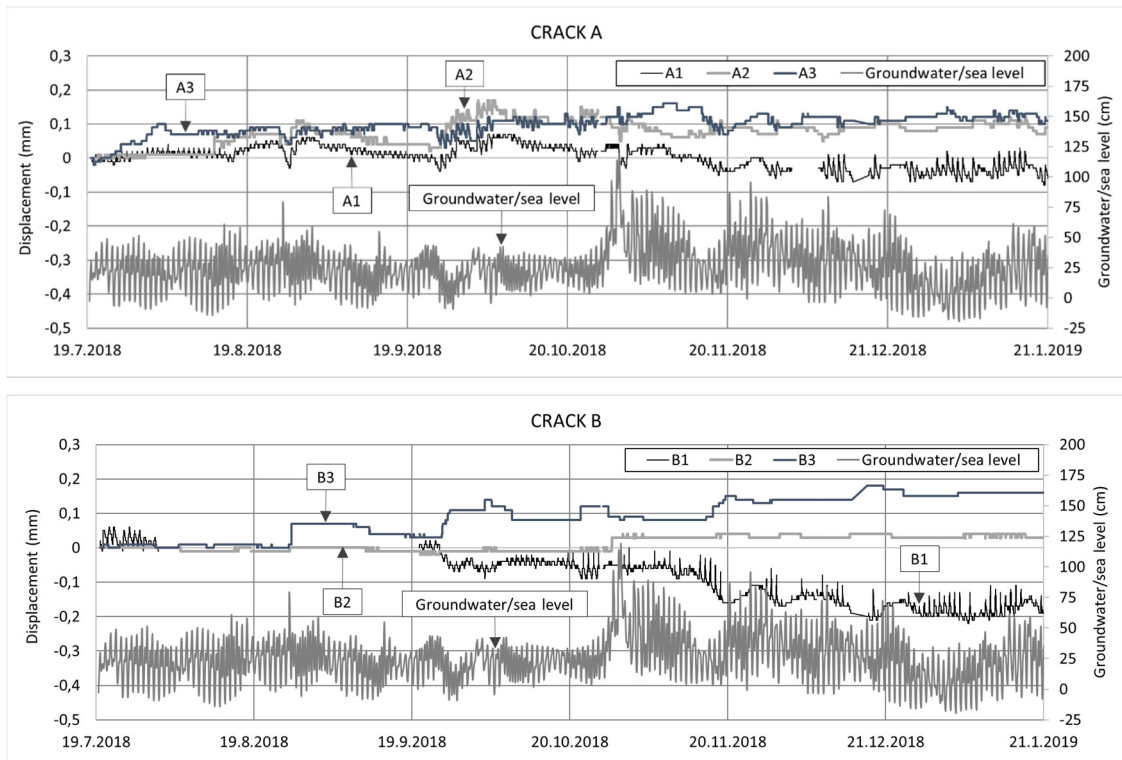
Figure 11. Crack width in relation to groundwater/sea level.

On Figure 11 crack widths are related to groundwater/sea level measurements, displayed as absolute levels. Measured levels mainly correspond to sea levels, which was confirmed by electro-conductivity measurements. Sea levels are higher during low air pressure and rainy weather, when the salinity decreases. The most frequently recorded levels are from +30 to +50 cm above sea level, while the high levels over +100 cm above sea level are very rarely recorded. Average value of groundwater/sea level during the observed period was equal to +26.4 cm above sea level, while maximum and minimum were +119.0 cm and -19.6 cm above sea level, respectively. So far no correlation was observed between the crack width change and groundwater/sea level measurements.
