Integrity Assessment of Thick Concrete Slabs Using NDT

Impact-Echo

N. Dawood¹, H. Marzouk²

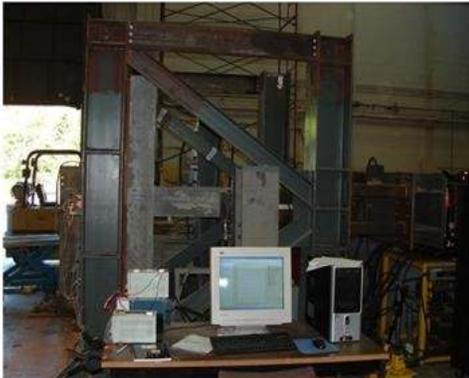
Figure 3 Test Set-up

The specimens were made with high-strength concrete of 70 MPa. The slabs were cured under moisture saturation of plastic sheeting to cover the surface for more than 3 weeks until the preparation of instrumentation and during the fourth week of curing, the specimens were prepared for testing of panels at an age of 28 days. The specimens were tested in a specially designed frame in the vertical position, as shown in Fig. 3.

The concrete slab was tested in a vertical position in order to detect and mark the cracks as it develops. The load was applied to the slab centrally through the stub column. Rubber packing pieces was provided immediately under the slab surface to insure uniform contact along the supports. The test was carried out using a closed-loop (MTS) testing machine with a maximum capacity of 670 kN. The load was applied by means of a hydraulic actuator. During testing, the slab was carefully inspected and cracks were marked at each load set. Deflection at the slab center was measured with an LVDT gauge. The loading process involved applying cyclic load test till the failure.

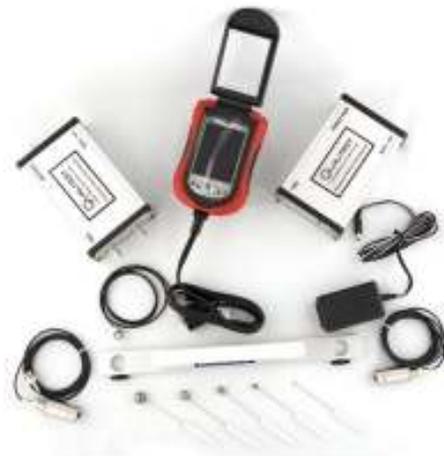
Figure 5 Portable Impact-Echo System Field Kit

The NDT system used in this study consisted of two Piezo-electric sensors, steel impact transducers, two-channel portable digitizer and Windows compatible software capable of graphing, calculations and presenting for report creation, as shown Fig. 5.
