The use of SHM in the evaluation of a railway bridge

Baidar Bakht¹, Shamim Sheikh², Aftab Mufti³, and Gamil Tadros¹

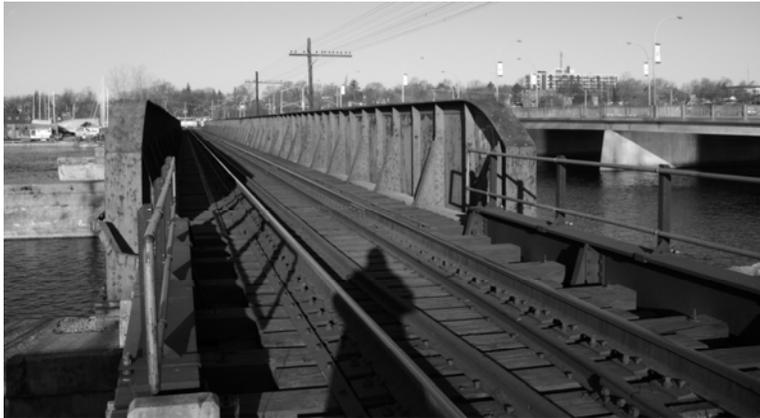
Figure 3. Photograph of the railway bridge in Belleville, Ontario, Canada

The Canadian Pacific (CP) railway bridge under consideration is in Belleville, Ontario, Canada; it has six simply supported spans, each comprising two built-up steel plate girders, connected with 10 transverse built-up steel floor beams, each pair of which is connected with four longitudinal rolled steel stringers. The cross-section of the bridge is shown in Fig. 1, in which it can be seen that the timber ties rest on the stringers. The rail tracks rest on the ties, midway between two adjacent stringers. Since the top surfaces of the floor beams are slightly higher than the top surfaces of the stringers, the timber ties are not placed above the floor beams. A partial plan of the bridge is shown in Fig. 2. As can be seen in Fig. 3, the rail track is near the bottom of the girders

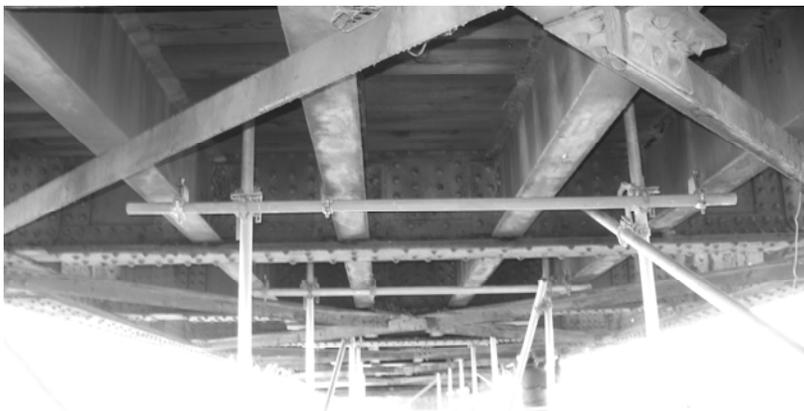
Figure 4. Photograph showing stringers connected to the floor beams

The rolled steel stringers can be seen in Fig. 4 framing into a built-up floor beam; timber ties above the stringers can also be seen in this figure along with the hangers for the scaffolding that was erected for the installation of the sensors.
