Performance assessment of deteriorated RC pier in marine environment

ABSTRACT: The aim of the present work is to develop a smart procedure for the assessment of aged and deteriorated RC structures. The effects of aging, especially in marine environment, must be considered in assessing both the static and seismic performances. Corrosion of steel reinforcement induced by chloride attacks from sea water is one of the most evident cause of strength and ductility loss for RC structures over time. On the other hand, the increased concentration of carbon dioxide in modern environments, principally due to industrial pollution, is the main cause of concrete carbonation. The adopted procedure to assess structures in adverse environments is a multi-scale analysis of materials up to structural system. Non-destructive evaluations and destructive tests and structural identification, as well as all possible methods in controlling deterioration are needed to evaluate the actual damage state and to predict future service life.

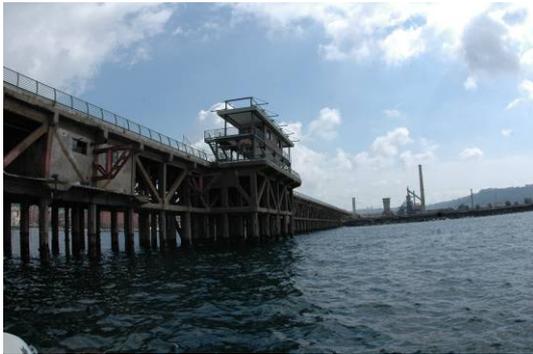
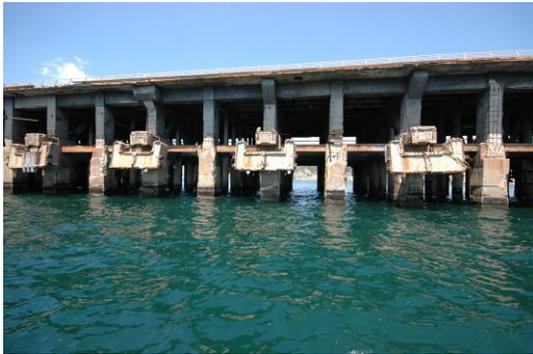
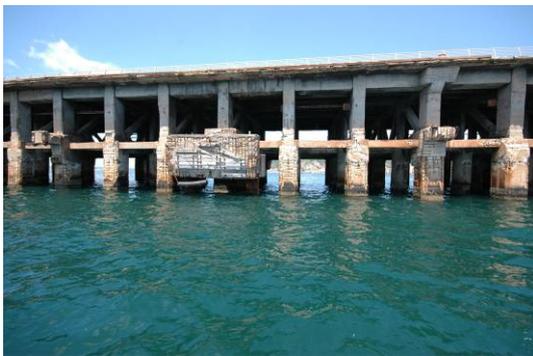
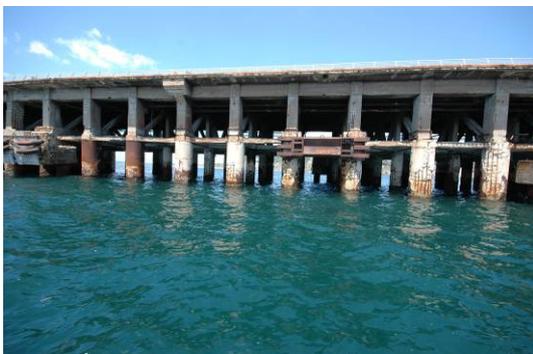
Figure 2. "Pontile Nord" RC pier: (a) first section; (b) second section; (c) third section; (d) fourth section.

In particular the first section (Fig. 2a), built in 1936, is about 585 m long and is made of a narrow and a wider part. A portion of the narrow part is out of the water. The first section presents pier columns directly inserted in the seafloor and other columns fixed on a foundation system, made of piles. Those piles reach the sea level and come few meters outside seawater. The second section (Fig. 2b), built in 1958, about 100 m long, presents the external columns fixed on the foundation system and the internal pier columns directly inserted in the seafloor. The third section (Fig. 2c), built in 1962, about 100 m long, presents all the pier columns fixed on the foundation system. Finally, the fourth section (Fig. 2d), built in 1968, about 100 m long, presents all the pier columns directly inserted in the seafloor. The entire deck structure is: (i) for the first section, longitudinally restrained at one side by a caisson and free at the other side outside the water and (ii) for the second, third and fourth sections, longitudinally restrained at both sides by the caissons. In the transverse direction all the sections are simply supported

A complete three-dimensional FE model of the “Pontile Nord” structural complex has been built using commercial computer code SAP 2000. In particular the RC beams, columns and braces of the pier structures have been modeled by means of frame elements. Different kinds of external constraints have been applied according to different foundation systems of the pier columns. The 3D model consists of: (i) 1696 nodes and 2892 frames for the first section (Fig.2a); (ii) 472 nodes and 1002 frames for the second section (Fig.2b); (iii) 435 nodes and 875 frames for the third section (Fig.2c); (iv) 327 nodes and 648 frames for the fourth section (Fig.2d). Linear elastic behavior has been assumed, with Young modulus equal to 22 GPa and mass density

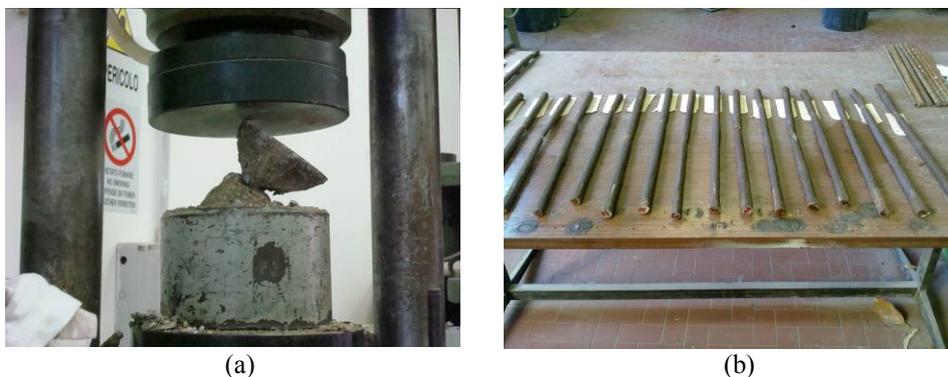
Figure 3. Destructive Material characterizations, failure of: (a) concrete specimens; (b) steel specimens

A huge variability in material properties was expected because of the construction period involving almost forty years. An extensive test activity was planned. For each section of the pier, many tests were conducted on steel and concrete materials from different structural elements (namely, piles, beams, columns, bracing elements). NDT tests mainly concerning acoustic emissions and rebound hammer were performed on badly deteriorated concrete. Their results were compared to destructive tests (Figure 3) on concrete samples got in the same locations where NDT tests were performed. The results of NDT were mainly jeopardized by crack damages, voids in the concrete due also to steel corrosion, surface degradation. Quite surprisingly, the concrete strength was almost similar for all the sections, despite the very different ages. Conversely, steel samples evidenced significant differences both in behavior as in the strength for each section and period. Corrosion was also a main issue because the environmental conditions was sea spray water and wet and dry conditions for the elements just above the sea level. However, below the sea level, the concrete and steel reinforcement of RC piles were perfectly undamaged, despite some plants and sea-weed. The design values have been obtained as ratios between tested average value and a confidence factor (1.20) as suggested by NTC '08. The confidence with which the properties of the structure components are known, when calculating capacities is established from the knowledge obtained based on access to original construction documents (for geometrical dimensions of members and internal reinforcements, confirmed also by visual inspection), and from the assessment of mechanical properties (based on destructive and nondestructive testing of sampled specimens). The value 1.2 for the confidence factor has been established because of the sample size analyzed. In this evaluation also the reduced level of knowledge on the complex boundary conditions at the bottom of the structure above the foundation piles is considered.
