Monitoring and Evaluation of Structural Safety of Railway Bridges

2 STRUCTURAL MONITORING OF THE SUAÇUÍ RIVER BRIDGE

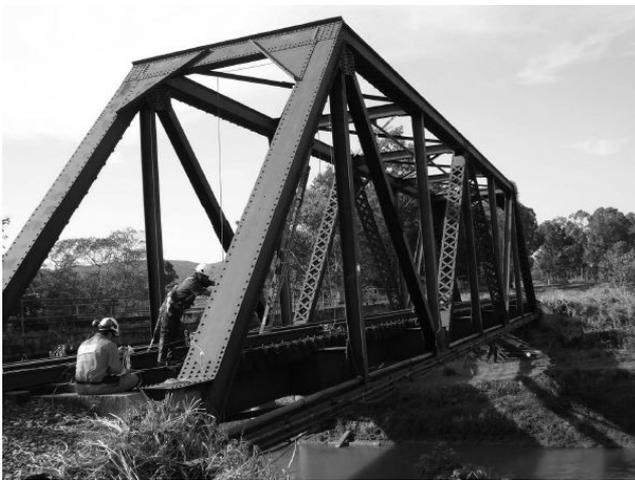
Located in the Vitória-Minas railway, in Baguari, Brazil, the Suaçuí River Bridge, shown in Figure 1, is a metallic bridge constructed in the 40's and has a span of 41 meters and height of 7,8 meters. Its superstructure is made of two Warren truss supported at the ends by metallic structural bearings. The trusses are interlinked in its lower region by transverse floor beams, with approximately 4,5 meters long, and stringers that connects to transverse floor beams. Over the stringers are supported the wooden sleepers, and over these, the rails. Nodal connections are made of riveted steel plates.

Figure 1. General view of the Suaçuí River Bridge.

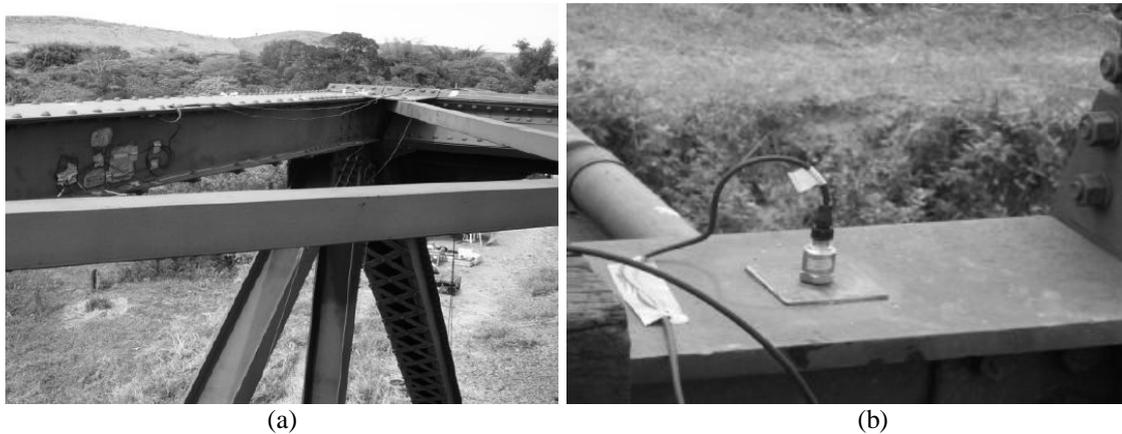
In Suaçuí River Bridge, 24 elements were instrumented, including truss bars, transverse floor beams, stringers and structural bearings. The sensor network installed was composed by 25 conventional sensors (measuring strains and displacements), 4 piezoelectric accelerometers and 4 fiber optic strain sensors. The railway track giving access to the bridge was instrumented with a system of transducers for measurement of wheel loads and detection of passage of axles, consisting of strain gages installed properly. Some of the sensors are presented in figure 2.

Figure 2. Strain gages and fiber optic sensors installed in the top chord (a) and accelerometer in the transverse floor beams.

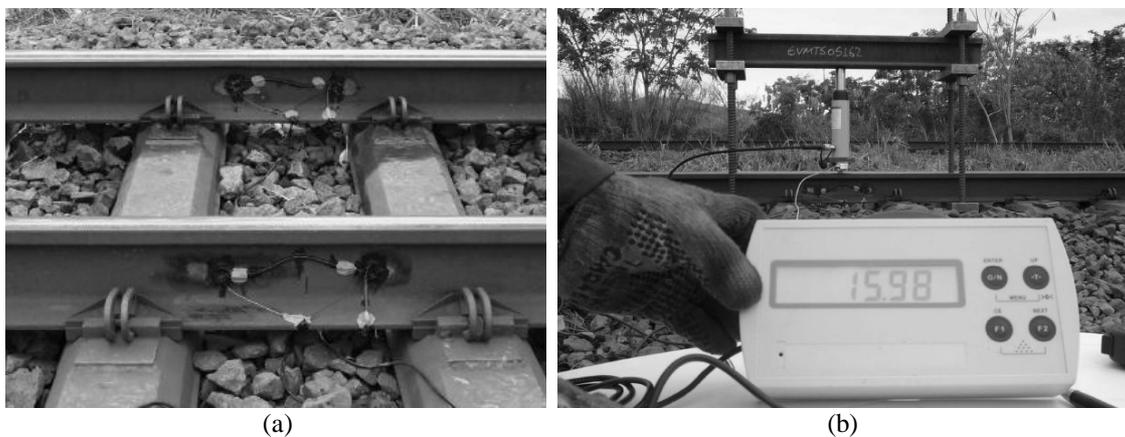
The use of the machine Plasser occurred at 23th September 2009, and before the start of the measurements, the vehicle wheel loads were determined using a special arrangement of strain gages installed in one of the rails, previously calibrated, as shown in Figure 3. Axle loads were estimated by taking twice the value of the load wheel, for each axle. Figure 4 illustrates the Plasser machine positioned on the floor beam under the vertical M4 of the bridge.

Figure 3. Special arrangement of strain gages for measure of wheel loads (a) and his calibration (b).

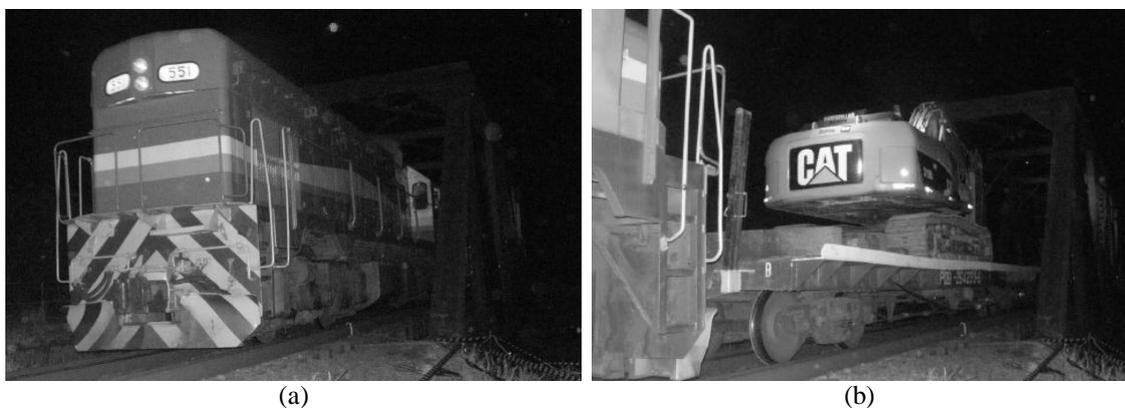
The pass of a train called Viliato, consisting of locomotive and four wagons (Figure 5) had been object of monitoring at 23th September 2009. This train passed through in four different nominal speeds (5 km/h, 14 km/h, 25 km/h and 35 km/h). The measurements in the speed of 5km/h correspond to a quasi-static solicitation of the bridge structure and allow comparisons with the correspondent computational model. The weighing of axles was held at this speed, while in the other speeds the wheel load transducer was used only for detection of the axles of the train, allowing, once known distances between axles of the locomotive, to estimate the effective speeds during the passages of composition. Measurements at different speeds of 5 km/h were performed to analyze the dynamic behavior of the structure.

Figure 5. Viliato train in the bridge during monitoring operations: locomotive (a) and wagons (b).
