Seismic upgrading of existing RC buildings by advanced techniques

G. Della Corte¹, F. M. Mazzolani¹

¹ University of Naples “Federico II”, Naples, Italy

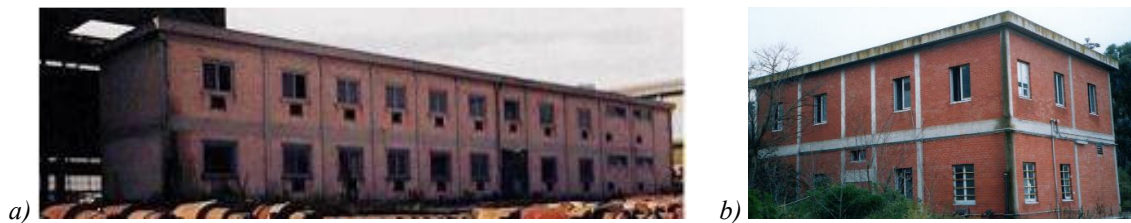
Figure 1. The first (a) and the second (b) building in their original conditions before testing.

The research consisted of full-scale tests on two RC buildings (Fig. 1). The buildings were both located in Bagnoli (Naples, Italy), in the area where competent Authorities destined to demolition the plants of the steel mill named ILVA (former Italsider). The first building (Fig. 1a) was preliminarily divided into six independent substructures, by removing all non-structural components and cutting the floor slabs. Then, each substructure was equipped with a different seismic upgrading system (Fig. 2) and subsequently tested more than one time. The whole experimental activity is described in Mazzolani (2006). This paper summarizes the tests carried out on those substructures strengthened by composite materials, steel buckling-restrained braces and steel eccentric braces. The second building (Fig. 1b) was initially tested two times: (i) in its original conditions, up to a strong damage state, and (ii) after some minor repair of damaged parts of concrete, reconstruction of perimeter masonry infill walls and their strengthening with C-FRP bars placed in the horizontal mortar joints of the masonry infills. A detailed description of the two tests can be found in Della Corte *et al.* (2008). Subsequently, the damaged building was equipped with three novel BRB prototypes, each of which tested up to failure. The main characteristic of the novel braces is the possibility to hide them within the space between the two panels of masonry infill walls commonly used for claddings of RC buildings. Then, the system avoids any change of the architectural appearance of the original building. The tests are here presented per category. This implies that tests on FRP material systems, which have been carried out on two different RC structures, and similarly tests on BRBs, are presented together.

Novel types of “only-steel” BRBs have been designed and tested. Two tests were conducted using substructure No. 2 of building No. 1 (Figs. 1a and 2). Three more tests were carried out using building No. 2 (Fig. 1b).

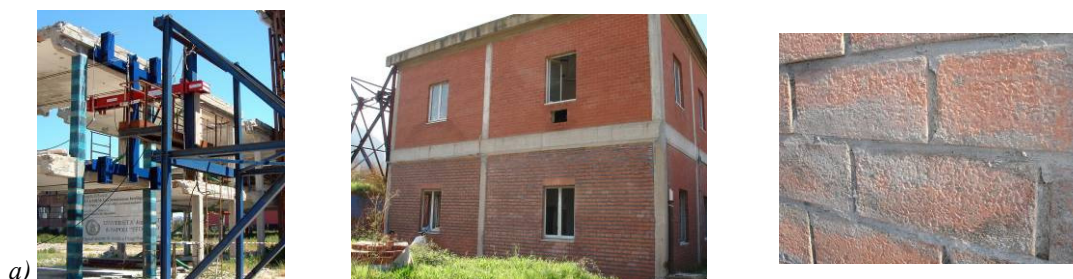
Figure 3. The C-FRP repairing/upgrading systems: a) building No. 1; b) and c) building No. 2.

The bare RC substructure of building No. 1 (third from the left in Fig. 2) was first tested in its original conditions and then repaired, strengthened and tested again. The strengthening system consisted of longitudinal C-FRP strips and transverse C-FRP sheets. Figure 3a shows the FRP strengthened structure, illustrating also the test setup. Figure 4 shows a comparison of response between original and upgraded structures, illustrating the column-sway collapse mechanism of the original structure (Fig. 4b) and the beam-sway mechanism of the C-FRP upgraded structure (Fig. 4c).

The second application refers to the masonry infill panels of building No. 2 (Figs. 3b). C-FRP bars were placed into the horizontal mortar joints (Fig 3c). The original building was first tested under full load reversals. Subsequently, some damaged portions of RC columns were repaired and perimeter masonry infill panels were rebuilt and strengthened using the structural repointing technique. Figure 5 shows a comparison of response between the original (test #1) and the repaired (test #2) structure. In both cases, a first story column sway mechanism was apparent. When looking at such a comparison, it should be considered that the second test was on a damaged structure, because the staircase and all the interior partitions, as well as the internal RC columns were not repaired. Test results show that the failure mode of masonry panels changed from the diagonal tension cracking mechanism, mainly observed during the first test, to the shear sliding mechanism, which was dominant during the second test (Fig. 6). A detailed description of these experimental results, as well as information about analytical modelling of test structures, can be found in Della Corte *et al.* (2006a, 2008) and Mazzolani *et al.* (2007).

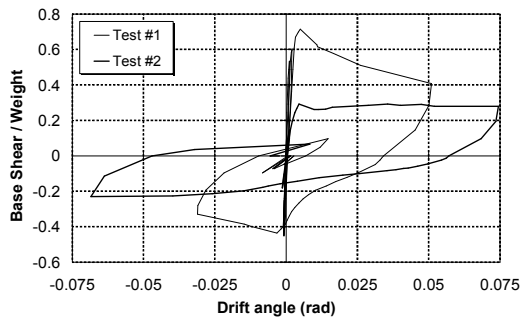
Figure 5. Base shear vs. 1st story drift angle for the original and repaired building.

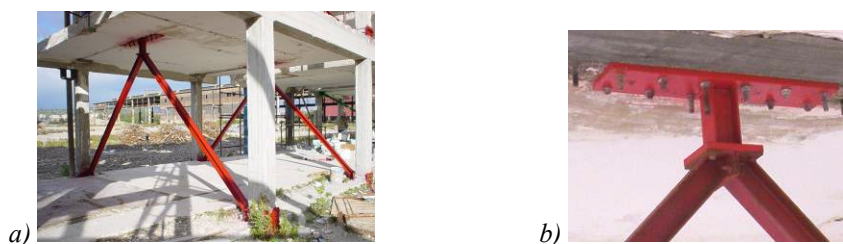
Figure 7. The RC structure equipped with eccentric braces: global view (a) and zoom in to the link (b).

Figure 7 illustrates the EB system. Three experimental tests have been carried out. The link cross-section as well as link end-connection details were changed from one test to another. In the first EB system, flexural failure of link end-plate connections occurred (Figs. 8a, 8b, 8c). In the second test, link end-connections were strengthened, increasing the end-plate thickness. The response showed now failure of bolts at the link-to-brace connections (Figs. 8d, 8e and 8f). In the third EB system, a weaker link built-up section was designed and the bolt steel grade was increased. The structure showed significant plastic shear deformation of links (Figs. 8g and 8h). At large link rotations, shear failure of bolts at the bottom connection was again observed (Fig. 8i). Further details as well as an explanation of the reasons for this behavior can be found in Della Corte and Mazzolani (2006b) and Della Corte *et al.* (2009a, 2009b).

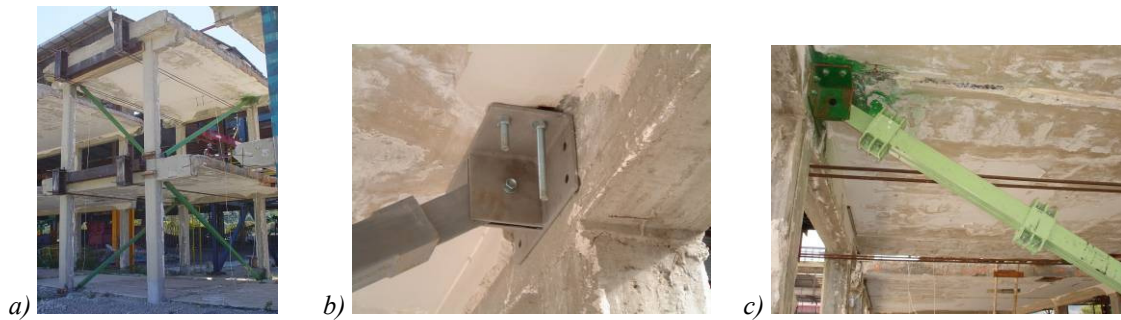
Figure 9. The RC structure equipped with BRBs: global view (a) and zoom in to the BRB 1 (b) and 2 (c).

Figure 9a illustrates the RC substructure equipped with BRBs (second from the left in Fig. 2b). Two slightly different types of BRBs were tested. In the first type (Fig. 9b) two buckling-restraining tubes were connected by welded plates and the gap between the restraining tubes and the yielding core was specified to be 0.5 mm at the design stage. Figures 10a, 10b and 10c show the structure response. There was yielding of the BRB core in both tension and compression, but local compression buckling of the end portion of the core produced large local plastic deformation (Figs. 10b and 10c). In the second type of BRB (Fig. 9c), the gap between the core and the restraining tubes was fixed to 1 mm and bolted connections were used between tubes. Besides, a more gradual tapering was designed for the inner core end portions (Della Corte and Mazzolani 2006b, Mazzolani *et al.* 2009) The structure response is shown in Figures 10d, 10e,

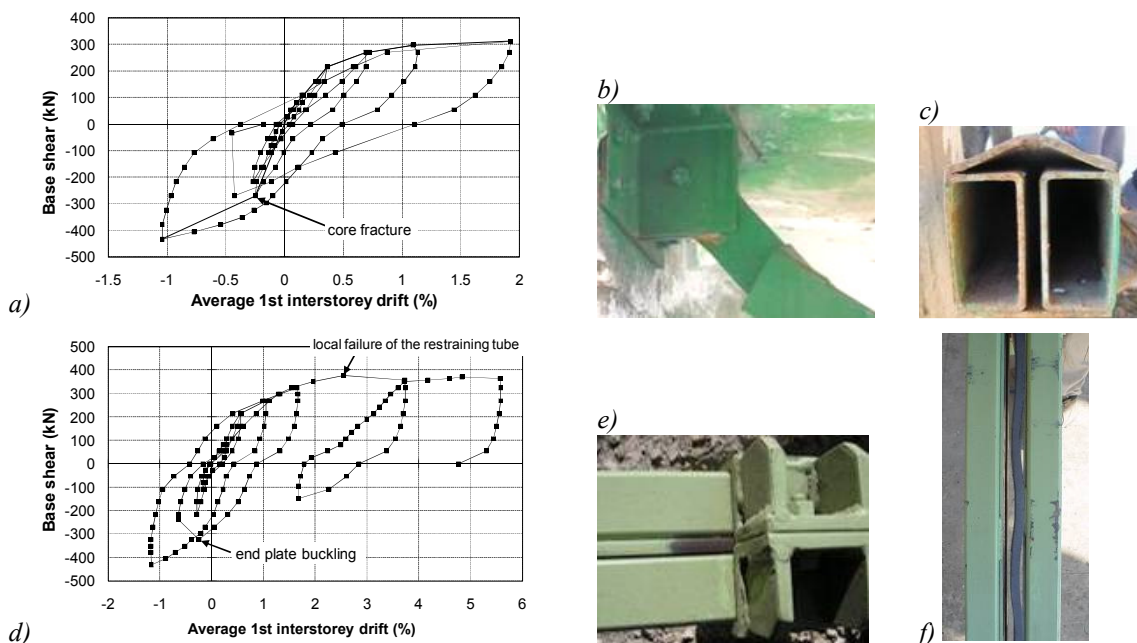
Figure 10. Tests results for two BRB systems.

10f. The dark part of the BRB core visible in Figure 10e highlights the relative displacement between the core and the restraining tubes. Figure 10f shows the high-order inelastic buckling of the inner core, which is expected to be a normal response of this system.

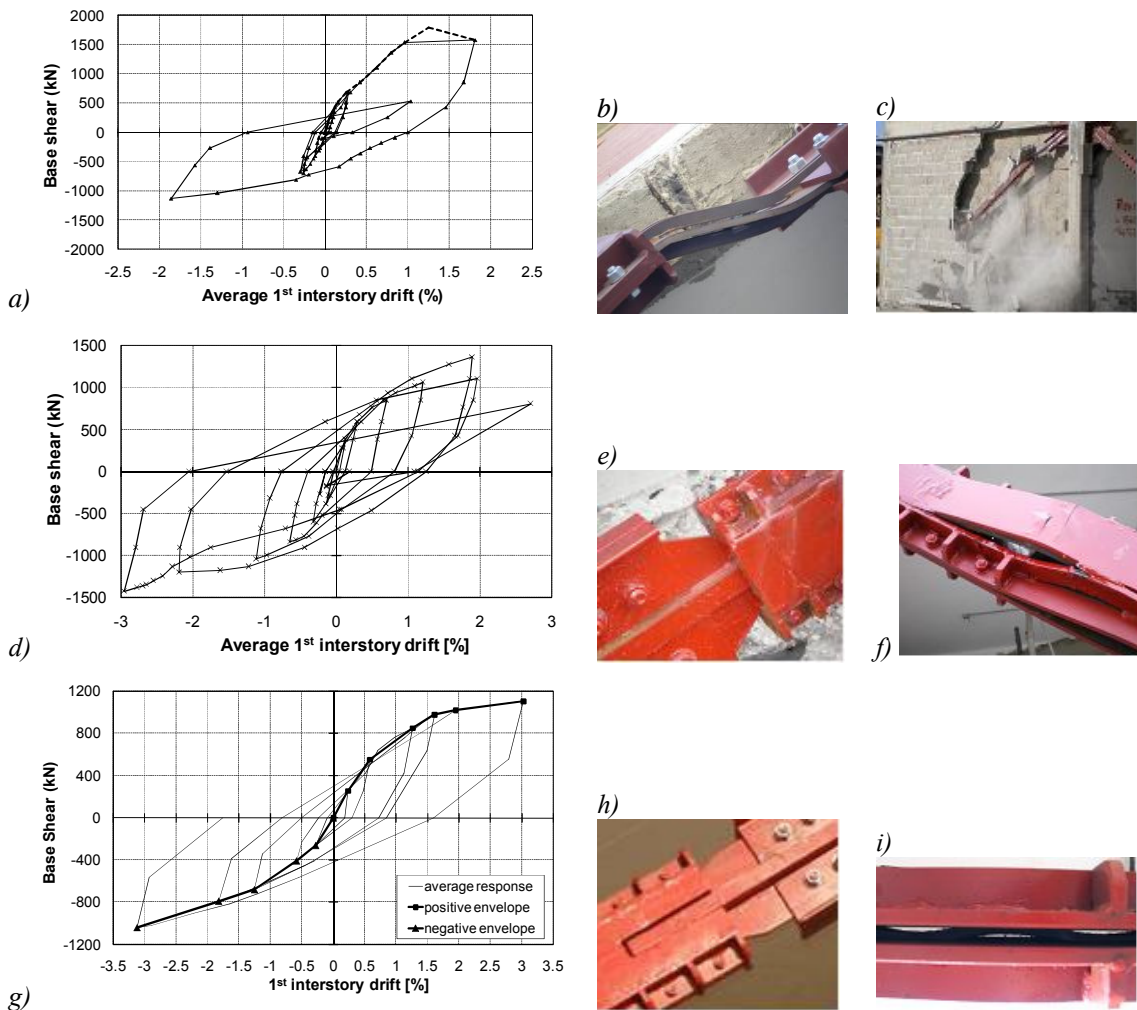
Figure 12. Test results for three BRB systems.

With reference to the second building, three BRB prototypes were tested (BRB No. 3, No. 4 and No. 5). The novel BRBs were designed to be hidden in the inner space between the two panels of masonry claddings (Fig. 11). The performance of BRB No. 3 was not satisfactory. Indeed, at an interstorey drift ratio equal to about 1.25% a local-distorsional buckling failure of the unrestrained end portion of the brace occurred, corresponding to a peak of the lateral strength (Figs. 12a, 12b). Buckling out-of-plane, the brace pushed against the external facing wall, leading to its complete collapse (Fig. 12c). BRB type 4 showed a satisfactory performance, with stable and symmetric hysteresis for interstorey drift ratios in the range $\pm 1.5\%$ (Fig. 12d). When the maximum displacement capacity of the tested device was achieved (Fig. 12e), two secondary failure mechanisms occurred: (i) local buckling and related plastic bending of the

steel plates constituting the restraining sleeve (Fig. 12f); (ii) global brace buckling (only for one among the four braces, not shown in Figure). BRB type 5 showed an excellent response (Fig. 12g) with a fully operational and symmetric response up to an interstorey drift ratio equal to $\pm 3\%$ (Fig. 12h). Figure 12i shows the typical high-order buckling of the restrained core.
