CFRP Strengthening of plain and reinforced concrete members

M. Elchalakani¹ and E. F. Tawifik²

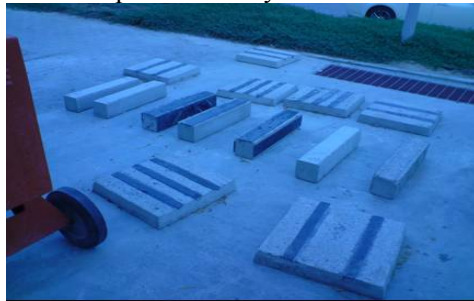
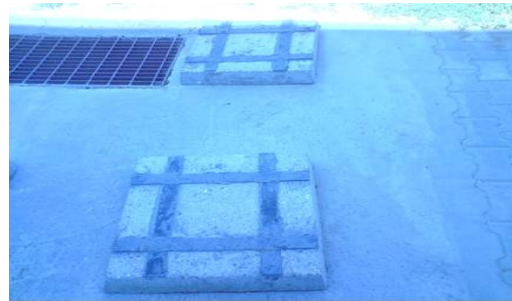
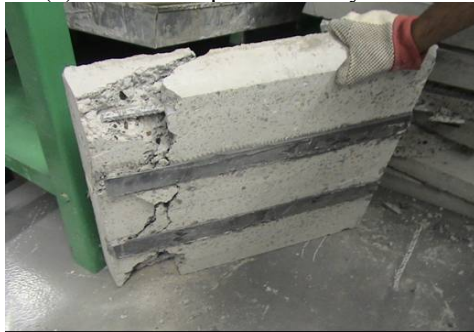
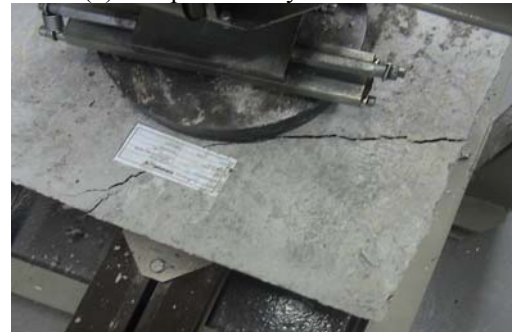
Figure 1 slab specimens and failure

(a) 2 and 3 strips in one way

(b) 2 strips in 2-ways

(c) typical slab failure (bottom view)

(d) typical slab failure (top view)

Figure 1 shows the typical failure mode for slabs. It is seen in Figure 2 that there is a significant increase in bending strength due to strengthening particularly for plain slabs. The increase is 87% and 114% for the plain concrete which failed in bending mode when comparing the results for the A series with 2 and 3 strips, respectively. This increase is only 17% and 39% for reinforced slabs failed by

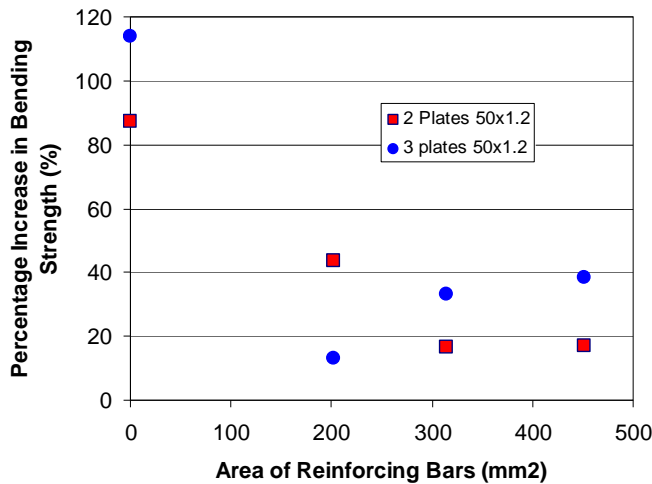
Figure 2 variation of bending strength of slabs with area of reinforcement

forming shear cracks for series D, with 2 and 3 strips, respectively. The results were inconsistent for CFRP strips in both ways.

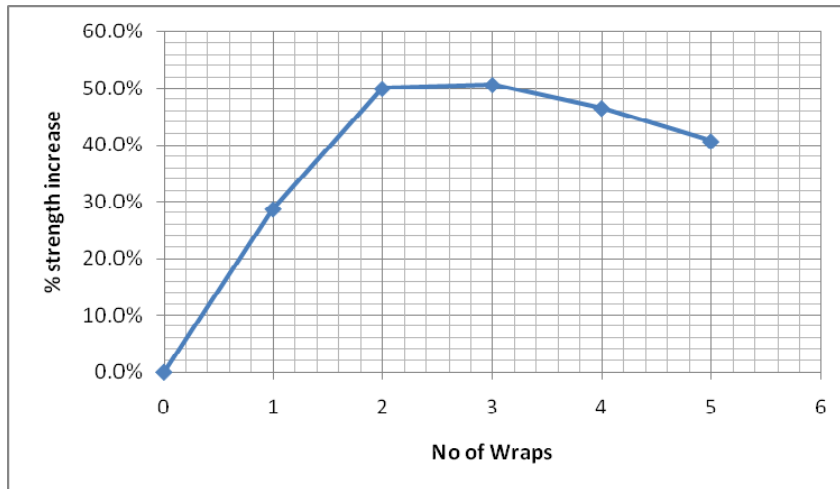
Figure 3 Variation of columns strength with increasing the number of wraps

Figure 3 shows the variation of column's strength with increasing the number of wraps. As all the wraps were applied in the same day to represent a particular constraint on site, thus there was insufficient time for the curing of the epoxy resin. Thus, it is clear that the optimum number of wraps is 2 with an increase in strength due to confinement of 50%. Figure 3 shows that increasing the number of wraps to more than 2, the additional CFRP sheets became less effective and reduce the strength. Figure 4 shows group photos for the specimens after testing. It can be concluded that the optimum number of wraps is 2, if the construction was to be done in a single day.
