Rehabilitation and strengthening of structures for lateral loads

ABSTRACT: In several countries, there are plans for systematic strengthening of infrastructure and public buildings such as bridges, schools, government buildings, utilities and power plants. However, there remains a large stock of vulnerable residential buildings that are in obvious need of rehabilitation. Recently, much research work and advances have been made in retrofitting techniques for structural elements such as beams, columns, beam-column joints and walls. The use of several techniques and materials such as advanced composites has been evaluated, tested and proven effective in the strengthening of structural components. In addition, energy dissipating and bracing systems have been developed. The objective of this study is to provide an evaluation of the element strengthening and systems approach to retrofitting of structure. To increase the effectiveness of rehabilitation and strengthening techniques and reduce their cost, selective and systems approach to rehabilitation and strengthening are examined.

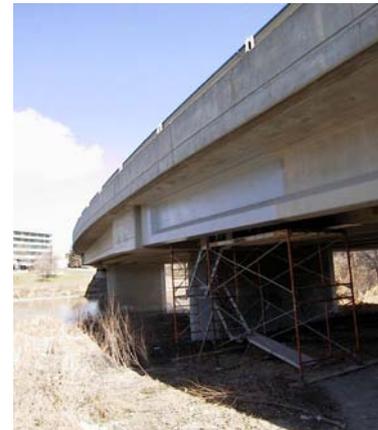
Figure 2. Shear strengthening of a concrete bridge girder

For two decades extensive research efforts were directed to the rehabilitation of various structural elements such as beams, columns, beam-column joints and structural walls. Different techniques have been studied to increase flexural, shear or torsional strength and ductility of various structural elements. Flexural strengthening of beams was initially conducted by Kaiser (1989), Saadatmanesh and Ehsani (1990), Triantafillou and Pelvris (1992). Berset (1992), Al-Sulaimani et al (1994) and, Chajes et al (1995) conducted the research on shear retrofitting of beams. Ghobarah et al (2002) studied torsional strengthening of beams using advanced composites. An example of the shear retrofit application of a reinforced concrete bridge girder is shown in Figure 2.

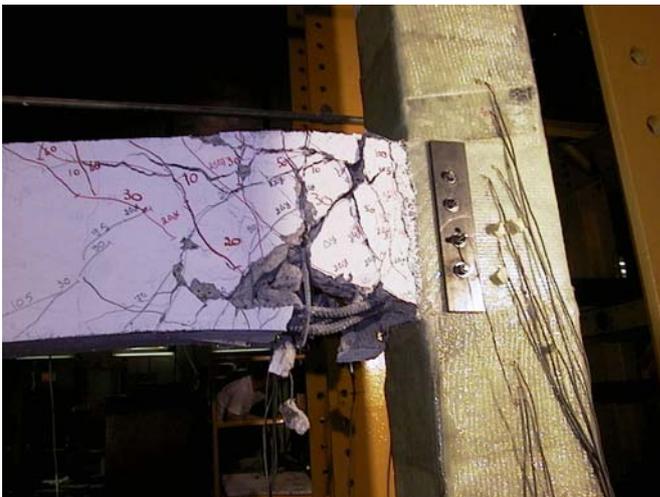
Figure 3. Beam hinging in a rehabilitated joint.

Ghobarah and Said (2001, 2002), El-Amoury and Ghobarah (2002), Ghobarah and El-Amoury (2003) investigated the behaviour of retrofitted beam-column joints using advanced composites to eliminate joint shear failure. Example of eliminating joint shear failure and instead transferring the failure to ductile beam hinging, is shown in Figure 3.

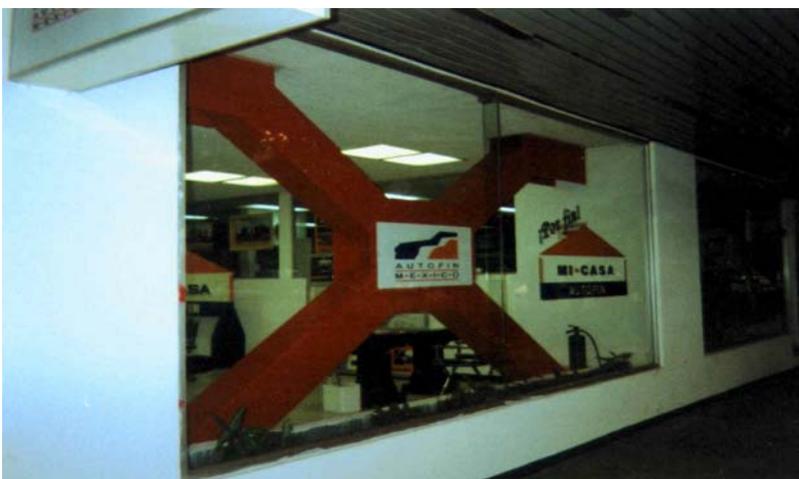
Figure 8. A reinforced concrete frame strengthened using a concentric steel brace.

The deficient reinforced concrete frame can be strengthened by installing concentric steel brace in the different bays. An example of a steel brace installed in a bay of a frame is shown in Figure 8. Steel bracing may be installed in one or several stories along the height of the frame. The seismic responses of four rehabilitation cases R1, R2, R3, and R4 shown in Figure 9 were evaluated to study the effect of the brace distribution along the building height. In the bracing case R1, the brace members were selected as round hollow sections (HSS 114 × 8) and were distributed uniformly over the frame height. This case represents the common practice in brace design and will be used as a reference case. For the other three rehabilitation cases, the brace properties (P_c / P_y), (P_r / P_c), radius of gyration (r) and total area are kept constant. The selected brace properties in this particular design were: modulus of elasticity = 200,000 MPa, yield strength, $f_y = 350$ MPa, $P_c / P_y = 2.41$, $P_r / P_c = 0.33$, $r = 37.7$ mm and $KL/r = 113$, where P_y is the brace yield load, P_c was the initial buckling load, and P_r is the residual buckling load. Details of the analysis and design are given by Abou Elfath and Ghobarah (2000).
