Structural Assessment of FRP-Strengthened Structural Members Using Cyclic Load Testing

Peter Emmons

Structural Group Inc., Baltimore, Maryland

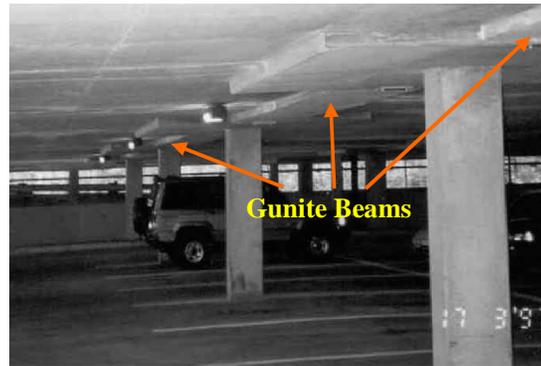
Figure 7. Gunitite beams applied to the underside of the garage decks

An earlier remedial repair consisted of heavily-reinforced, 75 mm thick and 900 mm wide Gunit beams that were added to the underside of the slab between the drop panels (see Fig. 7). During a non-destructive testing (NDT) investigation (pulse velocity test), it was found that 105 of the 133 beams tested had delaminated. Initial conclusions related the delamination to inadequate bond due to poor

roughening of the underside of the slab prior to the installation of the gunite beams and an incorrect placement method - using the cast-in-place method instead of the form-and-pump technique.

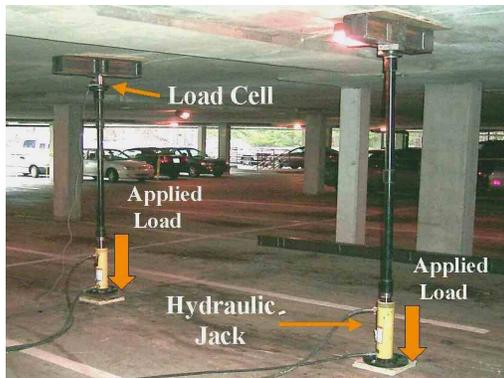
Figure 8. Hydraulic jacks

The CLT load testing procedure utilizes hydraulic jacks to induce the internal forces equivalent to those resulting from distributed loads. The load test equipment and setup used are shown in Figures 8 and 9. During the load test, the mid-span deflection was monitored for stability. When the deflection increased with a constant or dropping load, the test was halted.
