Rescuing the Sidi Rached Bridge

M. Petrangeli¹, A. Viskovic¹ and P.R. Marcantonio¹

¹University “G. D’Annunzio”, Chieti-Pescara, Italy

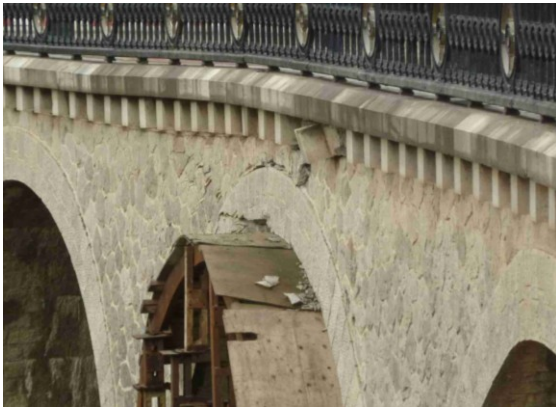
Fig. 2: Crushing of the arch between Pier 4 and 5

Various failure scenarios were therefore examined. Although very large, the sway of the deck could not cause collapse by triggering P-D effects. Also the crushed arch between Pier 4 and 5, although severely damaged, has been hold in place by erecting provisional supports (scaffoldings) from the ground. The numerical simulations clearly identified the brittle failure of the piers as the most critical scenario. Rotations at the piers bases are so high that the compression zones of these sections are very thin and subjected to very high stress, close to stone crushing, due to the bridge self-weight. The numerical predictions were confirmed in following months by splitting cracks developing in the stone facing of 4 piers, those where the kinematics of the bridge imposed the largest rotations at the base sections.

Once the soil instability will be tackled and the bridge will show no sign of further deformation, the collapsed arch between Pier 4 and 5 will have to be demolished and reconstructed. At that time, studies shall evaluate the possibility of inserting another buffer deck so as to allow for future soil sliding without introducing forces into the bridge. The interesting and critical aspect of this phase of the work is that, based on the numerical analyses, the bridge is still carrying a compression force in the deck of 900 tons. This force did not decrease substantially upon the removal of the buffer deck between the abutment and Pier 1 because the shear walls built between Pier 1 and Pier 2 prevented the structure to set back. Demolishing the arcade between Pier 4 and 5 will release the axial compression in the deck and the bridge will set back and recover from the swayed and rocked position. A very delicate operation to perform, because it affect the static on the main arch over the Rhumel canyon.

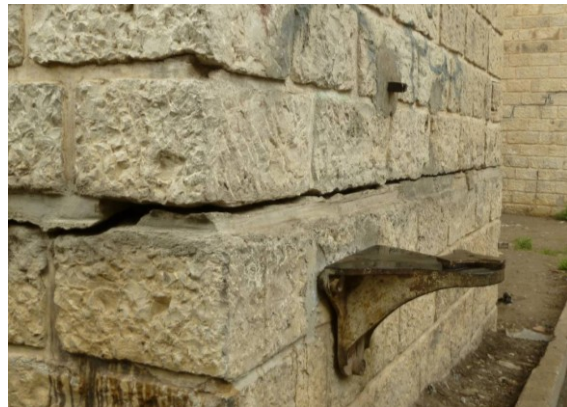
Fig. 3: Wide flexural cracks at piers bases

Given the size of the flexural cracks at the pier base, it was decided to start collecting high precision topographic reading of the bridge on a monthly base. This type of survey could take advantage of the limestone rocks surfacing close to the bridge and thus providing reliable reference points for the triangulations. Readings were taken at the four corners of each pier for the base section and arch set one. The reading fully confirmed the results of the numerical simulations. With reference to the arch set ones shown in Fig. 8, we notice the following. The tangential (downhill) displacements are larger at the abutment and quickly decrease with the surfacing limestone (around Pier 4, as shown in Fig. 2). Radial displacement are very high for Pier 3 to 6 where the deck has swayed outward because of the planimetric radius of the bridge. Vertical displacements of the pier founded on limestone confirmed the pier rocking with vertical displacements proportional to the radial ones time the aspect ratio of the pier (rigid rocking of the masonry section).

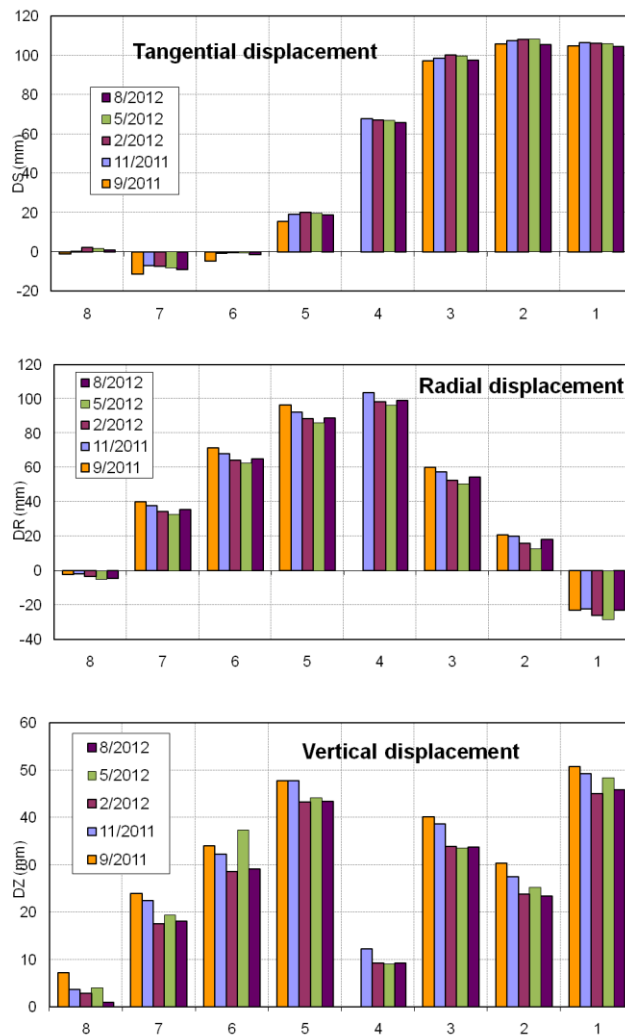
Fig. 6: Pier displacements at the arch set

The time evolution of these displacement are also very interesting. After the removal of the old buffer deck (summer 2011) the bridge started to slowly set back although restrained by the shear walls between Pier 1 and 2. Consequently small reduction in the radial outward sway was observed although the tangential (downhill) ones were still creeping during fall and winter 2011-12 because land slide was still active and progressive crushing of the arcade between Pier 4 and 5 possibly still ongoing. Last reading taken in summer 2012 shows a small increase of the radial displacement of the deck. This alarming inversion is very likely caused by the progressive damage at pier base sections, possibly facilitated by the inevitable vibrations caused by the micropiles and soil anchors borings currently being carried out to anchor the pier foundations to the limestone.

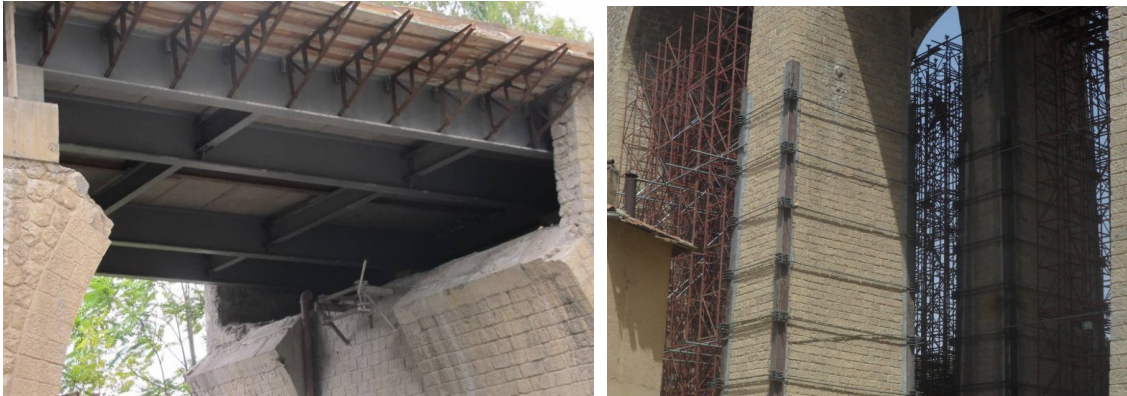
Fig. 7 – Fig. 8: The Buffer deck between the abutment and Pier 1 and emergency propping and pier jacketing with steel profiles and external posttensioning

The first interventions have been the temporary propping of the crushed arcade in order to allow the transit of pedestrian and cars on the bridge. Second intervention, in summer 2011, has been the removal of the old buffer beam that was jammed and its replacement with a new deck,

shorter, lighter and with enlarged gaps to allow differential displacement of the abutment. Unfortunately, during fall and winter 2011-12 the slope sliding peaked again requiring other two arcades to be propped and the most damaged piers reinforced with steel profiles and transverse prestressing so as to prevent their collapse.
