Post-tensioning for rehabilitation of the in-plane behavior of structural masonry walls

A. Sadeghi Marzaleh¹, B. Weber¹, K. Pfyl-Lang², and M. Motavalli¹

¹ Empa, Swiss Federal Laboratories for Materials Science and Technology, Dübendorf, Switzerland

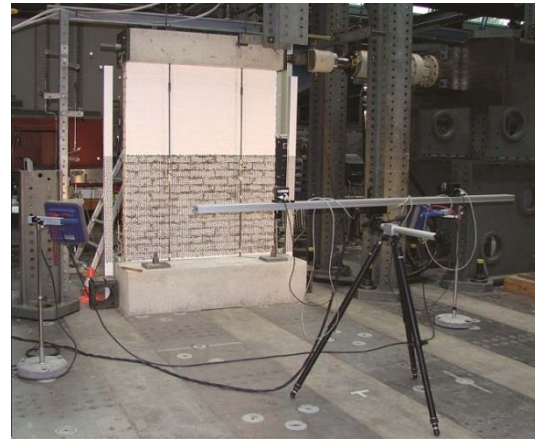
Figure 3. 3D image correlation system installation of Wall 4.

In addition to the conventional measurements with displacement transducers, optical measurements were carried out with a 3D image correlation system using the commercial product ARAMIS (2008). The installation of the image correlation system for Wall 4 is shown in Figure 3. This system encompasses two 4-mega pixel cameras with focal length of 20 mm. A random pattern is painted on the wall that allows comparing the two stereo photos of a specimen in a deformed state with those of the initial state. The image correlation system compares so-called facets of 15 x 15 pixels. With this setup, the displacement resolution is around 0.1 to 0.01 pixels. For the squat walls, the side length of the measuring window of 4 m is mapped into 2000 pixels. This corresponds to 2 mm/pixel and results in a resolution of 0.2 to 0.02 mm. For the slender walls, a smaller measuring window was chosen, covering only the lower half of the wall and resulting in a resolution of 0.1 to 0.01 mm.

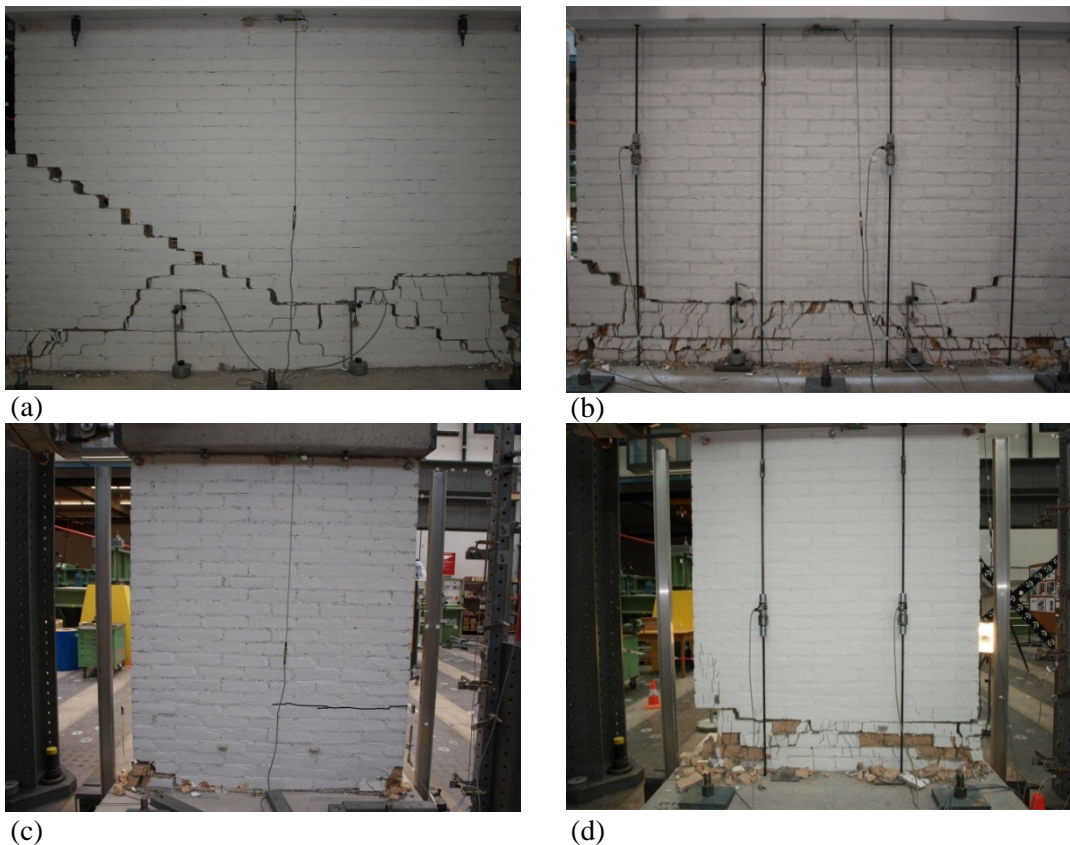
Figure 4 shows the final state of the walls. All walls showed initially a rocking behavior with a single flexural crack opening at the tension side and, with increasing horizontal displacements, additional nearly vertical cracks in the compression zones.

Figure 4. The final state of (a) Wall 1, (b) Wall 2, (c) Wall 3 and (d) Wall4.

For both squat walls, the first visible cracks formed in the bed joints during the load step with a target drift of the horizontal jack of 0.15%. These cracks did not necessarily form in the bottom bed joint but two or three layers higher up and then stepped down to the bottom bed joint towards the center of the wall.

For the slender wall without post-tensioning (Wall 3), the first crack was observed in the 8th bed joint above the foundation slab already at 0.04% drift of the horizontal jack. However, once the flexural cracks formed in the bottom mortar bed joint, the first crack remained closed. For the slender wall with post-tensioning (Wall 4), the flexural cracks in the bottom mortar bed joint started to form at 0.075% drift of the horizontal jack.

After the initial rocking behavior, a diagonal stepped crack opened in the squat wall without post-tensioning (Wall 1), at a target displacement of the horizontal jack of 0.6%. This changed the behavior of the wall from rocking to sliding. At the same time large vertical cracks formed in the compression zones and spalling of the bricks in the most compressed corners occurred. In contrast, the slender wall without post-tensioning (Wall 3) did not change to a sliding mode and showed an almost pure rocking behavior with a flexural crack in the bottom mortar bed joint

and localized damages in the compression zones. In fact, the test on Wall 3 was stopped before the ultimate condition of the wall was reached because of the limits of the test set-up (fixation of the steel beam and displacement capacity of the horizontal jack). At the end of the test, the maximum horizontal drift was over 4.0% without significant loss of the horizontal resistance.

The two post-tensioned walls, the squat Wall 2 and the slender Wall 4, showed both a predominant rocking behavior. However, in both cases the damaged zones were much more extended with vertical cracks over the whole bottom part of the walls. In fact, once the damaged zones extended to the center of the walls, new tensile flexural cracks formed above the damaged zones leading to a modified rocking behavior about them. In addition, the rocking movement of Wall 2 was accompanied by an increasing sliding movement along the new tensile flexural cracks in both directions. This led to the compression zones being pushed outwards producing an increasing offset between the bottom layers below the newly formed tensile flexural cracks and the layers above them.

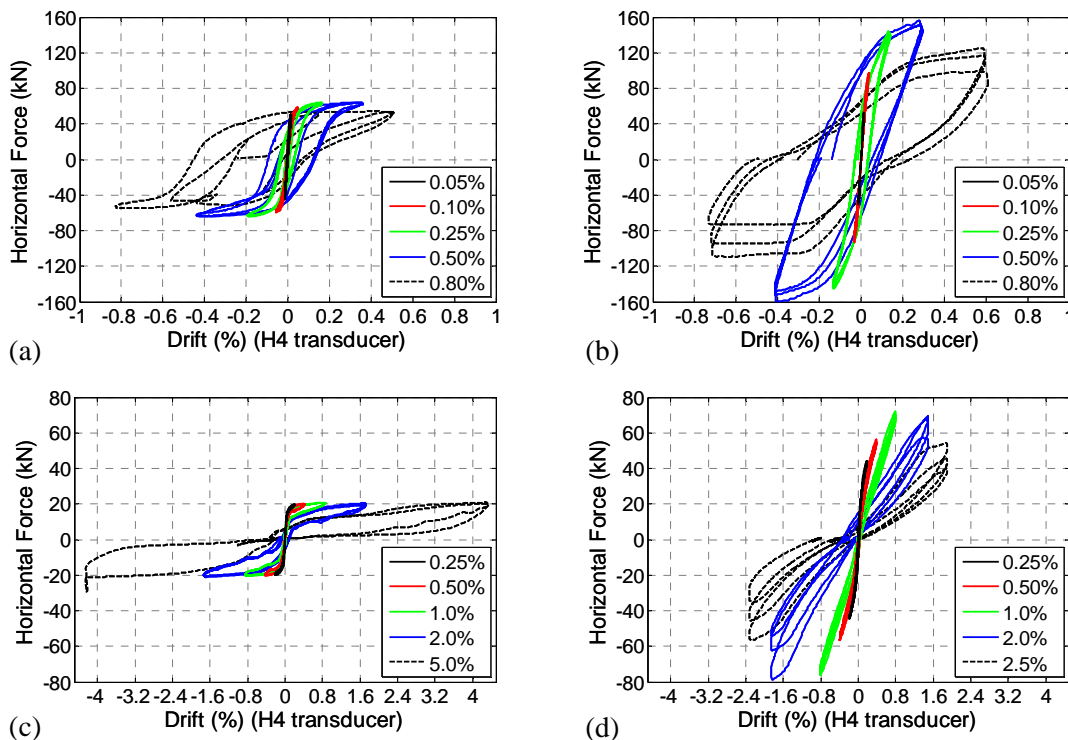
Figure 5 depicts the horizontal force-drift of the walls. In this figure, the dash line shows the last load step based on the displacement protocol introduced to the horizontal jack.

Figure 5. Horizontal force versus drift of (a) Wall 1, (b) Wall 2, (c) Wall 3 and (d) Wall 4 for different drifts of the horizontal jack (H3 transducer).

The initial rocking behavior of Wall 1 was well reflected by the horizontal force-displacement curves with the wall returning very close to the origin after each cycle. Simultaneously the wall was sliding on the tensile cracks, which opened the hysteretic curve gradually. By forming the diagonal stair stepped crack, the behavior changed from rocking to sliding over this crack and the hysteretic curve opened significantly leading to large residual displacements.

Also Wall 2 started initially with rocking and sliding over the tensile flexural cracks. The increasing sliding movement is well reflected by the growing opening of the hysteretic curves and, hence, the increasing residual displacements in the unloaded state. After several steps, due to high compressive stresses, toe regions crushed that resulted finally in the degradation of stiffness and strength.

Wall 3, the slender wall without post-tensioning, showed an almost pure rocking behavior up to the very last load steps when a concentrated toe crushing occurred. The residual displacements in the unloaded state before toe-crushing were less than 1 mm. Only during the final load steps the hysteretic curves opened up, however, the residual displacements remained small, i.e. the wall returned almost to its original position at the end of the test.

Also Wall 4, the slender wall with post-tensioning, showed a pronounced rocking behavior. However, whereas Wall 3 showed a flag type behavior, the behavior of Wall 4 showed no distinct plateau. The behavior at each load step was more “linear” and the opening of the hysteretic curves remained limited. Crushing of the both bottom corners led to a decrease in the stiffness and strength of the wall.

As can be seen in Figure 5, post-tensioning enhances the shear resistance of both squat and slender walls. Two different mechanisms can be considered responsible in the two cases. The first mechanism is more effective in the squat wall where the applied post-tensioning increases the normal stress on the sliding parts. Hence, the friction between them becomes greater and the diagonal stepped cracking is prevented. As a result, the failure mode changes to toe crushing and the shear resistance increases. The other mechanism occurs notably in the post-tensioned slender wall where the rocking mode generates extra axial force in the post-tensioning bars due to vertical displacement of the loading beam. The generated axial force in the bars, especially those located further from the rotation center of rocking, provides a moment that resists the imposed horizontal force. The more horizontal displacement is introduced to the wall, the larger resisting moments the post-tensioning bars generate.
