Structural Performance Monitoring of GFRP Reinforced Concrete Flat Slab Parking Garages

Ehab Ahmed¹, Brahim Benmokrane², and René DeBlois³

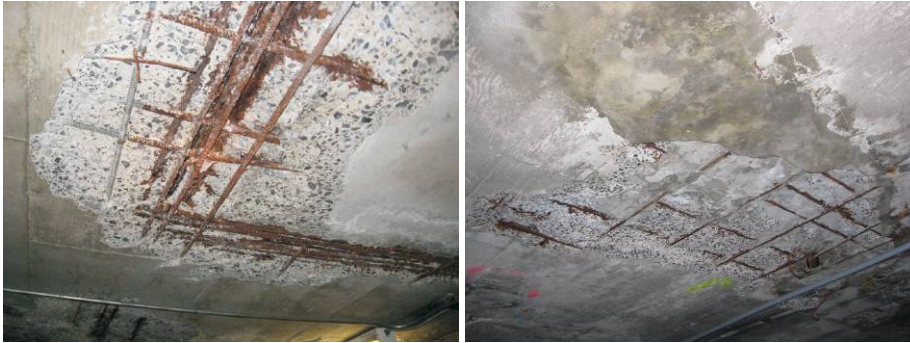
Figure 2. Corrosion of steel reinforcement of in parking garage.

La Chancelière parking garage, which is located in Quebec City, Canada is a 40 years old reinforced concrete structures. The structural system of this parking is a two-way flat slab supported on columns and retaining walls. La Chancelière parking garage showed a severe deterioration resulted from the corrosion of steel reinforcement and the consequent spalling of the concrete cover (as shown in Figure 2) which led to faster degradation and reduction in the cross-sectional area of the steel reinforcement. These deteriorated conditions led to the need of costly rehabilitation of the parking garage. As the structural system of the parking was flat slab and the corrosion of steel reinforcement was very severe in almost all the slabs, it was decided

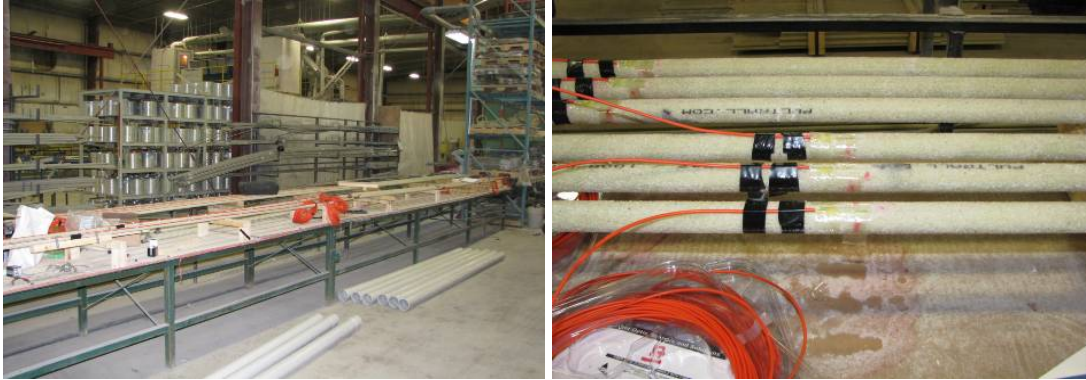
Figure 5. Instrumentation of GFRP bars.

To monitor the behavior and evaluate the performance of the GFRP-reinforced flat slabs of the parking, a representative area of the parking, shown in Figure 3, was selected. The GFRP reinforcing bars as well as the concrete section of the slab were instrumented at critical locations for strain data collection using fibre optic sensors (FOS). The GFRP bars were instrumented thereafter were transported to the construction site. Figure 5 shows the instrumentation of the GFRP bars. A total of 26 FOS were glued on bottom and top reinforcing bars in the two orthogonal directions at the location of the maximum expected stresses (maximum bending moments). In addition, two FOS were glued on two dummy bars embedded in the flat slab

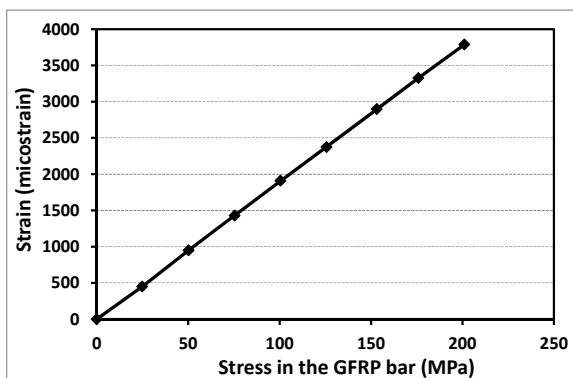
Figure 8. Strain-strain relationship of the GFRP bars from FOS strain measurements.

The used FOS sensors were of $\pm 2500 \mu\epsilon$ measuring range. Since the readings resulted from the bottom GFRP bars (Figure 7a) were close to $2500 \mu\epsilon$, the FOS was calibrated to verify its ability capture any further strain increase or not. To achieve that, an FOS was glued to a GFRP bar (from the same production lot used in the parking garage) and was tested in tension on a universal loading BALDWIN machine to determine the stress-strain relationship and measure the maximum strain that FOS sensor can capture. Figure 8 shows the relationship between the stress in the GFRP bar and the corresponding strain measured from the FOS sensor. The figure indicates that the FOS is capable of achieving a reasonably high strain level (up to about $3700 \mu\epsilon$) without any problems.
