## Sustainable RCC Building Construction and Rehabilitation in Bangladesh: The Urgent Needs

**ABSTRACT:** In the past two and half decades, major business districts including Dhaka the capital of Bangladesh have experienced a marked growth in infrastructure, particularly in the building construction sector. However, the capital city Dhaka and its adjoining counties are gradually becoming unsustainable for living. Lack of enforcement of building codes in structural design and slack enforcement of regulations by the capital development regulatory authority (RAJUK), inadequacy of detail design drawings and poor quality of construction have already caused unbearable loss of life of factory workers. Severe injuries from building collapse have also resulted in permanent disability. In recent times (April 2013), the collapse of Rana Plaza in Dhaka have resulted in more than 1100 deaths of garment workers. It is believed that this is the largest death toll in human history in a single building collapse. Many building are even unsafe for gravity loads. In particular, there is a growing apprehension that a moderate to severe earthquake in any major city will result in devastating loss of li

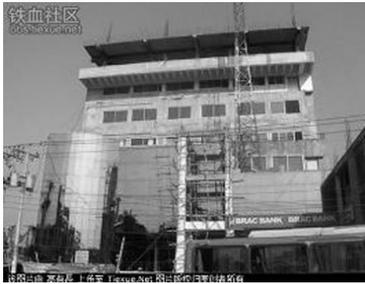
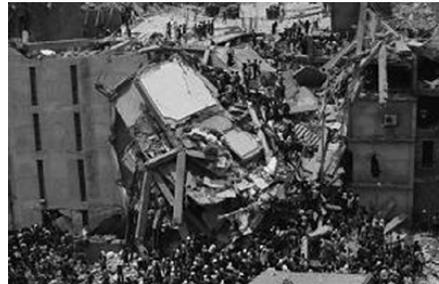
Figure 1: Deadly Collapse of Rana Plaza Building at Savar County, Dhaka

Rana Plaza building, the day before collapse

Wreckage of ill fated Rana Plaza building

- Poor quality of concrete used in the columns is the main reason for the collapse of the building. The coarse aggregate made from locally burnt bricks were used. Such aggregates absorb too much water and produce very low strength concrete. The total construction was supervised by the owner himself who had no technical capacity for quality construction

- Sewing machineries and the generators for the factories were placed in the upper floors. BNBC does not approve generators in upper floors. Vibration of the generators accelerated the gradual weakening of the poor concrete which, finally resulted the collapse of the building.

- It is mandatory to take approval of plan from Capital Development Authority (RAJUK) in order to construct any building in Dhaka City (including Savar County). Rana Plaza was constructed without permission from RAJUK. The revised plan for vertical extension (5 storied to 9 storied) was approved by the local council without considering the original structural designs

-An architect was involved for the preparation of the 5-storied building plan. However, no registered structural engineer was engaged for structural analysis and design checking for possible vertical extension with appropriate strengthening or retrofitting technologies. The building was vertically extended upto 9 storied without considering the capacity of the pile foundation to take additional loads

- In Bangladesh National Building Code (BNBC), a structural importance factor is included for different types of super structure. This was totally ignored for the case of Rana Plaza.

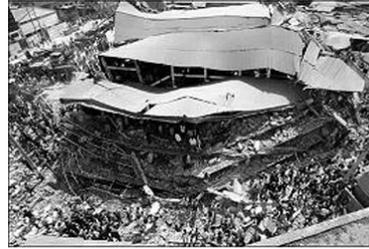
Figure 2 (a) Collapse of Spectrum building

killed and about 90 workers were injured. It took more than a month to clean the debris from the site even though this building (Figure 2) is located in relatively open space compared to other densely populated locations and structures in Dhaka city. Investigation on this collapse revealed that the discontinuity in the pile foundation and the respective column resulted progressive collapse of the structure. Although initially the start of progressive failure was reported, no measures were taken by the concerned authority before the sudden collapse.

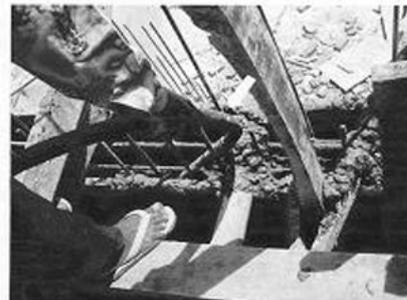
Figure 3 (a) Concrete mix with high W/C ratio

(b) Vibrator at inclined position
