Pre- and post-retrofit structural assessment of a fire-affected industrial building strengthened with FRP materials.

ABSTRACT: The paper focuses on the importance of in-situ assessment of damaged structures finalized to properly design and calibrate innovative structural strengthening solutions such as FRP (Fiber Reinforced Polymers). Accordingly, the paper aims to assess this topic by presenting a remarkable case study of a fire-damaged reinforced concrete industrial structure, located in Dubai (UAE), on which an extensive experimental campaign on materials and structures was carried out to evaluate the damages caused by the fire. The assessment of the building included structural surveys, *in situ* non-destructive testing techniques (NDT), laboratory testing of collected samples and full-scale structural evaluation by means of cyclic load testing. Consequently, a specific strengthening system with FRP materials was designed and realized. In addition, quality control of the retrofit application was carried out with NDT techniques as well as evidence of structural efficiency was given afterwards with the execution of full-scale cyclic load tests on the strengthened structures.

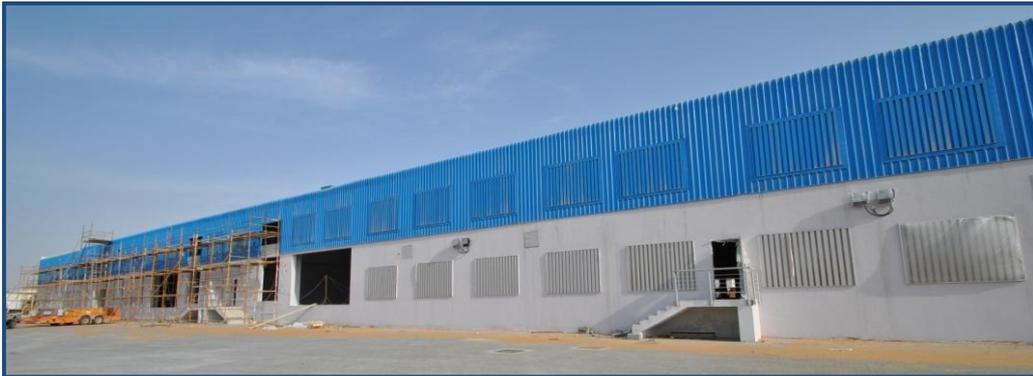
This paper presents a significant case study of structural assessment and FRP strengthening of existing structure which SGM *Experimental Engineering* [1] recently completed in the Middle East region, together with the partner companies of the Network “*The First Brick*” [2]. The building hereafter presented is a reinforced concrete (RC) industrial warehouse (Figure 1) located in the Jebel Ali Free Zone of Dubai (UAE).

Figure 1. View of the investigated building

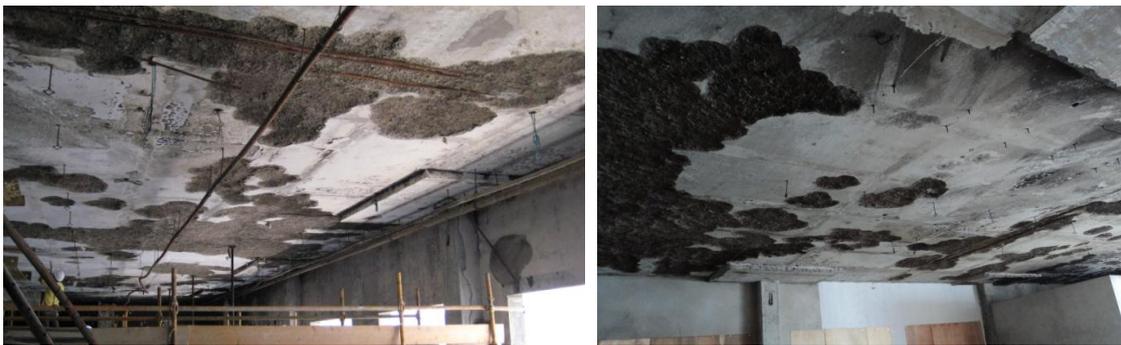
While the construction process of the warehouse was at its last stages, a fire event accidentally occurred at the ground floor, in the area where the construction materials and MEP furnishings were stored. The building is a two stories RC structure of 6,000 m² total and only part of it, about 600 m², was affected by the fire. As expected, the most damaged elements of the structure resulted to be the soffits of the two-way slabs and the upper part of the columns. The damages consisted mainly in concrete cover spalling over large areas of the slab, over-heating of exposed reinforcing steel rebars and overall degradation of materials due to high concentration of dense smoke (Figure 2).

Figure 2. Damages to the two-way slabs caused by the fire

From the structural surveys, ferroskan readings and GPR investigations, the structural elements investigated resulted to be complying with shop drawings in terms of geometry and structural conformity (concrete cover, rebar location, spacing, diameter, etc.). Thermography and visual inspection of the site showed that the fire event extensively damaged relevant portions of the surveyed structure by means of deep concrete spalling and detachment with consequent reinforcing steel exposure and degradation. The test results allowed estimating the fire affected area to be approximately 500 m². From petrography and x-ray diffraction test, it resulted that the maximum temperature experienced by the concrete slab was about 570-580 °C. Non-

destructive and chemical/mechanical tests of the constitutive materials did not show any evident critical value, although experience in analyzing similarly damaged structures induced thinking that a loss in terms of ductility of the overall member behavior occurred, consequently leading to a reduction of the safety design factors. Further, cyclic load tests were carried out on five horizontal structural elements to assess the overall behavior of the structure. It was agreed to apply a maximum concentrated load of about 11,000 daN, equivalent to a uniformly distributed load of about 500 daN/m² (50% of the design live load). From the analysis of the results, the maximum deflections recorded at midspan during the tests always satisfied the serviceability parameters provided by the code [3, 7]. Nevertheless, during the load test on slab n.2, the deviation from linearity, at a certain load level, was recorded to be IDL=24%, very close to the maximum allowed value of 25% provided by the code as one of the acceptance criteria to be monitored during a load test (maximum deflections, recovery of deflection upon removal of test load, repeatability index, crack opening, etc.). For this reason, the test needed to be stopped. As expected, slab n.2 was located in the area mostly damaged by the fire. On the other hand, test results clearly showed how the slabs not exposed to the fire performed indeed better with an overall improvement of the performances moving away from the fire affected area. Therefore, according to the available population of test results and also relying on experience with similarly damaged structures, an average flexural strength reduction of the slabs of 25% was estimated, due to the severe exposition of horizontal elements to the fire event.

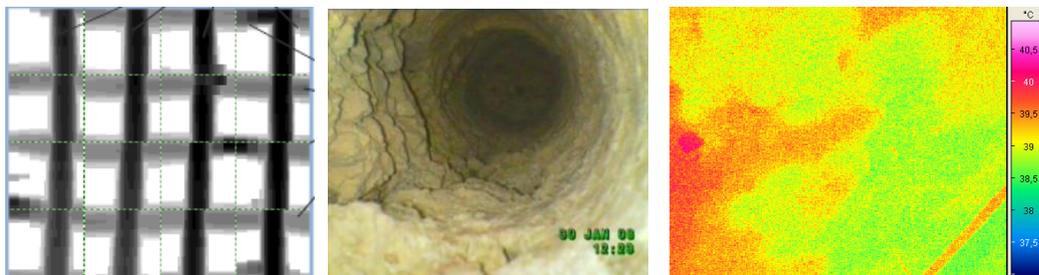
The first step of a structural assessment is the classification of the structural configuration and the geometrical survey of the investigated areas and structures. Visual inspections and observations are important to identify the specific parameters influencing the overall performances of the structural elements, and in particular: load paths, geometry, type of connection between the elements, presence of cracks, weak or soft storey, etc. A fundamental step in the characterization of a RC structure is the detection of the steel reinforcement by means of type and diameter of the bars and their arrangement. This goal can be achieved either by removing the concrete cover in some areas and directly locate and measure the bars (*structural survey*) or by using special tools, as the *Ferrosan*, capable of locating steel rebars, estimating their diameter and concrete cover depth (Figure 3a). Also advanced NDT tools, as *Videoendoscopy*, *GPR* and *Thermography*, are used to improve the level of knowledge of the investigated structure by characterizing each construction element. Particularly, *Videoendoscopy* is performed using a remote visual inspection tool, instrumented with a video camera and a led light source, capable of inspecting areas otherwise not visible, as the internal structures of concrete and masonry walls, slabs, roofs, ceilings, etc. (Figure 3b); *Ground Penetrating Radar (GPR)* uses electromagnetic radiations to image the subsurface of elements and to detect objects, changes in material, voids and cracks. *Thermography* also is a non-destructive test which uses an infrared camera to investigate the surface of a construction element previously subjected to a thermal distress to define different isothermal areas within the concrete surface (Figure 3c). This test allows emphasizing any non homogeneity within the element, presence of cavities, analysis of cracks, mapping of humidity, analysis beyond frescos and plastered walls or detachment of plaster and concrete substrate.

Figure 3. Captures from: (a) Ferrosan, (b) Videoendoscopy, (c) Thermocamera.

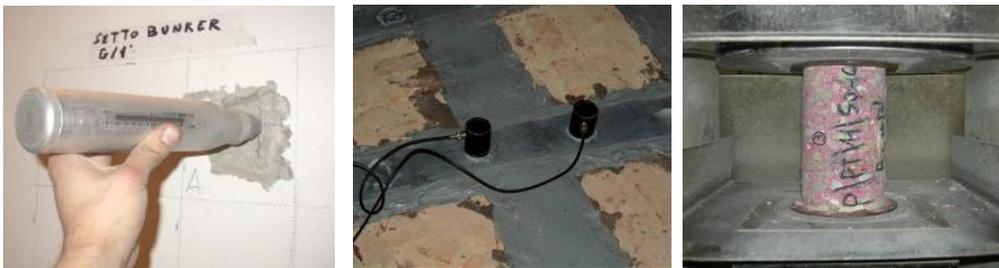
A comprehensive structural assessment cannot be completed without characterizing the mechanical and physical properties of the materials used for the construction. The available *in situ* tests for concrete range from the completely non-destructive tests (NDT), through those where the concrete surface is slightly damaged, to partially destructive tests, such as core sampling and pull-out tests, where the surface has to be repaired after testing [4]. The range of properties that can be assessed using non-destructive and partially destructive tests is quite large and includes such fundamental parameters as density, elastic modulus, compressive and tensile strength, surface hardness, etc. The most common *in situ* material surveys for concrete are: Schmidt rebound hammer test (Figure 4a), ultrasonic pulse velocity measurement (Figure 4b), carbonation depth measurement and concrete core sampling for laboratory determination of compressive strength (Figure 4c). Whereas, for steel rebars the most common tests are: measurement of corrosion potential and the *in situ* steel sampling for laboratory determination of tensile strength. NDT testing can be applied to both old and new structures. For new structures, the principal applications are likely to be for quality control or the resolution of doubts about the quality of materials or construction [4].

Figure 4. Material testing: (a) Rebound hammer; (b) Ultrasonic survey; (c) Concrete core testing.

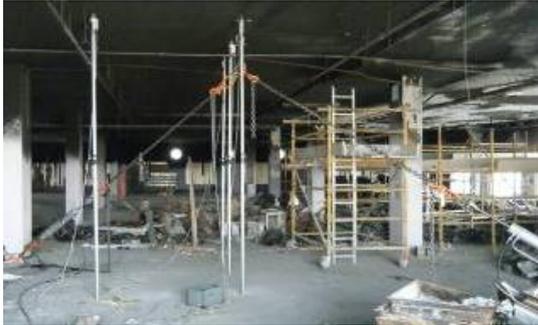
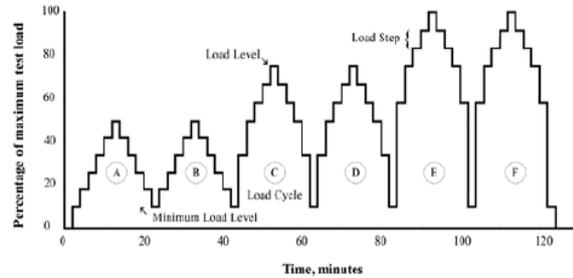
One of the most useful techniques to perform a structural evaluation of an existing building is represented by the *in-situ* load testing. This non-destructive load test allows determining the actual behavior of structural elements, such as slabs, beams, cantilevers, stairs, etc. by subjecting them to successive loading and unloading cycles and consequently to evaluate whether a structure or a portion of a structure satisfies the safety requirements of the code. The procedure of a cyclic load test consists in the application of a certain number of concentrated loads through the use of hydraulic jacks (Figure 5a), in a quasi-static manner, having magnitude capable of equalizing the uniformly distributed design load, and in the measurement and monitoring of deformations at specific critical sections of the member being tested. Utilizing loading cycles up to a predetermined maximum load (Figure 5b) allows the engineer to perform a safer real-time assessment of member characteristics, such as linearity and repeatability of response, as well as permanency of deformations [3]. This technique is very popular thanks to its ease of execution and thanks also to the variety of important information provided to the engineers who will be able to assess the structure and eventually design a *tailor made* strengthening intervention in order to meet the requirements of the code with minimum costs. An additional field of application of the *in-situ* load testing is the validation of the performances of structural members strengthened with innovative materials, and therefore to verify the efficiency of the strengthening system where the novelty of the upgrading technique raises doubts in the mind of owners, engineers, and building officials.

Figure 5. Load testing: (a) Hydraulic jacks and sensors; (b) Load cycles as per ACI 437.1R-07 [3]

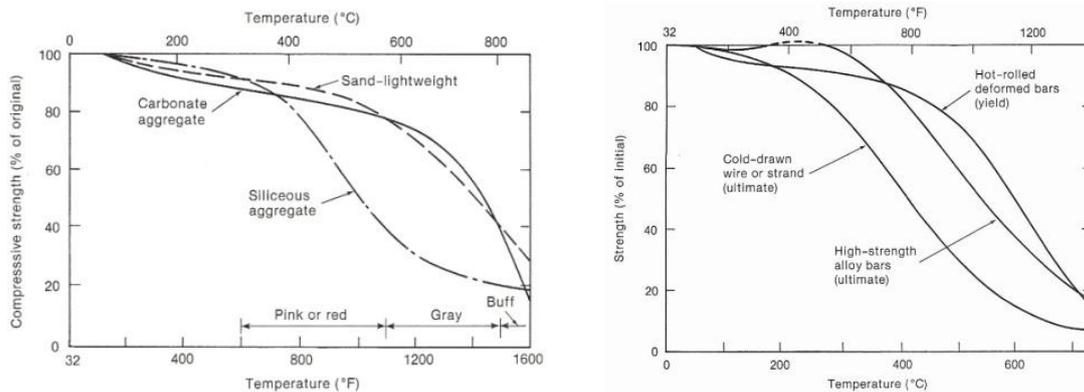
The rise in temperature generated by a fire in a reinforced concrete structure causes a decrease in the strength and modulus of elasticity of the constituent materials, both concrete and steel reinforcement. However, the rate at which the strength and modulus decrease depends on the rate of increase in the temperature of the fire and the insulating properties of concrete [5]. Therefore, if the soffit of a RC slab is subjected to fire, the strength of the concrete and the reinforcing steel will decrease as the temperature increases while steel changes its properties becoming more brittle, so decreasing the overall ductility of the concrete section. As the strength of the steel reinforcement decreases, the moment capacity of the slab decreases as well as compressive-flexural strength of columns (Figure 6), and in addition the ductility of the overall structure decreases as well, so reducing the overall safety factor which it has been designed for [6]. In addition, it is important to point out that the duration of fire that causes the reinforcing steel reaching the critical strength depends on the protection to the steel bars provided by the concrete cover, so the less concrete cover the less time needed for a fire of equal intensity to degrade portions of a reinforced concrete section.

Figure 6: (a) Fire degradation of concrete; (b) Fire degradation of steel [4]

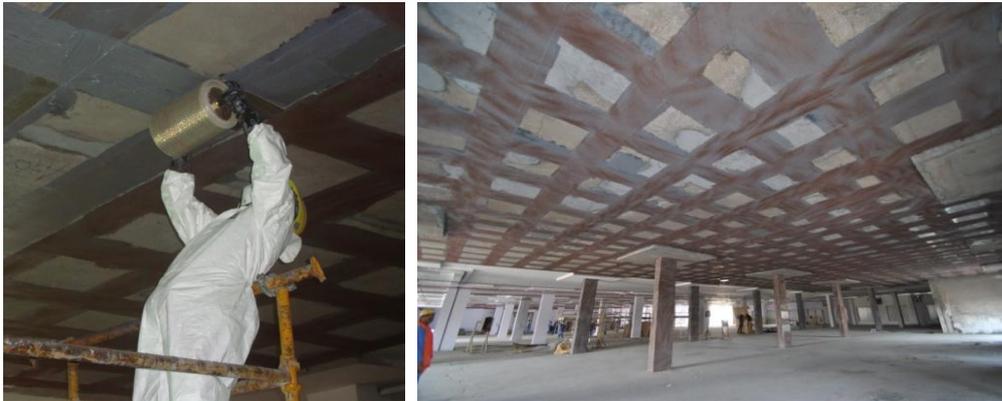
Figure 7: FRP flexural strengthening of the slab

Specifically, the slab was strengthened for flexure with FRP unidirectional layers of UHTSS high strength steel fiber sheets [9] running along the whole affected area in both directions (Figure 7). The retrofit was increased in those areas mostly damaged by fire, estimated to be about 200 m². Even though the columns were not directly or heavily interested by the fire, they surely had undergone a strong thermal-shock which could have affected not only the concrete but also the steel reinforcement, with decreasing magnitude moving away from the area where the fire originated. Therefore, the columns were strengthened using two different configurations based on their location respect to the origin of the fire. The solution adopted for the columns involved only shear strengthening by complete wrapping. Specifically, six columns were fully confined with UHTSS steel fiber sheets [9] for the total height and eight columns, showing a lower level of damage, were partially confined with FRP basalt unidirectional fiber sheets [9]. Therefore, different strengthening solutions were adopted for the columns based on their geometry, level of damage and target performances.

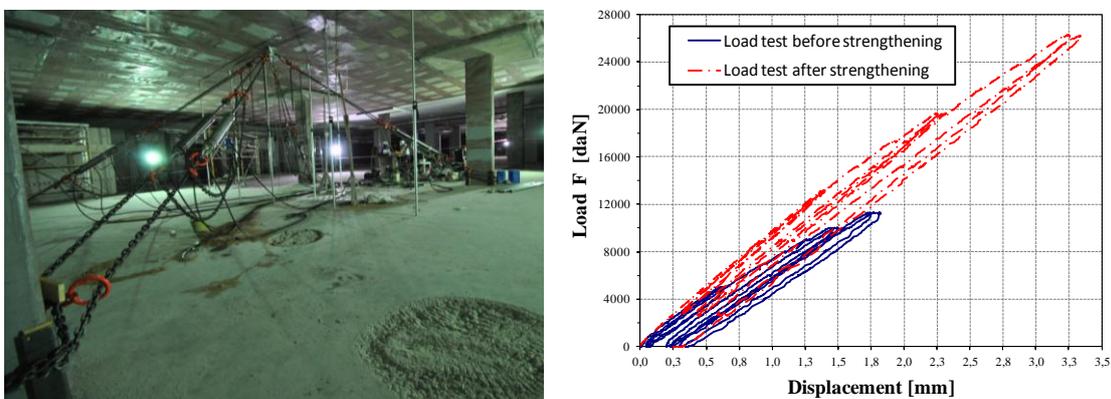
At the completion of the FRP strengthening intervention, a post-retrofit experimental campaign was carried out to check quality and efficiency of the retrofit system. According to CNR DT-200/2004 [8], various testing procedures were applied to define method, practice and reporting accuracy for qualifying the quality and uniformity of installation of the FRP strengthening system bonded to the concrete surface. Specifically, pull-off tests were carried out on non-critical strengthened areas to evaluate the tensile bond strength of FRP; high frequency ultrasonic readings were carried out adopting the *first peak amplitude variation* technique to localize defects; also, thermographic surveys were performed to detect presence of spots with different heat exchange and temperature variations over the FRP surface; all the quality checks had successful result. In addition, to prove the efficiency of the FRP system, a full-scale cyclic load test was carried out on the most damaged slab n.2 (Figure 8a) which previously experienced structural deficiency due to the high level of damage. The aim of the load test was therefore to assess the performance of the structural member, now strengthened with FRP, by applying an higher load and verify the efficiency of the retrofit against the test results obtained during the pre-retrofit experimental campaign. Hence, in accordance with the responsible engineers, a load test magnitude of about 26,000 daN, equivalent to a uniformly distributed load of about 2,000 daN/m² (200% of the design live load), was applied at the last load cycle. As a result, all the acceptance criteria monitored during the test always ranged within the safe limit values of the code [3]. In addition, the resulting hysteresis diagram (Figure 8b) showed how the slab always behaved in the elastic range as well as it experienced an increase of its elastic modulus compared to pre-retrofit cyclic load test.

Figure 8: (a) Cyclic load test on slab n.2; (b) Hysteresis diagram
