Proposal for the application of carbon fiber reinforced polymers (CFRP) for suspenders of arch bridges in China

J. Gao¹, C.M. Chen¹, A. Winistörfer², and U. Meier³

ABSTRACT: Arch bridges have been a main bridge type in China since ancient times. In modern time the application of steel and composite materials to the arch bridges enriched the structural type of those, i.e. the half-through and through arch apart from the deck arch. In through and half-through arch bridges, the dead-load of the deck system and the live load are transferred to the arch rib by suspenders. Therefore, suspenders are the most critical load-carrying members. They are exposed to fatigue and corrosion. Easy installation and low cost are important factors within the application of suspenders. In the past few years, there were failures of steel suspenders due to corrosion and fatigue. Even the collapse of bridge decks happened due to suspender failures. It is definite that the corrosion and fatigue resistance of suspenders have to be enhanced.

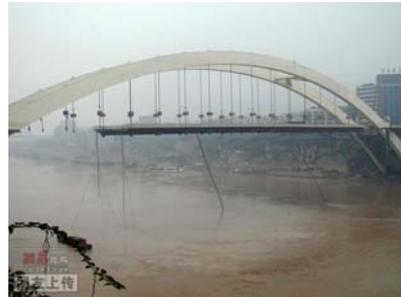
Figure 3. Xiao-nan-men Bridge with collapsed bridge deck.

The Xiao-nan-men Bridge was built in 1984 and opened to traffic on June 30, 1990. It is a half through reinforced concrete arch bridge with a total length of 387m. The clear span of the arch is 240m and the rise is 48m, i.e., a rise-to span ratio of 1/5. Fig. 2 shows the bridge before the deck collapsed. In the early morning about 4:00a.m on Nov.7, 2001, the deck of Nan-men Bridge, about 40m in the south and 20m in the north, partly collapsed due to several pairs of broken suspenders. Fig. 3 shows the bridge after the collapse.

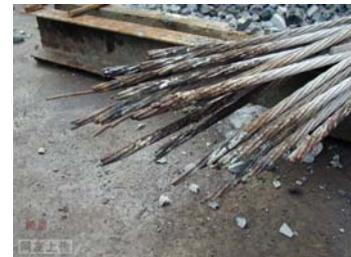
Figure 5. Socket longitudinally opened with a blow torch for investigative purposes. Strands of parallel strand cable.

The bridge site has been investigated after the collapse. Figs. 4-6 show details of failed suspenders. The corrosion of the steel wires was obvious. There were totally four pairs of suspenders broken, three pairs in the south and one in the north. It was found that all failures of the broken suspenders were in the vicinity of the bottom sockets connected to the deck. The damage investigation showed that parts of the corrosion protection had been cracked.

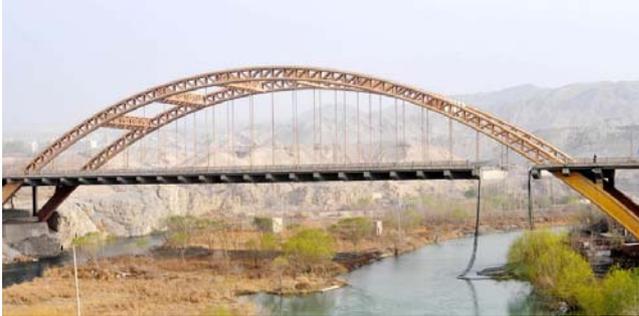
Figure 7. Kong-que-he Bridge after failure in 2011.

Kong-que-he Bridge (Peacock River Bridge) in Xin-jiang was a half-through concrete filled steel tubular arch bridge with the main span of 150m and width of 24.5m. The deck system consisted of 5.0m and 7.5m span reinforced concrete T-shaped girders and was suspended below the truss arch rib by 23 pairs of suspenders. The bridge was opened to traffic in August, 1998. At 5:30a.m. on Apr. 12th, 2011, a part of the deck in Kong-que-ke Bridge collapsed and dropped into the river. Fig. 7 shows the bridge after the collapse. Because of the deck collapse, the Kong-que-he Bridge was closed to traffic forever. It had been in service for only 13 years, which is very far from its design lifetime. The local highway agency decided to remove the entire bridge and to rebuild a new one at the same site.

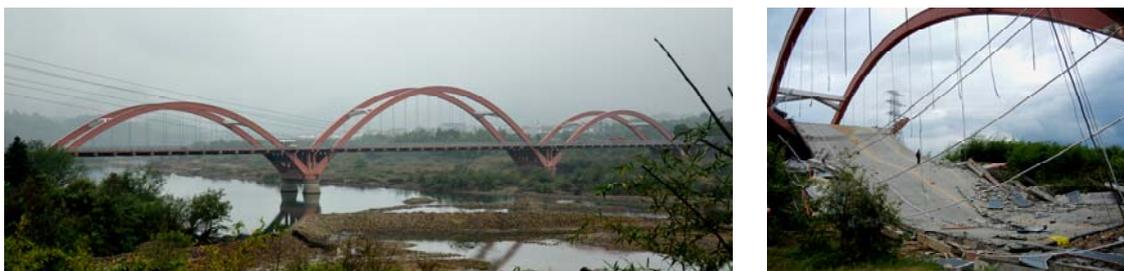
Figure 8. Left: Gong-guan Bridge before collapse. Right: collapsed bridge deck in 2011.

Gong-guan Bridge is located in Wu-yi-shan Scenic Area, Fujian, as shown in Fig. 8. It was opened to traffic Nov.20, 1999. It is a half-through reinforced concrete arch bridge with three spans, 80m+100m+80m. At 8:50a.m., July 14, 2011, when a tourist bus and an overloaded truck were passing the bridge, the deck of the first span partly collapsed as a result of broken suspenders, as shown in Fig. 8. The bus dropped into the river with 22 injured and the driver dead. However, the truck, having a self-weight of 20.6t and carrying 60t sand, was the direct reason for the collapse, because the nominal carrying capacity of the truck is only 15.65t. The overloaded truck may be the obvious reason for the collapse. But the bridge is located in a very important road and had heavy traffic. Many overloading vehicles passed the bridge everyday, which resulted in the damage of suspenders to varied degrees. Furthermore, this bridge was built in 1990', the sealing and anti-corrosion technique during that time was relatively poor. Similar like in the other case studies the failure of the suspenders was at or near the bottom sockets. This is a clear indication that corrosion played an important role. The local highway agency decided to remove the whole bridge and to build a new one.

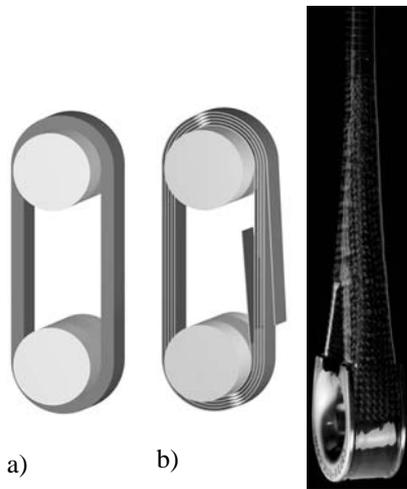
Figure 10. Conceptual design of pin-loaded strap elements.

A carbon fiber reinforced laminated pin-loaded strap, as shown in Figure 10 a), might provide a practical tendon for suspenders. Such an element consists of a unidirectional fiber reinforced polymer, having a fiber volume fraction of about 60%, wound around two cylindrical steel pins in a racetrack shape. No machining of holes is required to make a pin-loaded strap. The two pins could transfer the tensile load from the bridge deck through the strap to the arch rib. However laboratory experiments and analytical modeling by Winistörfer (1999) have shown that there are severe stress concentrations in the region where the strap and the pin meet. The tensile resistance of the strap is therefore limited to less than 60 % of the material's expected unidirectional strength. This is attributed to stress concentrations, which lead to premature failure.

An option to reduce the undesirable stress concentrations and cost is the use of a non-laminated strap. The concept which has been patented by Meier and Winistörfer (1998) is shown in Figure 10 b). The CFRP strap now comprises a number of unidirectional reinforced layers, formed from a single, continuous; tape of about 0.12 mm thickness. The tape is wound around the two pins and only the end of the outermost layer is bonded to the next outermost layer to form a closed loop.

The non-laminated strap element enables during loading the individual layers to move relative to each other, which allows an equalization of forces in the layers as the strap is tensioned; Winistörfer (1998). The stress concentrations are reduced since the new structural form is more compliant than the laminated equivalent. Control of the initial tensioning process reduces inter-laminar shear stresses so that a more uniform strain distribution in all layers can be achieved. The approach allows greater flexibility in terms of the geometry of the tendon, and it can be manufactured on site. Moreover, the concept is going to be more effective since more than 90% of the high strength of the CFRP will be applied.

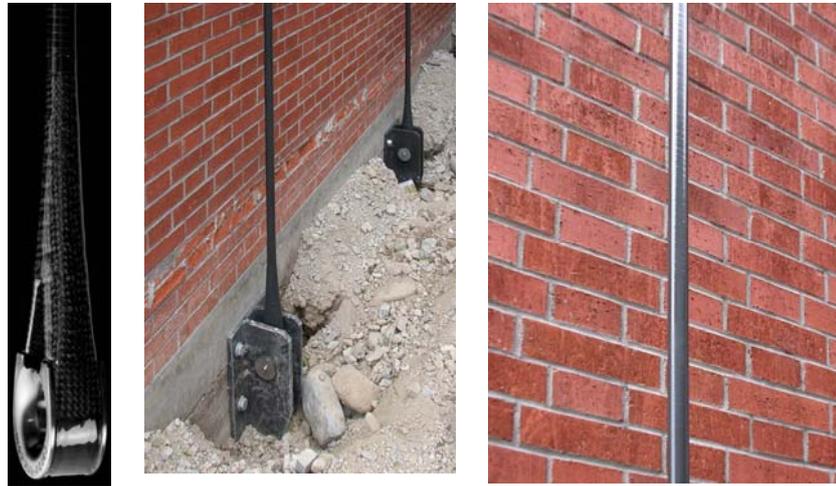
Figure 11. Seismic retrofitting of a masonry wall post-tensioned with a pin-loaded CFRP strap system. *Left picture:* termination for pin-loading. *Middle picture:* Attachment of the CFRP strap to the concrete foundation with pin-loading. *Right picture:* Post-tensioned CFRP tendon of 1 MN load capacity.

Suspenders made of pin-loaded CFRP straps can be fabricated with an automatic tape-laying machine in the factory of the Carbo-Link Company or on site. Thermoplastic polymers like polyamide 12 or thermoset polymers like epoxy are used as matrix materials. The best solution for suspenders would be: to fabricate the strap elements with epoxy preregs on an automatic tape-laying machine in the factory, to load it up to service load, to wrap fibers around the straps to get a circular or even better an oval-shaped (better aerodynamics!) cross section, to roll and ship it. As a flexible element it could easily be connected with a pin to the deck and another pin to the arch rib. Then the epoxy resin will be cured on the bridge site using the load carrying carbon fibers as an electrical resistance heating element. Results of such a process are shown in Figure 11.
