Reconstruction of bridge abutments on Corridor 10 section Veles - Katlanovo in R. Macedonia

ABSTRACT: Republic of Macedonia is positioned at the crossroads of Corridor 8 (East – West) and Corridor 10 (North–South). The Corridor 10 is the most important communication and transportation route connecting the Hellenic Republic with Austria and further with the rest of Europe. On the section between Veles and Katlanovo revitalizations of 10 bridges has been planned. The project is aiming to upgrade the structural capacity of the bridges as well as the abutments. It is financially supported by NATO as a strategic partner to R. Macedonia. In the past 30 years of exploitation significant settlements and deformations on the road-bridge transition elements had developed. Several unsuccessful attempts using surface improvement techniques have been made. Therefore this time, more comprehensive study has been prepared which considers different techniques, such as: jet grouting, earth reinforcement and end-bearing piles. The final decision regarding the methods used and reconstruction solution has been made considering two major aspects, namely the economic and technical.

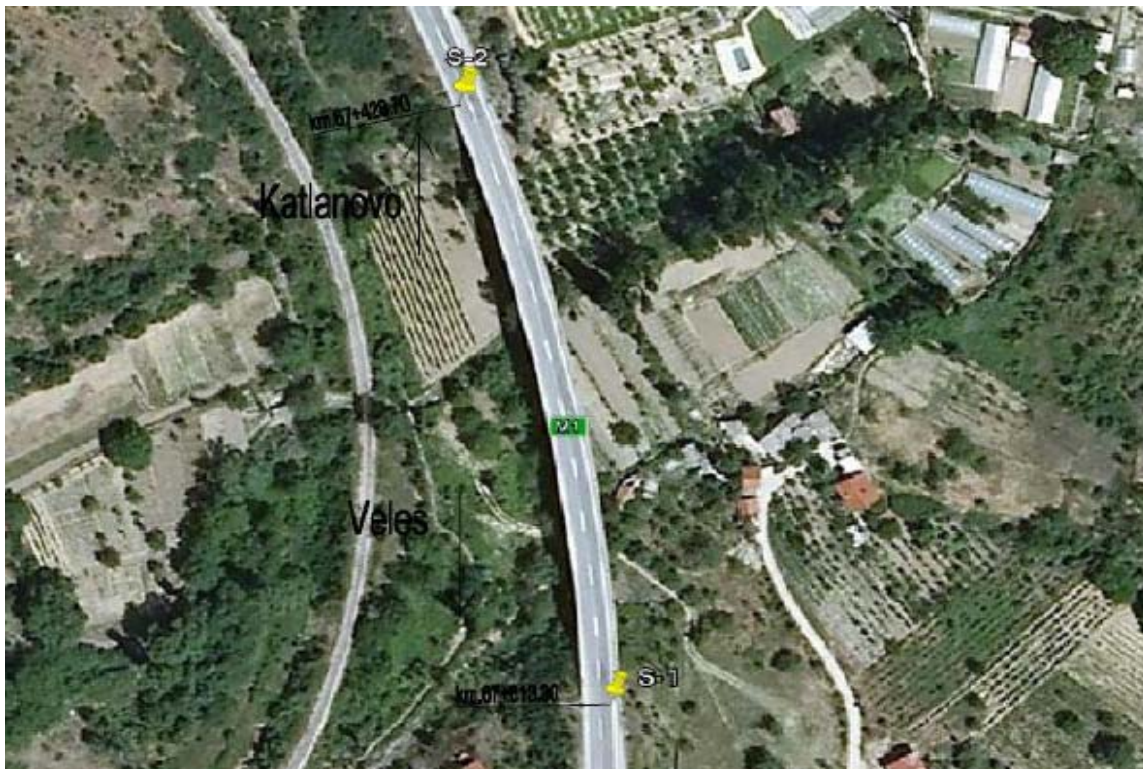
Figure 1. Position of bridge B65 with abutments S-1 and S-2

In both cases different dimensions on some of the elements e.g. pile or column diameter had been considered which did not improve the solution greatly. In the present paper for convenience reconstruction works on one of the bridges will be presented, namely the abutments on bridge B-65 (km. 67+521.00) Highway m1 (E-75) section: Veles-Katlanovo, see Figure 1.

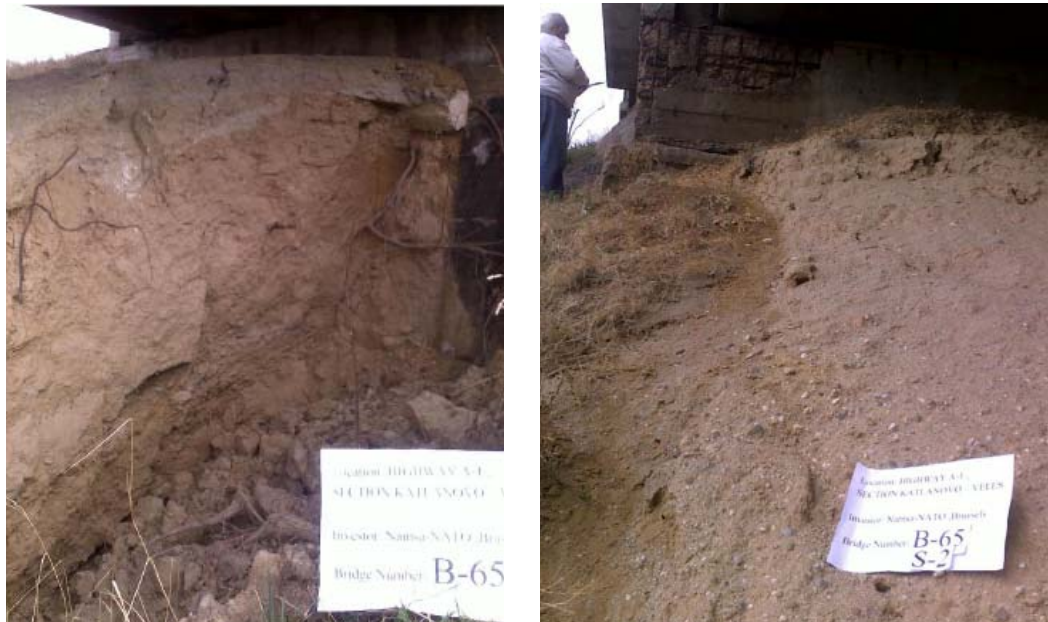
The slope erosion on the bridge B65 abutments has been evaluated as critical. On S-2 abutment there is evidence of a sliding mass just below the bridge, while on abutment S-1 there is significant surface erosion, see Figure 2.

Figure 2. View of eroded ravine in front of abutments S-1 (left) and S-2 (right) on bridge B65

The observed soil deformations are alarming putting the structural integrity at risk. This fact is supported by the registered large deformation and cracks on reinforced-concrete bridge sections. Therefore, it has been decided to take immediate measures for reconstruction, thus as soon as possible prepare a technical documentation. The first bridge to be reconstructed will be the presented bridge B65.

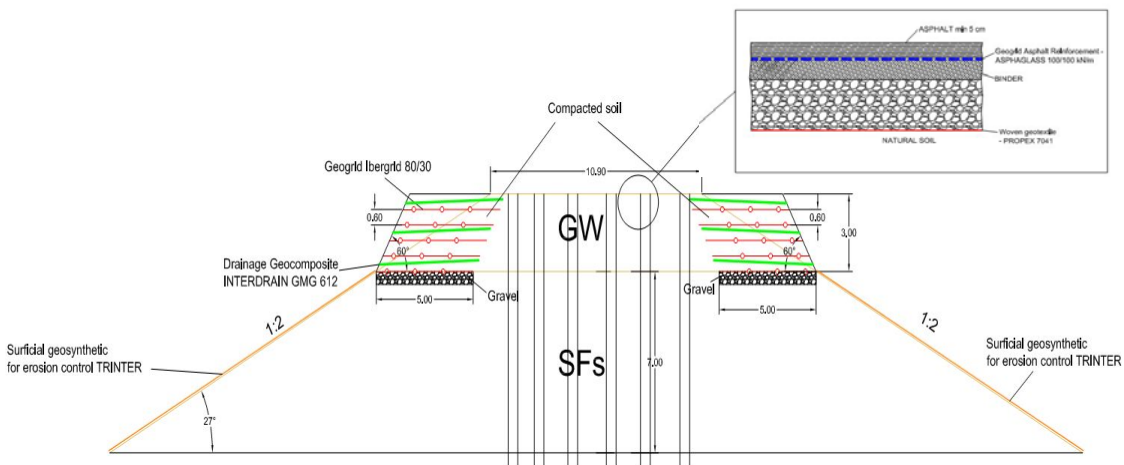
For evacuation of water a drainage geocomposite strips are placed into the abutment with width 0.5m, vertically spaced on 1.2m and horizontally spaced on 4m. The height of the drainage system is 5m with slope of 3%. On the top surface over the columns a woven geotextile (Porpex 7041) is placed after which a compacted fill material is placed above which binder is connected through geogrid asphalt reinforcement (Asphaglass) to the finishing asphalt layer (5cm), see Figure 6.

Figure 6. Cross section of abutment S-1 with geogrids and jet grouting columns (RS2)
