Crack propagation of the FRP strengthened masonry walls

Arash Sayari

Islamic Azad University, Sanandaj Branch, Kurdistan, Iran, E-mail: sayari_51@yahoo.com

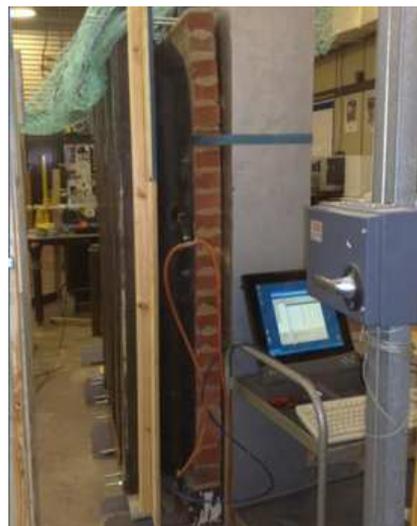
Photo 1. General view of 1/2 brick thickness walls and airbag

Five specimen walls were constructed with clay bricks and mortar. Samples were constructed as a single layer brick masonry walls (1/2 brick thickness equal to 102mm thickness, Photo1).

An airbag (photo 1) covering the whole surface of the wall was placed between the wall and the reaction support and strapped to the strong reaction frame (Photo 1). In each test, the airbag was filled with air using a foot pump to apply uniform out-of-plane pressure to the wall. During the whole process of loading, the pressure was recorded using a digital pressure gauge. The pressure was applied in increments of 0.5 kN/m². Two readings of pressure were recorded for each increment, one at the beginning and the other after 5 minutes.

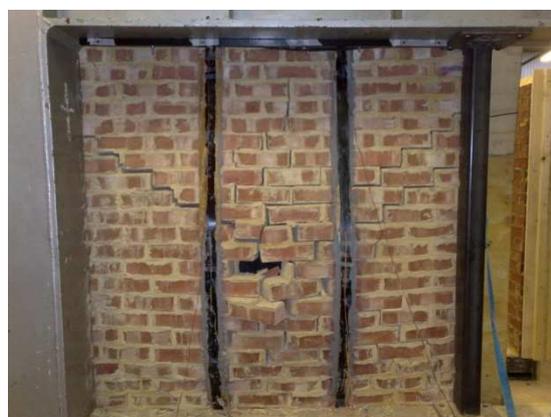
Photo 4. Damage of the Wall 3

At a pressure of 23.5 kN/m^2 , a small vertical crack appeared in the middle of the wall and it developed toward the corners of the wall with increase in the load (Figure 1). When the pressure was about 25.5 kN/m^2 , cracks were visible easily. Finally, at a pressure of 32.5 kN/m^2 , the wall suddenly failed (Photo 4).

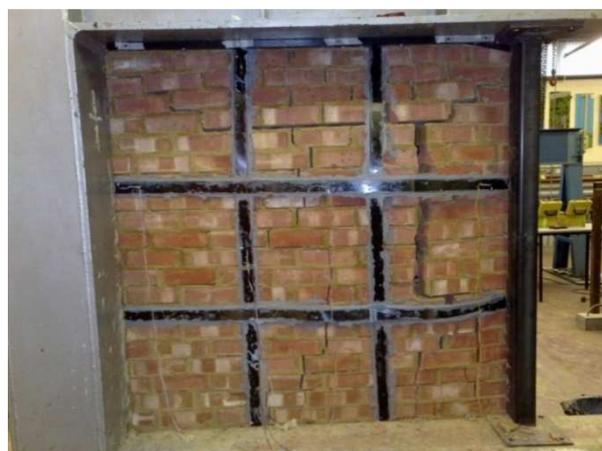
Photo 5. Damage of the wall 4

At a pressure equal to 39.5 kN/m^2 , the wall failed suddenly in a brittle mode. Photo 5 shows the cracks of the wall after destruction.

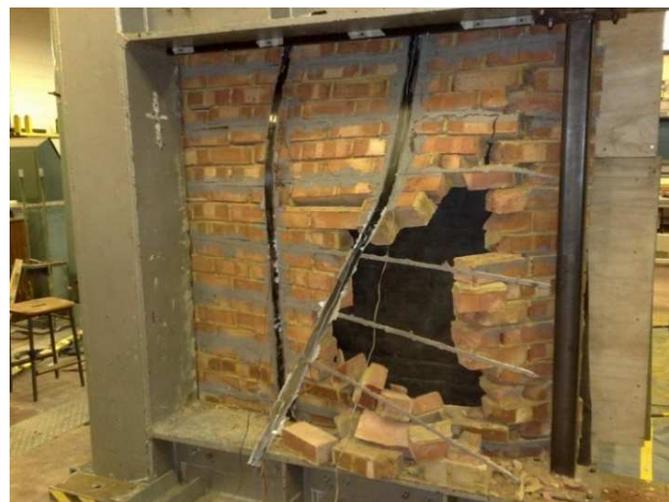
Photo 6. Damage of the wall 5

The cracks observed before the collapse of the wall are presented in Figure 3. First crack appeared in the middle of the wall when the pressure was about 36kN/m^2 . At a pressure of 38kN/m^2 , some small and diagonal cracks appeared in the middle of area 2 and between BFRP bars 2-3 and 4-5 from top edge of the wall. At a pressure of 42kN/m^2 diagonal cracks developed from the middle of the wall toward the corners and finally when the pressure increased to 45.5kN/m^2 , the wall failed in a brittle mode of destruction (Photo 6).
