Seismic retrofitting of 15th century mosques using CFRP composites

Veronika Shendova¹, Predrag Gavrilovic², and Goran Jekic³

^{1, 2, 3} Institute of Earthquake Engineering and Engineering Seismology, IZIIS, Skopje, Republic of Macedonia

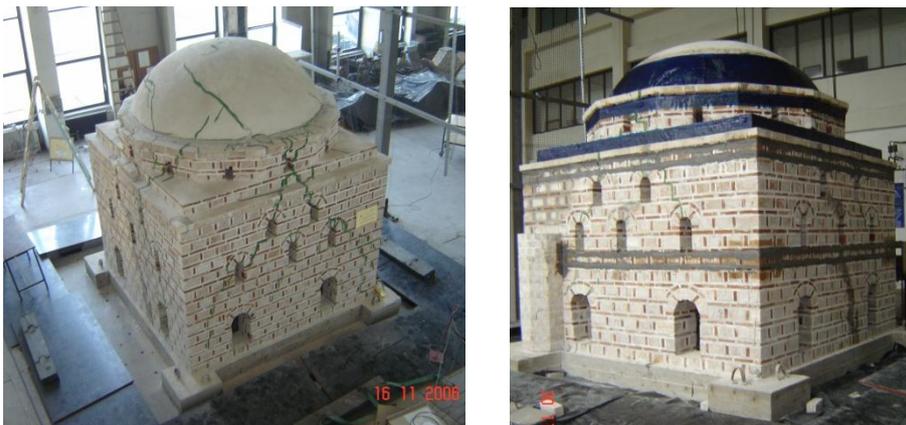
Figure 1. The 1:6 scaled model of Mustafa Pasha Mosque.

a) Damage to the model

b) Retrofitting of the model

Shaking table tests on a model of the Mustafa Pasha Mosque in Skopje were carried out in IZIIS Laboratory within the frames of EU FP6 project “Earthquake Protection of Historical Buildings by Reversible Mixed Technologies”- PROHITECH, (Mazzolani et al, 2007). The 1:6 scaled model has been subjected to the effect of a series of earthquakes that caused damage (Fig. 1a). Then the model was strengthened by application of CFRP elements and subjected to iterative tests, (Fig. 1b). The strengthening solution consisted of formation of a horizontal belt course around the bearing walls by CFRP rods as well as around the tambour and at the base of the dome by CFRP wrap.

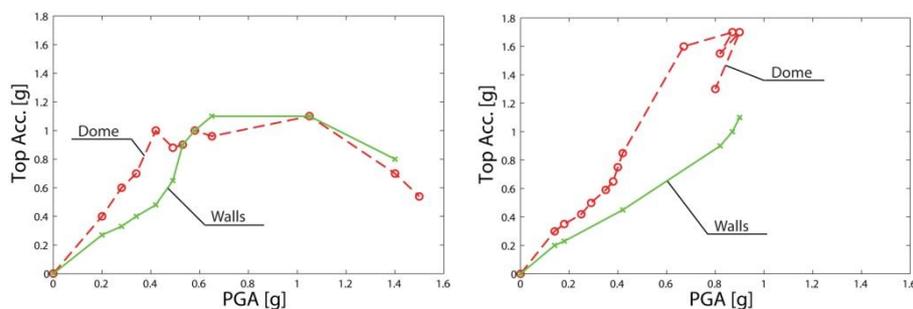
Figure 2. Response of the model: acceleration measured at the top of the shear walls and of the dome as a function of input acceleration, original and retrofitted model.

Shaking table testing showed that the strengthening of the minaret by application of a CFRP wrap enabled stiffening and increasing of its bending resistance. Push-over curves were constructed based on the different intensity level of the repeated seismic test, within an input acceleration of 0.05g - 1.50g, (Fig.2). Comparing the obtained results it can be concluded that the applied strengthening technique has significantly improved the seismic resistance of the monument. The results from the investigation, although obtained for small geometrical scale, have shown that the system is efficient, which was the starting point in making the decision about the concept of seismic retrofitting of the prototype.

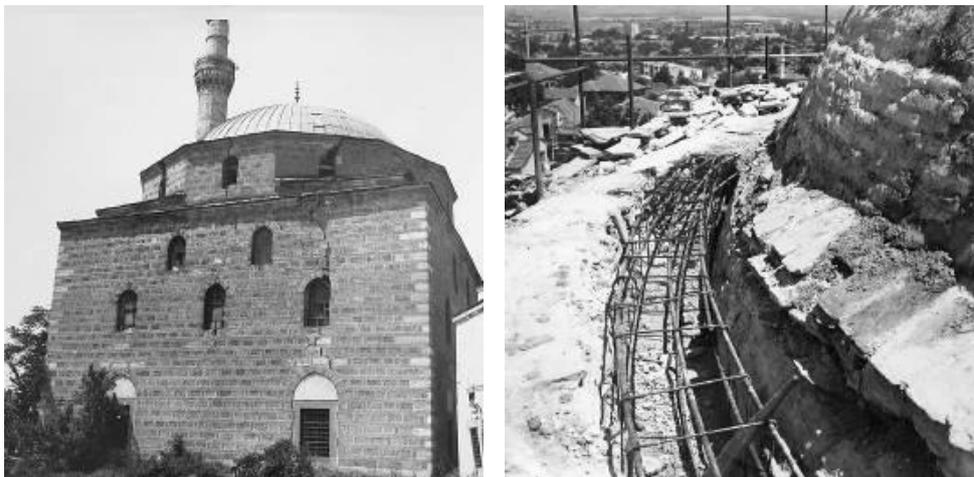
Figure 3. Mosque after Skopje earthquake: east facade damage (1963) and strengthening of dome (1965)

The structural system of the mosque consists of massive peripheral walls in both orthogonal directions with a thickness of about 170 cm constructed partially of hewn stone and brick. The catastrophic Skopje earthquake of 1963 inflicted damage to the mosque structure that dominantly affected the central dome and the domes of the porch, the east facade and the minaret. In 1968, these damages were repaired by injection of cement mortar based mixtures as well as incorporation of RC belt courses, (Fig 3).

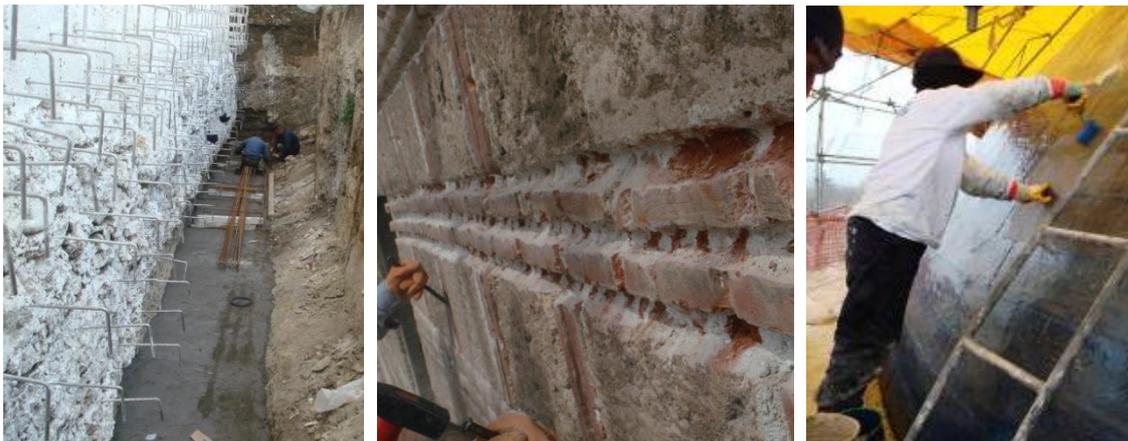
Figure 4. Strengthening of Mustafa Pasha Mosque: foundation strengthening; preparation for incorporation of CFRP rods into bearing walls; CFRP wrap in a layer of epoxy glue over the dome

Strengthening of the mosque structure in accordance with the designed system started in the fall of 2007 with strengthening of the foundation structure, (Fig.4). After removal of the cement mortar layer over the dome placed in 1968, the following was carried out on the dome structure: (1) coating of the formerly constructed reinforced concrete ring in the base of the main dome with an injection mixture based on lime mortar and (2) placement of a CFRP strip in a layer of epoxy glue along the perimeter of the dome base within a width of 2.9 m. Then the entire dome was externally coated with a protective layer of lime mortar and covered in accordance with the project on the conservation of the architecture, (Fig. 4).

The realization of the project continued on the bearing walls. After cleaning of all the joints on the outside with a depth of ~8 cm, it is anticipated to place CFRP bars of defined mechanical characteristics (tensile strength $f_t=1800-2000$ MPa) in an epoxy mortar layer and connect them in the vertical joints. Then, the joints were filled with pointing lime mortar in accordance with the project on conservation of the architecture. In the entire part of the structure extending above

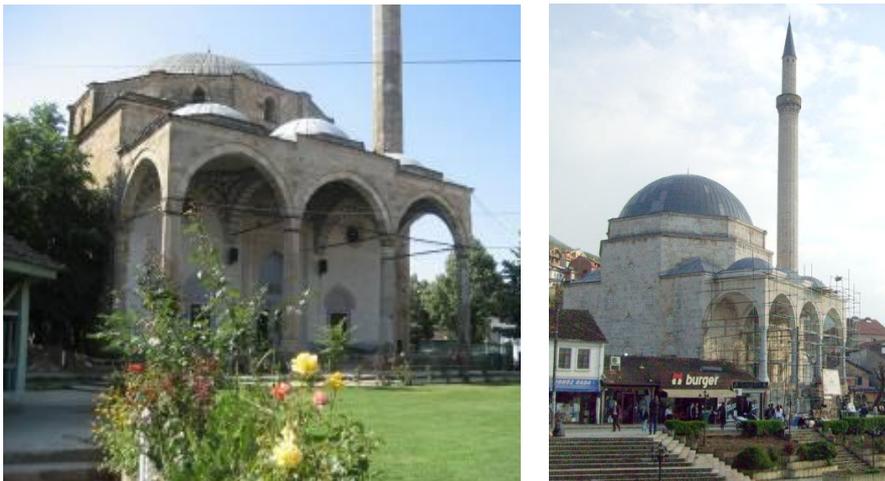
The monuments in Kosovo dating back to the Ottoman period are of a special interest having in mind their significance from historic and artistic point of view. The Kosovo authorities in cooperation with the Turkish foundation TIKa supported the conservation projects for two important mosques in Kosovo, i.e., the Fatih Mosque in Prishtina and the Sinan Pasha Mosque in Prizren, (Fig. 5).

Figure 5. 15th century mosques in Kosovo: Sultan Mehmet Fatih Mosque, Sinan Pasha

It was constructed upon the order of Sultan Mohammed II Fatih –the Conqueror. An inscription, written in the Arabic alphabet in six rows, located above the main portal gives the construction date as 1461, according to the Gregorian calendar. At the end of the 17th century, during the Austrian-Turkish wars, it was converted into a Catholic church. During the Second World War, the German Army refurbished the interior of the mosque, as it's highlighted by the swastikas painted above the main gate. For its monumentality, method of construction and decorative elements, this monument is listed among the most important buildings of the Islamic architecture in South-Eastern Europe. The wall thickness reaches 180cm. The cupola is one of the biggest cupolas of the XV century and is one of the best architectural examples in South-East Europe. The damage to the Sultan Mohammed Fatih's Mosque is caused by climatic changes, ravages of time and permanent vibrations caused by traffic. The damage is manifested by separation of sandstones, vertical cracks in the walls indicating separation of rigid blocks as the first mode of failure, cracks in the arcade columns, vertical cracks in the corners and the dome.

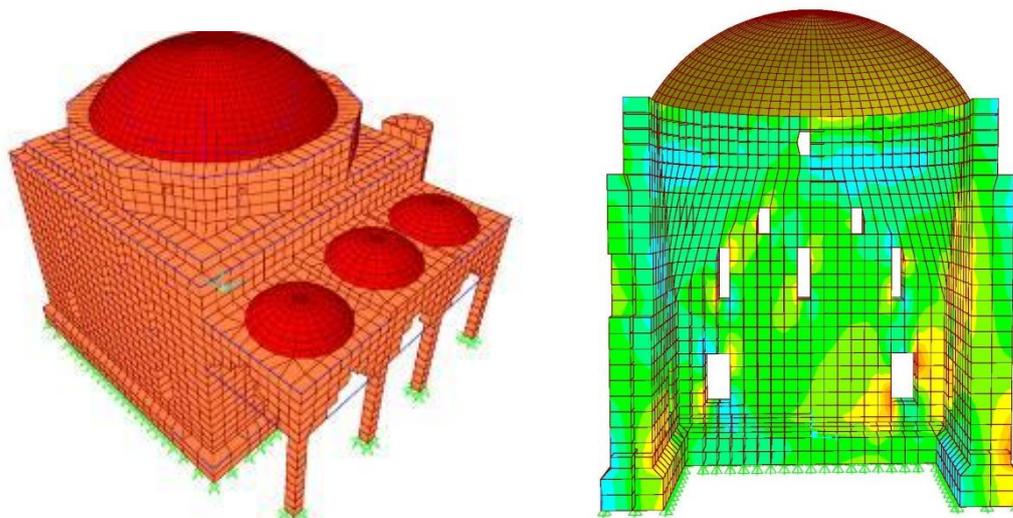
Figure 6. Sultan Mehmet Fatih Mosque: 3D analytical model and Stress distribution for dead load

For analysis of the existing structure under gravity and seismic load, the finite element method has been used, modeling the structure as 3D, the walls as solid elements and the domes as shell elements. In the case of the strengthened structures, the strengthening elements have been modeled as frame tied elements with own characteristics, (Fig. 6). The natural period of vibrations being $T_x=0.263$ sec, $T_y=0.249$ sec for the Fatih Mosque and $T_x=0.289$ sec, $T_y=0.253$ sec for the Sinan Pasha Mosque, with appropriate mode shape. The analysis of stresses due to gravity load for both mosques points to maximum vertical stress of 4.-4.5 kg/cm^2 in the upper part, with some areas under low tensile stresses of 0.1-0.2 kg/cm^2 . According to the observations and investigations of the structural conditions and stability, it is evident that the structure and the structural system is safe and satisfies the criteria for gravity and serviceability load. Having in mind that the monuments represent masonry not-ductile structures located in

zones of high seismicity, representing monuments of the first category of importance, their seismic stability should be increased. As to seismic conditions, there are evident tensile stresses at the end of the walls and on the domes in the range of 1.2-1.5 kg/cm², meaning overstress and potential damage. The analysis shows large tensile zones, below the domes and in the upper part of the structures. Consequently, the structures are not safe under seismic loads, meaning that, in the case of an earthquake; they will be damaged and will experience partial collapse. Strengthening of the structures is therefore a prerequisite.

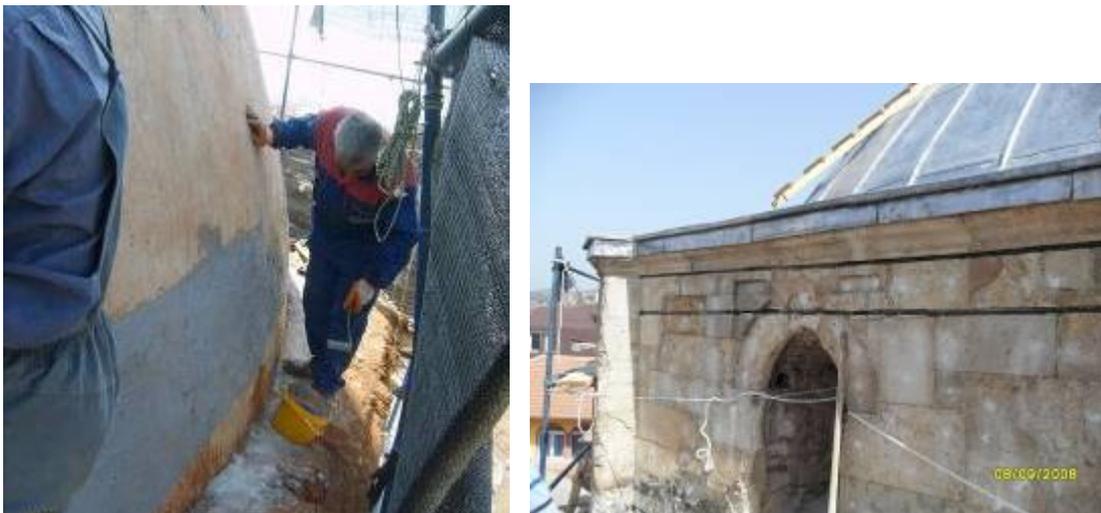
Figure 7. Seismic retrofitting of dome and walls, Sultan Mehmet Fatih Mosque

Structural consolidation and retrofitting works started as the first phase of the field works before the conservation activities by the Akcayalar Restorations Company from Afion, Turkey and continue. Consolidation and retrofitting of the dome started after removal of the roof cover and mortar and two operations have been carried out: (i) coating of the base of the main dome with injection mixture based on lime mortar and (ii) placement of CFRP wraps on a layer of epoxy glue along the perimeter of the dome base within 2.5m.

After these operations, the entire domes have externally been coated by lead according to the conservation requirements and design. Retrofitting of the walls started after cleaning all the joints on the outside surface of the walls, (Fig.7); CFRP bars of defined mechanical characteristics (tensile strength of $f_t = 1800 - 2000$ MPa) have been inserted in the horizontal joints and covered with an epoxy mortar layer, connecting them to the vertical joints. Then the joints have been filled with pointing lime mortar. In the entire part of the structure extending above the ground level, all the cracks together with the additional cracks detected after the opening of the external joints, have been injected with lime mortar of defined (increased) mechanical characteristics.
