Pre and Post Retrofit behaviour of an existing Railway Open web Steel Girder bridge

Sitesh Kumar Singh¹ and Nirjhar Dhang²

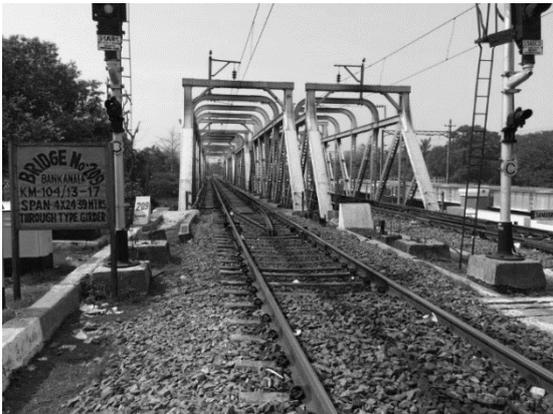
Figure 1(a). Front view of Bridge No. 209

Keeping the above objective in mind, an instrumentation study has been conducted on Banka Nallah Bridge (Bridge No. 209) situated between Gangpur & Barddhaman stations of Up Main & Chord lines of Howrah Barddhaman busy quadruple route at km 104/13-17 of Howrah Division (Eastern Railway) (Figure 1(a) and 1(b)). The span of this through steel truss bridge is 4x24.40 metres each simply supported on supports. From the records, it is found that this bridge was built in 1914 for the East Indian Railway (E.I.R.) by the Contractor, P. & W. Maclellan Limited, Clutha Works Glasgow (U.K.). The steel has been manufactured by ‘Skinningrove-England’.

This bridge has served for more than 100 years in one of the busiest & oldest routes of Indian Railways. So far it has carried about 1267 Gross Million Tonnes (GMT) of traffic. The load bearing members (Stringers) have been badly corroded and as such a speed restriction of 50 kmph has been imposed on this bridge for the safety of running traffic due to distress.

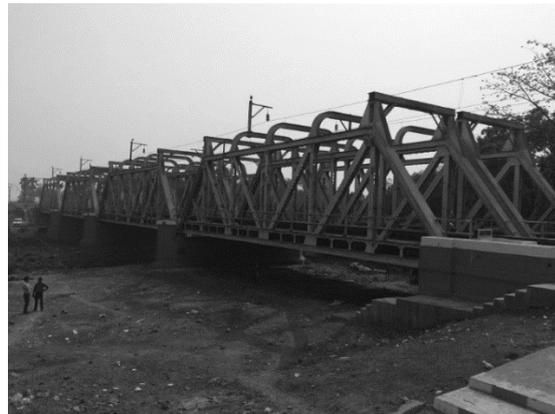
Figure 1(b). Side view of Bridge No. 209

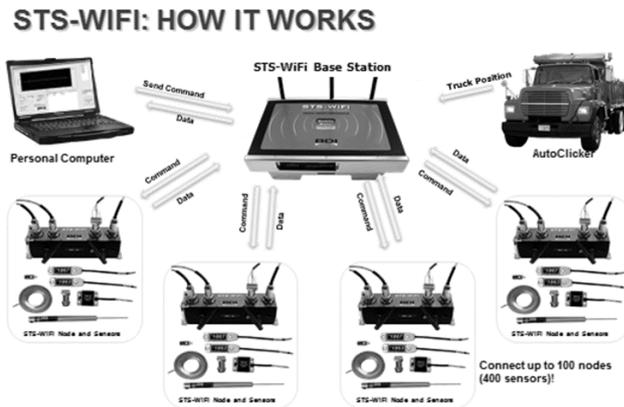
For field measurements of superstructure, the state of the art Structural Testing System (STS) manufactured by Bridge Diagnostics Inc. (BDI), USA, has been used. The sensors were fixed to the members with the help of quick hardening epoxy/adhesive e.g. Loctite etc. These sensors were connected to STS WiFi nodes through Ethernet cables. Each WiFi node accommodated four sensors. Through the antenna of WiFi Node, the signal was transmitted to the antenna of WiFi mobile base station. Then these signals were further transmitted through WiFi to the computer as shown below (Figure 2):

Figure 2. Working of Structural Testing System (BDI Inc., USA)

The range of Strain transducer was +/- 4000 micro-strain, sensitivity = 500 micro-strain/ V_{out}/V_{ext} with accuracy < +/- 1%.

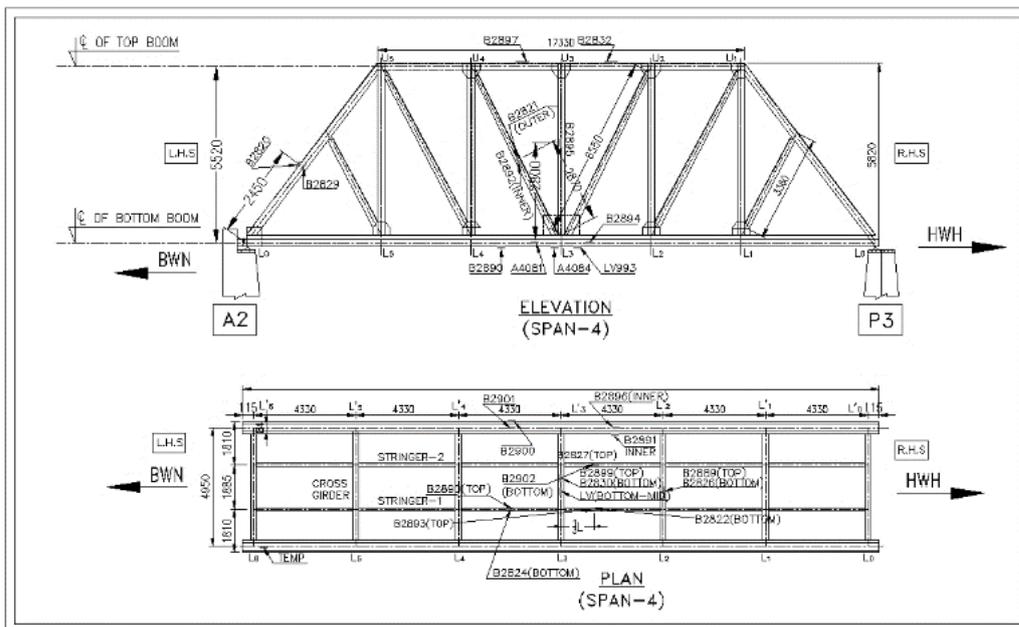
Based on theoretical analysis of the bridge using MATLAB, sensors such as strain gages, accelerometers, LVDTs, temperature gage etc. were placed at critical locations as shown in Figure 3 below:

Figure 3. Location of Sensors

Pre-retrofitting measurements were taken on 3rd March, 2016 under moving load of coupled two WAG9+WAG7 locomotives (6 axles each and weighing 123 metric tonnes per loco) with 3 coal loaded BOXN wagons (weighing 75 metric tonnes each) at different speeds of 5 kmph, 15 kmph, 38 kmph & 50 kmph.

After replacement of all corroded load bearing members (stringers), post-retrofitting measurements were taken on 19th June, 2016 under moving load of coupled two WDG4+WDG4 locomotives (6 axles each and weighing 126 metric tonnes per loco) at different speeds of 5 kmph, 15 kmph & 30 kmph.

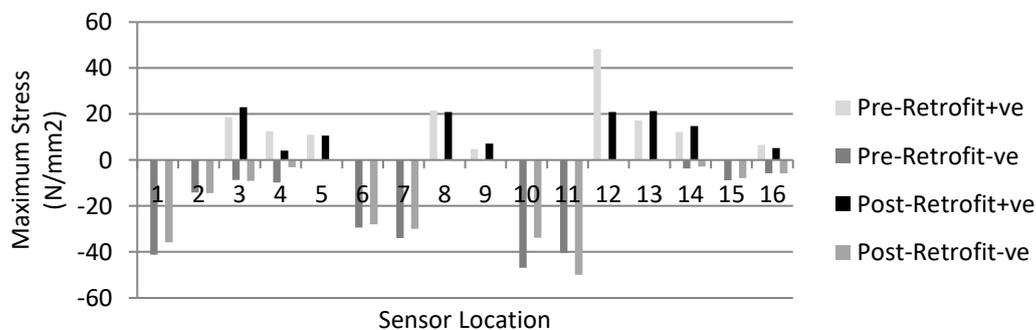
The above values have been compared graphically as shown in Figure 4.

Figure 4. Comparison of Pre and Post retrofit stresses at identical locations

1. It has been observed that compressive & tensile stresses in the diagonal member L3-L4 on outer side have reduced considerably by 68%. However, there has been 23% increase in compressive stress for this member on inner side.
2. It has been further observed that tensile stress in cross girder L2 bottom has reduced by 57% whereas there is 23% increase in compressive stress at top for this member. Tensile stress in cross girder L3 bottom has increased by 24% whereas there is 28% reduction in compressive stress at top for this member.
3. In the replaced stringer, there is 21% increase in tensile stress while 20% reduction in compressive stress.
4. In the end raker & top chord, there is 12% & 13% reduction in compressive stresses respectively.
5. In the bottom chord bottom flange, tensile stress has increased by 48%, though actual increase in the tensile stress is from 4.8 MPa to 7 MPa.

6. Inner side of the diagonal member carries substantially more compressive and tensile stresses than the outer side of the same member.
7. End raker web carries substantially more compressive stress than the flange at the same location.
8. Stringers experience reversal of stresses.
