## Retrofitting of Ayala Bridge, an Historic Steel bridge in Manilla (Philippines)

**ABSTRACT:** Ayala Bridge, in the center of Manilla, is a steel arch bridge built in the 1950s. It is comprised of 2 simply supported steel bridges constructed with 3 trusses connected together. The bridge has to be retrofitted for conformity to new codes (traffic and seismic). The retrofitting solution designed by Freyssinet was chosen because of its economy when considering both deck and foundations: it consists of minimizing the current seismic loads on piers and abutments, to get them lower than actual loads seen in the past under historic seismic and typhoon. Longitudinally, the 2 decks are linked together and extended with beams and new piles: the overall structure is working as a frame. Transversally, some seismic devices are placed. The overall steel structure is then strengthened using additional steel profiling and prestressing. Major parts of the work has been done with no traffic interruption at all.

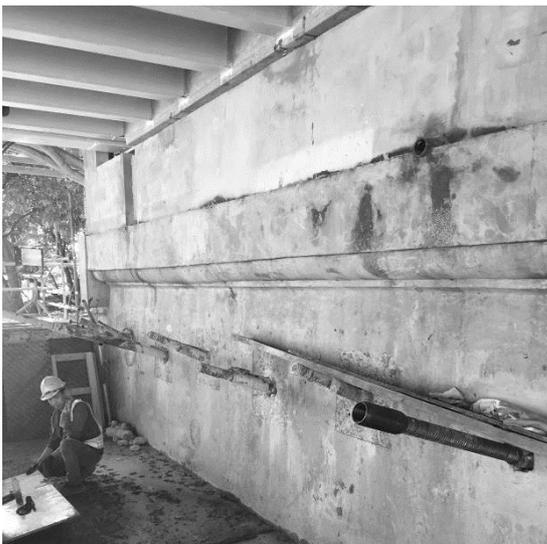
Figure 8. Soil nails dispatched along north abutment

This solution could not be applied to the south abutment, due to the depth of the river bed. Indeed, the stone embankment would have defined a slope that would have had an impact on the ship channel. To ensure stability of south abutment, 18 soil nails each of 25 meters long (capacity 800 kN) were required to be placed along the abutment [figure 8].

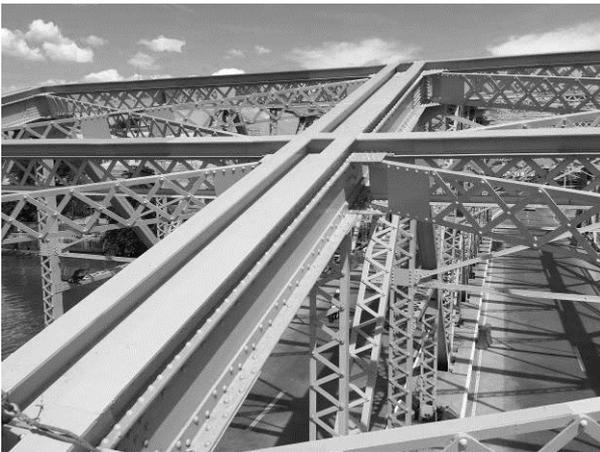
Figure 11. Example of node strengthening

Specific top nodes of the steel truss have been detailed to provide a proper connection between top chord and the top transverse strengthening members by taking into account the existing riveted gusset plates [figure 11].

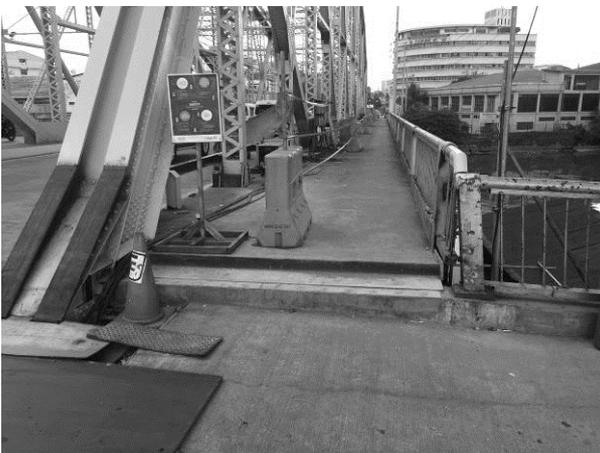
Figure 12. View of the top chord being protected

Finally, the full steel structure was sand-blasted, restored locally as required to protect using a long-term corrosion protection system [figure 12].
