Bridge pier and embankment foundation real time scour monitoring system development

Yung-Bin Lin¹, Kuo-Chun Chang¹, Meng-Huang Gu¹, Xiaoqin Liu¹, and Jih-Sung Lai²

¹ National Center for Research on Earthquake Engineering, 200, Sec. 3, Xinhai Rd., Taipei, Taiwan

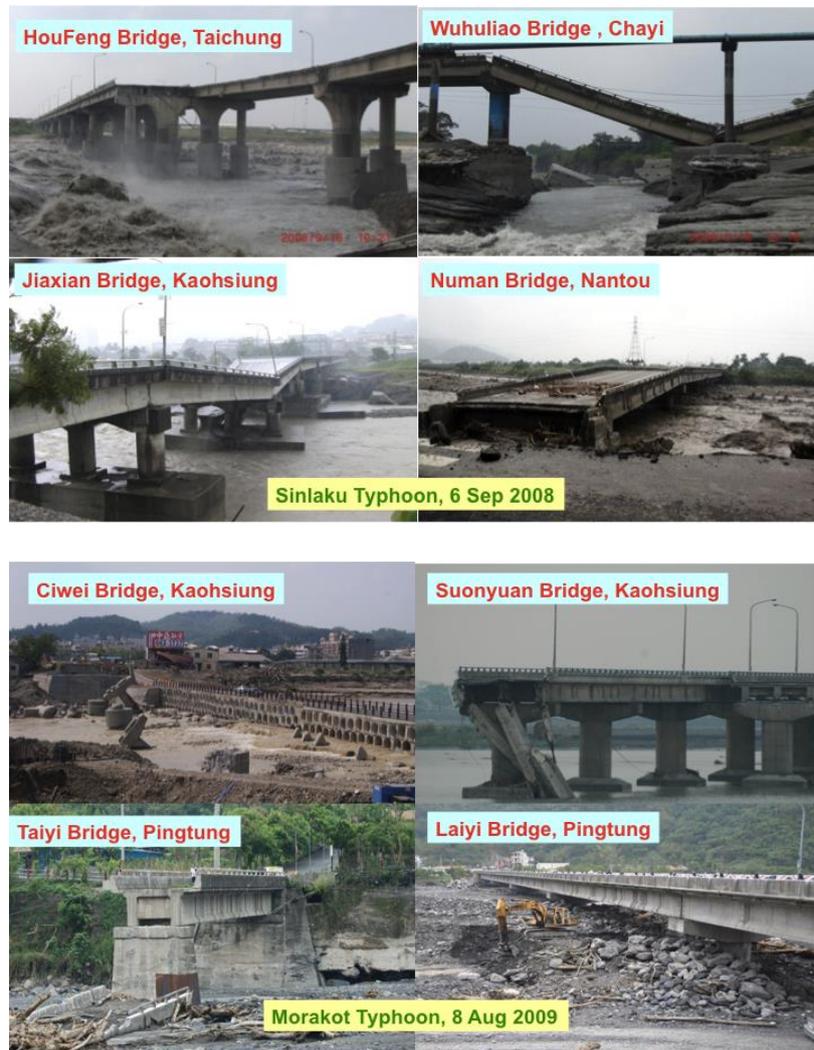
Figure 1. Bridge failure due to bridge scour

Taiwan resides on the Tropic of Cancer, and its general climate is marine tropical. In May and June, the rainy season is concurrent with the onset of summer convective thunderstorms, and typhoons are common from June through September. Therefore, Taiwan experiences large rainfall volume throughout the summer season, and its average annual rainfall reaches 2,500 millimeters. Due to the special geographical location and unique terranes, averagely 3.5 typhoon events and dozens of torrential rain events would occur each year on the Taiwan Island, which often trigger severe landslides and flooding. In particular, typhoon-induced flooding impose substantial threats to river-basin bridges by eroding the riverbed in the direct vicinity of bridge piers or abutments and thus causing scour-induced bridge failure. Scour at bridges is a problem of national scope, and scour-induced damages and destruction of highway bridges (Figure 1) can have dramatic impact on economics and on the safety of the traveling public.

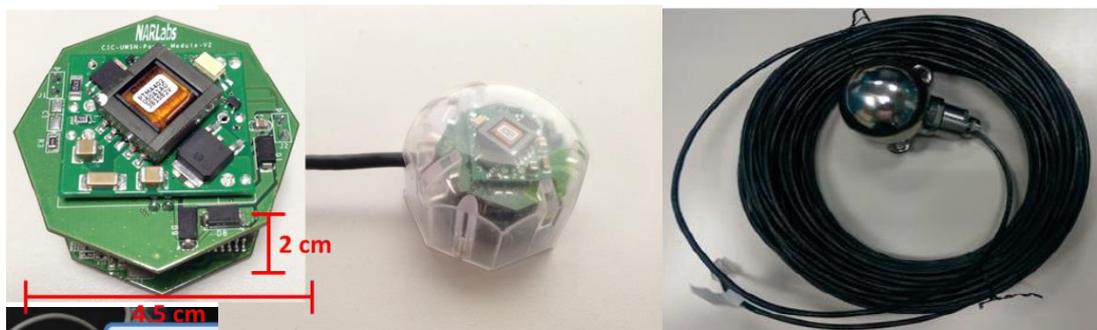
A sensor unit was formed by first fixing an accelerometer sensor (STM, LSM303DLHC) between two stacked octagonal printed circuit boards (PCBs), and then enclosing the structure with a plastic case. Subsequently, the sensor unit was sealed in a steel hollow ball for waterproof purpose (Figure 2). The power module mounted onto the top PCB generates 1.2–5 V outputs from the 48 V input to supply the power to the sensor unit. Each sensor unit was connected to a Power-over-Ethernet (PoE) switch (TI, TPS2376DDAH), through which the sensor signal is retrieved by a data logger.

Figure 2 Sensor Design

To monitor the scour process of a bridge pier or abutment in a timely manner, a sensor matrix consisting of the sensor units can be deployed onto bridge piers length wisely. The accelerometer enclosed in the sensor unit detects the steel ball's vibration triggered by water motion in the river, and then the accelerometer signal is received by the data logger through the PoE switch.

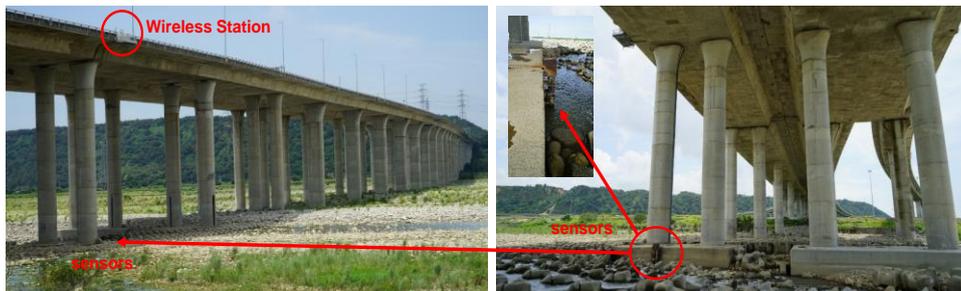
The scouring system was installed on the bridge pier P28L in the main channel of the Da-Chia River where the greatest scour depth had occurred during the flood (Figure 3). All the sensor systems including the wireless station were fabricated in the laboratory factory. The scouring system was subject to floating debris impact. The signal and performance of all the sensors corresponding packaged waterproof and long-term durability were tested and analyzed before being used in the field.

Figure 3 Sensor installation at the Da-Chia Bridge

The scour monitoring system consisting of five vibration-based sensors was installed on pier P28L of the National Highway No.3 in the Da-Chia River, Taiwan. The system was subject to harsh flooding environments. Packaged within a waterproof steel ball and protected in a steel reinforcement cage, each sensor was tested and analyzed before being used in the field for long-term durability.
