Strengthening, Restoration and Rehabilitation of the Greek Orthodox Church of Saint George - Old Cairo

Dr. Hanan H. Eltobgy¹

¹ Associate Professor, Faculty of Engineering, Benha University, Cairo, Egypt

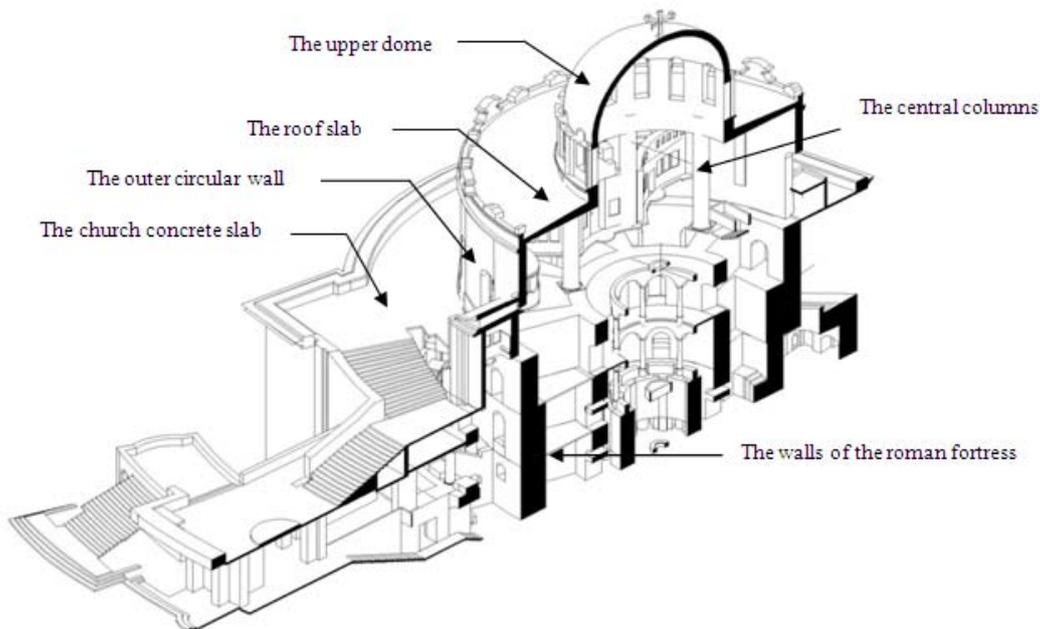
Figure 1. Half section in the building presenting the structural system.

The building is made of different structural systems and even with different construction materials. The upper church comprises a double shelled rotunda with a middle inner colonnade consists of eight columns that supports an elevated concrete dome. The outer roof slab (Gothic Vaults) is supported on these columns and on the outer circular stone wall. The outer roof slab consisted of a light weight bricks supported on radial steel beams (Figure 1). The middle circular columns and the outer stone wall are supported on a continuous concrete slab constructed on top of the remains of the old Northern Roman Babylon Fortress. The slab is reinforced with steel beams. The Old Fortress walls are made of limestone blocks with layers of red bricks.

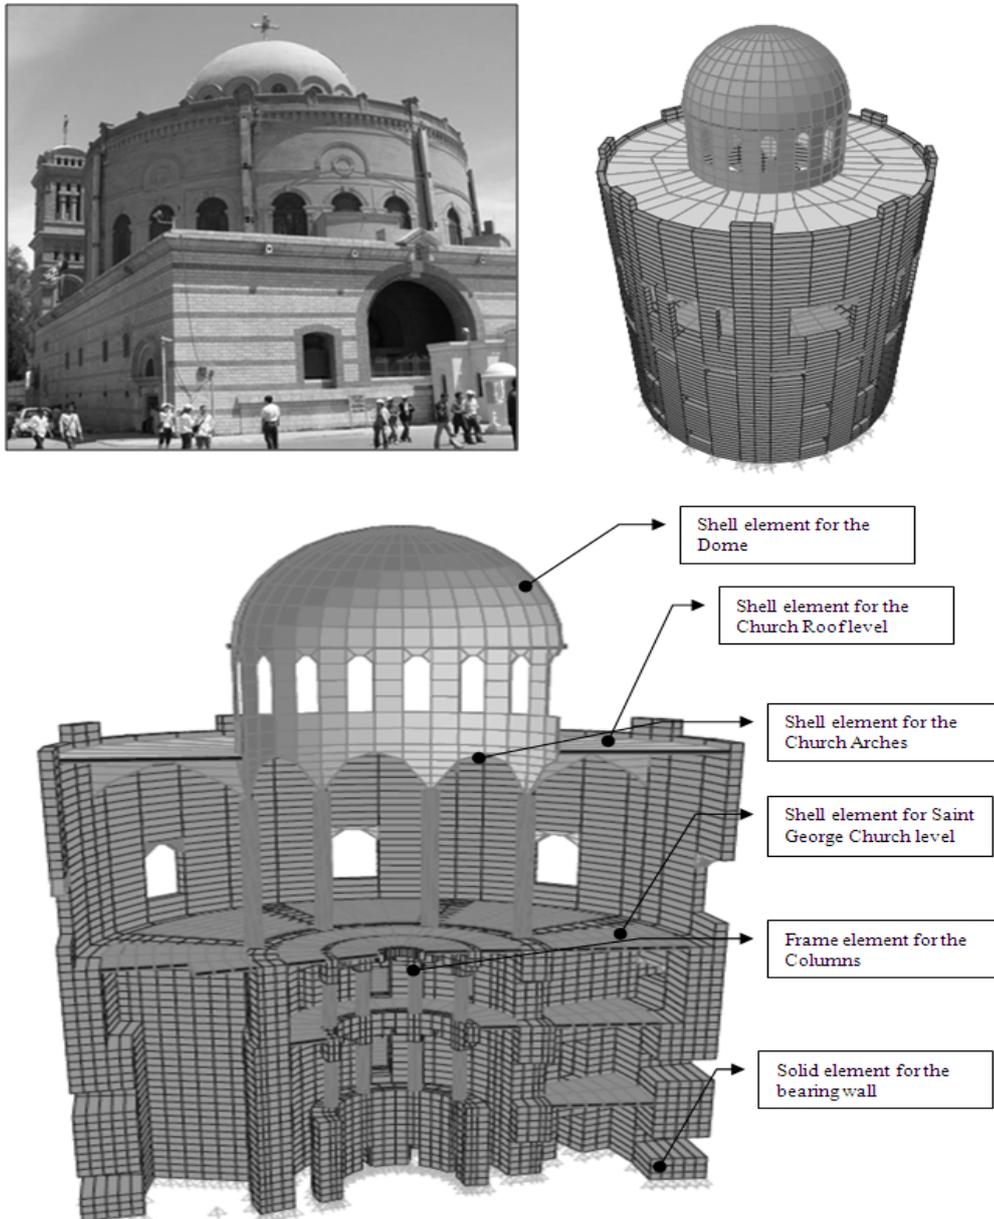
Figure 2. General Perspective of the Building and Representation of the structural elements.

A three dimensional finite element model is prepared with the aid of SAP2000 computing program. Figure 2, represents the geometry of the model. All the structural details were induced as they are shown in the structure photographs.
