Upgrade of seismic safety evaluation considering dispersion of R/C column's shear strength

Kenji Kabayama¹, Tetsuro Baba², and Atsushi Kobayashi¹

ABSTRACT: Two R/C school buildings in Ibaraki Prefecture, Japan were damaged by 2011 Tohoku Pacific Earthquake. Dynamic response analyses with the 3-D model of those buildings were carried out applying several input ground motions. Obtained analytical response showed consistency with inspected earthquake damage of buildings. The seismic index; I_S conducted from the current method for the Seismic Safety Evaluation had difference with the analytical response. The modified seismic index; I_{Sb} was proposed in order to consider dispersion of R/C column's shear strength for upgrading the Seismic Safety Evaluation. It was confirmed that I_{Sb} was more suitable than I_S for expressing the seismic performance of the objective buildings.

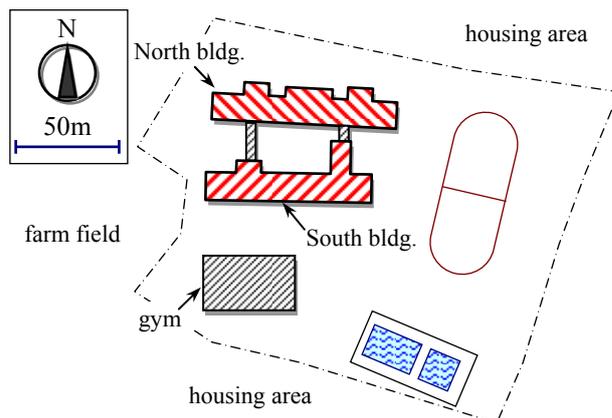
Figure 1. Site and layout of the elementary school

The elementary school was located in the plain of a valley, which were located in the mid west area of Ibaraki Prefecture. The site and circumstance environment were shown in Figure 1. The

Two R/C school buildings, The North bldg. and the South bldg. shown in the Figure 1 and Figure 2 were investigated by authors. Those buildings were connected by corridors installed expansion joints. Both buildings' data are summarized in Table 1.
