Crack monitoring in the Baptistery of the Euphrasian Basilica in Poreč

Davor GRANDIĆ¹, Paulo ŠĆULAC¹, Igor RUŽIĆ¹, Nino KRVAVICA¹

¹ University of Rijeka, Faculty of Civil Engineering, Rijeka, Croatia

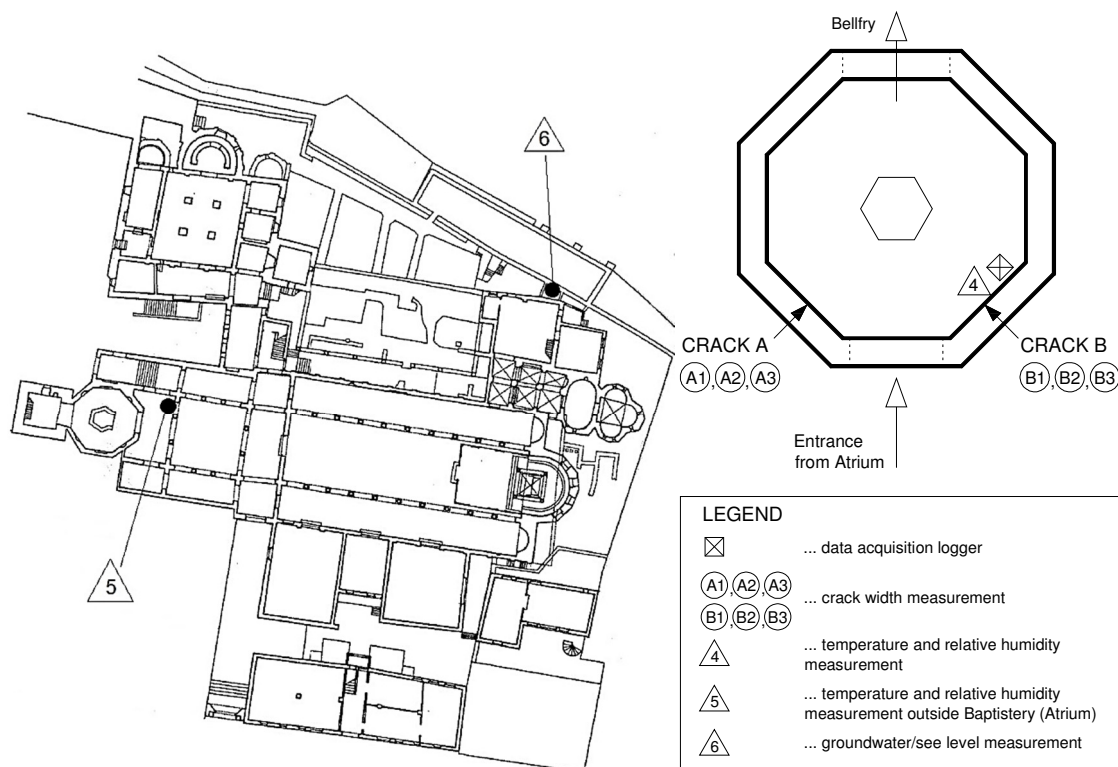
Figure 3. Ground plan of the Episcopal Complex (adopted from Terry and Gilmore Eaves, 2001) with enlarged plan of the baptistery showing the layout of the static monitoring system.

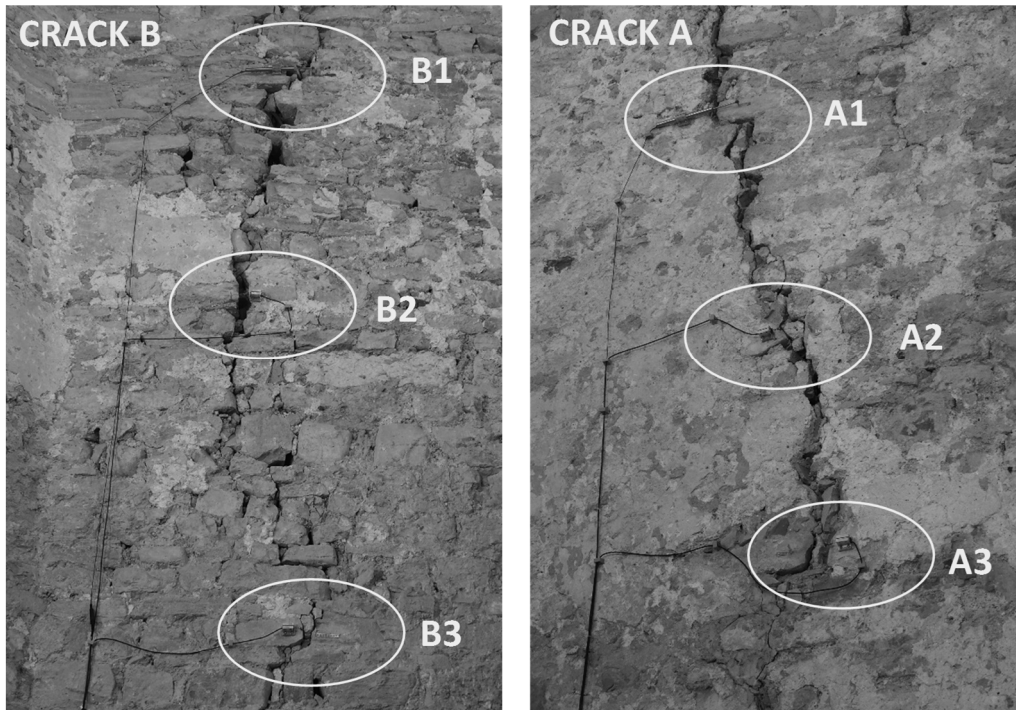
Two types of LVDT were installed (Figure 4 and 5): (i) LVDT with a measurement range of ± 25 mm (A1 and B1) and (ii) LVDT with a measurement range of ± 2.5 mm (A2, A3, B2 and B3). They both have high linearity ($<0.3\%$ FSO). They were connected to the masonry wall with the adhesive without damaging the wall, and secured from falling on the ground or on visitors of the Baptistery.

Figure 5. Crack width measurement points.

Figure 8 presents crack width changes (displacement) related to the outside temperature for the considered six-month period. Note that the measured crack width changes are extremely small in size: width of crack A is within 0.15 mm, while width of crack B is within 0.2 mm.

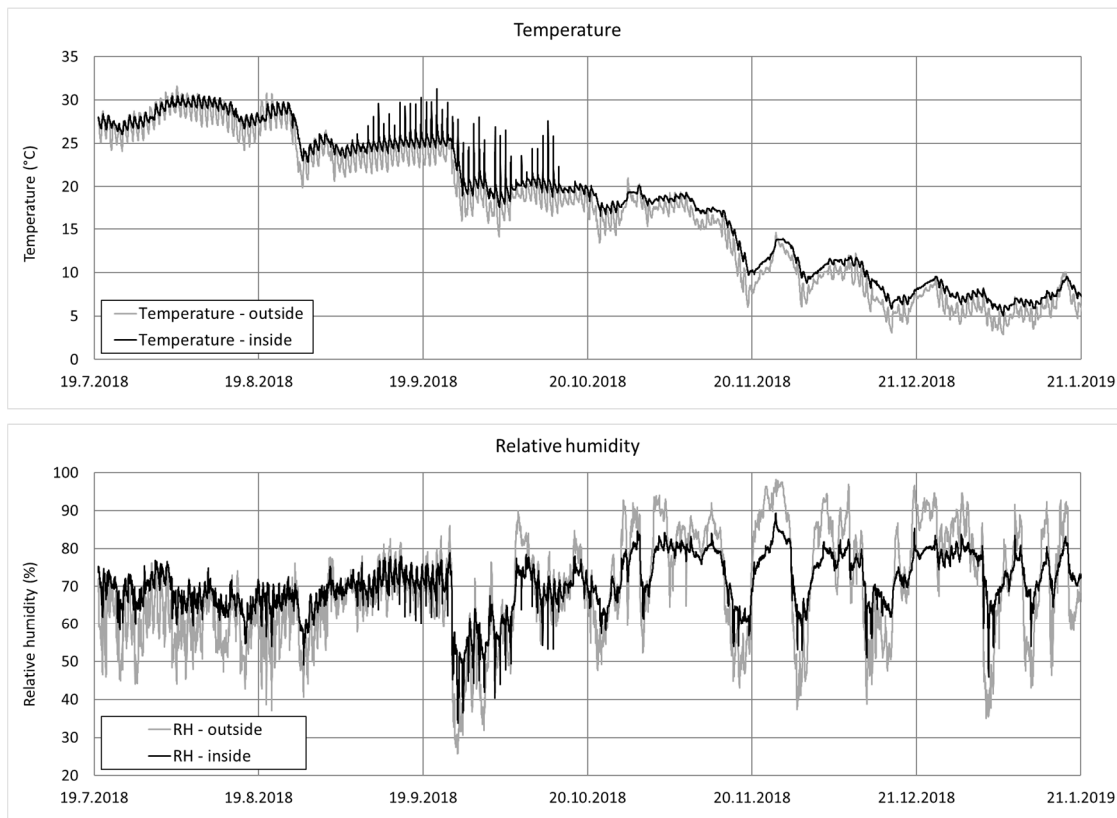
Very high values of relative humidity inside Baptistery have been recorded almost through the whole six-month measuring period. During the summer it was mainly above 70%, while during autumn and winter bigger fluctuations have been noticed with the values often above 80%.

Figure 7. Temperature and relative humidity measurements.
