Monitoring Damage of Rehabilitated Beam-Column Joints under Simulated Seismic Loading

ABSTRACT: Multi-storey RC frames built in the 1960's are generally considered deficient according to seismic requirements of current design codes and may behave in a non-ductile manner. The lateral load capacity of these structures is often insufficient due to non-ductile reinforcement detailing which includes either inadequate or no transverse reinforcement in the beam-column joint area. Several major earthquakes have demonstrated that the joint capacity is an important factor in maintaining the integrity of the entire structure. Due to the large extent of the problem, it is necessary to develop economic means to upgrade the joint's capacity to avoid brittle failures and instead shift the frame failure towards beam flexural hinging mechanism. The latter mechanism is a more ductile type of failure and is associated with significant energy dissipation. A simple and effective rehabilitation technique will provide safety to the occupants of the structure. In this study, the behavior of a beam-column joint representative of old constructions is investigated before and after the application of a rehab

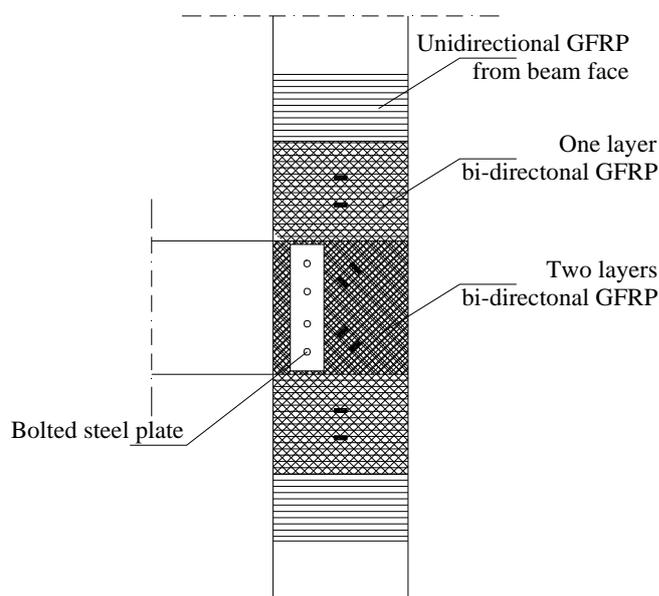
Figure 2. Layout of the rehabilitation scheme.

The rehabilitation scheme applied to the specimen (shown in Figure 2) consists of wrapping the reinforced concrete joint area with two U-shaped layers of bi-directional FRP laminates. One layer covered the joint area, and the second layer extended 30 cm above and below the joint area. The fiber directions were placed to correspond with the direction of diagonal tension forces in the joint at 45° with the vertical. A final layer of unidirectional FRP covered an L/6 distance of the column. This configuration provided adequate confinement to the joint and prevented its shear strength deterioration. Subsequently, a steel plate was added using threaded steel bolts to allow the laminate to develop its full capacity through the tying of the free ends of the U-shaped laminates.

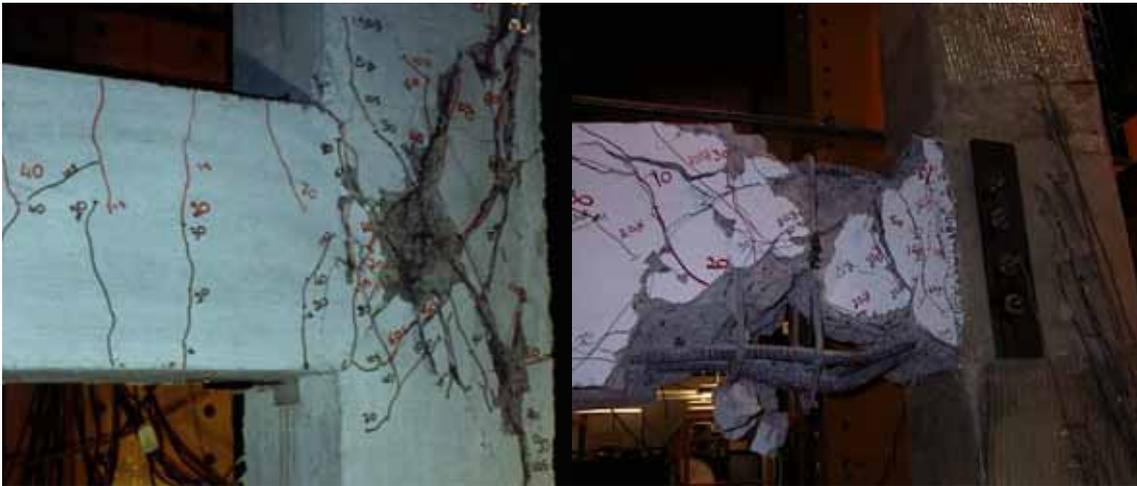
Figure 3. Final crack pattern for the control (left) and rehabilitated (right) specimens.

For the control specimen, the first crack was recorded at the column face at a tip load of 15 kN in both directions. Cracking in the beam increased gradually in the pre-yield cycles. Before first yield of longitudinal steel in the beam, a diagonal shear crack was noted in joint area in each loading direction forming an X-shaped pattern. The specimen was then loaded to yield. The joint shear capacity deteriorated as the specimen underwent deformation equivalent to $1\delta_y$ to $1.5\delta_y$ to $2\delta_y$. At failure, these cracks extended to the back of the column. A considerable degradation in strength occurred at $2\delta_y$, which caused the termination of the test as major chunks of rubble fell from the joint and back of the column area. The specimen failed in classical joint shear failure pattern. The final crack pattern for the control specimen is shown in Figure 3 while the load-displacement relationship is shown in Figure 4.

For the rehabilitated specimen, the first crack was observed at the interface between old concrete and grout. The beam was already cracked from to first test. These cracks widened progressively during the test. At a displacement of $2\delta_y$, the beam became extensively cracked for a distance equal to its depth from the face of the column. Cracking sounds of the jacket were heard but noting detected visually. At a displacement of $2.5\delta_y$, limited delamination was detected mainly on one face of the joint and the top part of the back of the column. In the following cycles, very wide cracks developed in the beam hinge area and rubble started falling. At a displacement of $4\delta_y$, the flexural hinge area lost most of it's concrete and the beam longitudinal reinforcement buckled. The test was stopped as the beam capacity dropped but the axial load and the joint areas were intact. The final crack pattern for the rehabilitated specimen is shown in Figure 3 while the load-displacement relationship is shown in Figure 5.

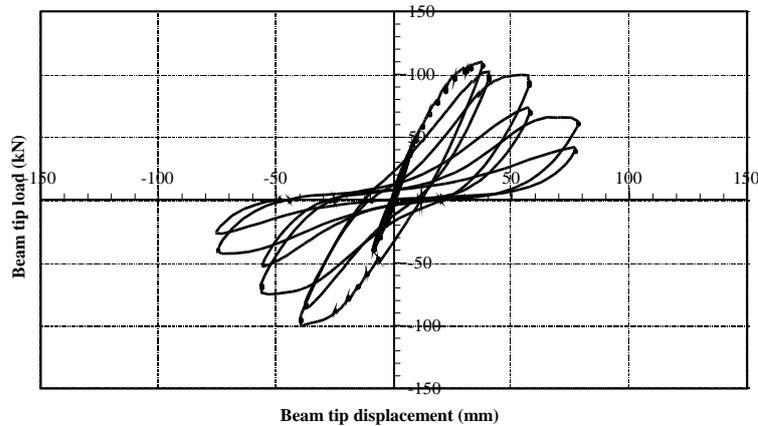
Figure 4. Beam tip load-displacement of the control specimen.

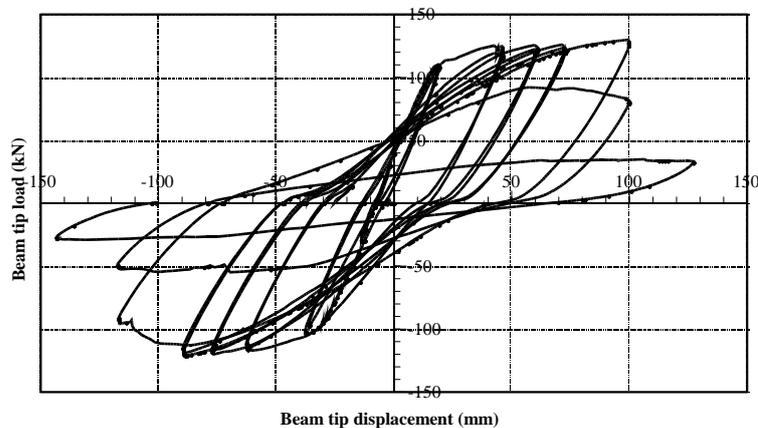
Figure 5. Beam tip load-displacement of the rehabilitated specimen.

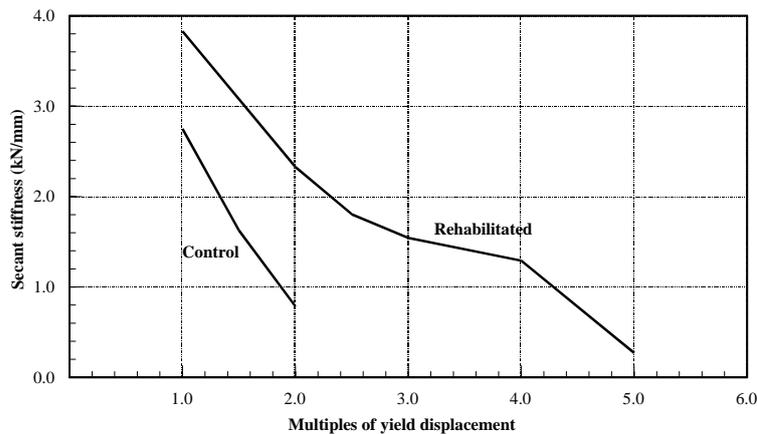
Figure 6. Secant stiffness-multiples of yield displacement plot for the control and rehabilitated specimens.

Secant stiffness is calculated as the peak-to-peak stiffness of the beam tip load-displacement relationship. Its magnitude represents the specimens' damage through stiffness degradation from one cycle to the subsequent cycle. Loss of stiffness of RC elements during cyclic loading is due several internal damage mechanisms (Priestly et al., 1996). An examination of the secant stiffness plots for the tested beam-column joint specimens, shown in Figure 6, indicates that the rehabilitated specimen had higher initial stiffness. Furthermore, the specimens had initially similar rates of stiffness deterioration. However, as the rehabilitated specimen's performance surpassed the control specimen, the rate of degradation decreased as the joint was able to maintain its integrity. However, the rehabilitated specimen degraded as the beam underwent plastic hinging.

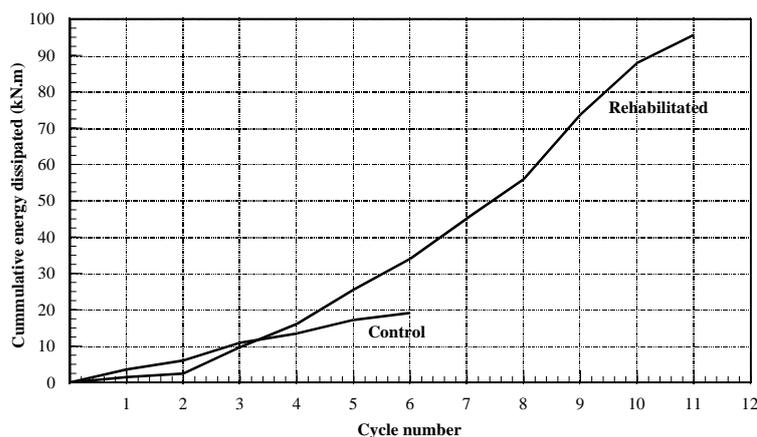
Figure 7. Energy dissipation at different cycles for the control and rehabilitated specimens.

The ability of a structure to survive an earthquake depends on its ability to dissipate the energy input from the ground motion. Despite the difficulty in estimating such energy input during a ground movement event, a satisfactory design should have a larger energy dissipation capability of the structure than the demand. The cumulative energy dissipated by the beam-column joint specimens during the reversed cyclic load test was calculated by summing up the energy dissipated in consecutive load-displacement loops throughout the test. The energy dissipated in a cycle is calculated as the area that the hysteretic loop encloses in the corresponding beam tip load-displacement plot. Figure 7 shows plots of the cumulative energy dissipation versus storey drift for the tested specimens. Results show that the investigated joint repair technique enhanced the energy dissipation by about 5 times compared to that of the control specimen, which is a substantial increase.
