## Behavior of mullions formed in non-structural RC partition walls with openings

**ABSTRACT:** Mullions formed in-plane with non-structural reinforced concrete (RC) partition walls with openings, found in residential buildings, were severely damaged in 1995 Kobe and 2011 Tohoku earthquakes without any noticeable damage on their boundary beams and columns. Damage of such non-structural elements does not affect design strength of buildings but leads to damage of surroundings fittings. Hence, investigation of behavior of the non-structural RC partition walls is necessary for damage mitigation. In this study, experimental tests with a series of specimens simulates mullions formed in non-structural RC partition walls with openings in one-bay frame designed on the basis of weak beam and strong column concept were conducted. From the experimental result, deformation behavior of mullions formed in non-structural RC partition walls involved with deformation of boundaries was evaluated and their failure mechanisms were investigated.

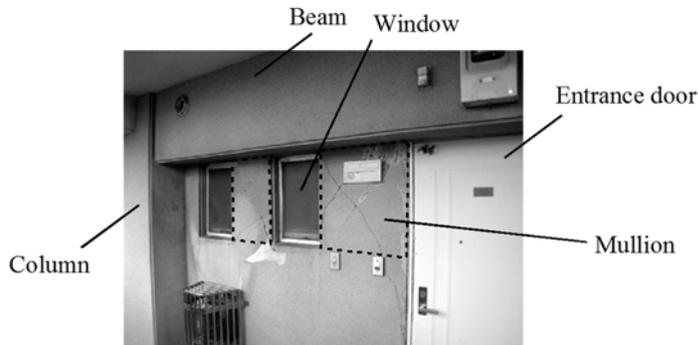
Figure 1. Damage of mullions formed in non-structural RC partition walls in 2011 Tohoku earthquakes.

Mullions formed in-plane with non-structural reinforced concrete (RC) partition walls with openings are found in residential buildings, which were severely damaged in 1995 Kobe and 2011 Tohoku earthquakes without any noticeable damage on their boundary beams and columns as shown in Figure 1. Damage of non-structural member is accepted in structural design in Japan not to bring damage of structural members; however, the damage leads to damage of surrounding fittings which disturb daily business. Recently, although non-structural reinforced concrete walls are fabricated with slit (Okubo, 2009) to avoid damage, it is preferable to construct non-structural walls without slit in consideration of cost of construction and strength. Especially, mullions is susceptible to be damaged due to their low bearing capacity, hence, to evaluate behavior of mullions is necessary to preserve function of buildings and to prevent damage of non-structural walls. Additionally, in recent buildings flexural deformation of boundary beams is predominant without shear failure of columns because beams are designed to yield prior to columns to establish a design concept of weak beam and strong columns, which may enhance damage of non-structural walls joined with beams. Therefore, in this study experimental test of a series of specimen simulates one-bay frame with mullions formed in non-structural wall were conducted, and investigated behavior of mullions and failure mechanism considering axial force on mullion involved with beam deformation.

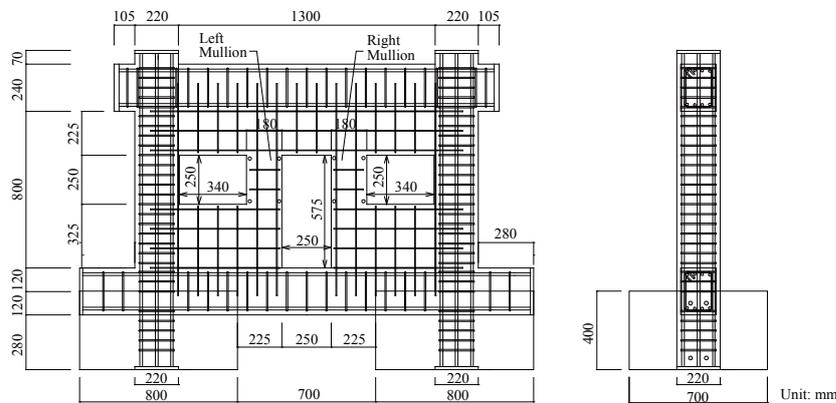
Figure 2. Configuration of test specimen (B-WOA)

There are three specimens assuming one-bay frame with non-structural RC partition walls with openings which properties are shown in Table 1. They were fabricated as 1/4 scale frames assuming in mid-story RC condominium buildings in Japan and the geometric properties are shown in Figure 2. Two mullions are formed next to openings represent windows and entrance of residence. The geometry and reinforcement of mullions are different between specimens: vertical and horizontal reinforcement of 0.35% used for the specimen B-WOA; horizontal reinforcement of 0.35% and vertical reinforcement of 0.7% used for the specimen BH-WOA-V; and vertical and horizontal reinforcement of 1.6% used for the specimen BH-WOA-VH. The longitudinal reinforcement in beams and columns are arranged to control order of their yielding. Normal strength of deformed steel bars are used in beams for all the specimens whereas above 390 MPa and 785 MPa strength deformed steel bars are used in columns in order that column reinforcements yield prior to beam reinforcements. The compressive strengths of concrete were targeted as 21 MPa for all specimens. The material properties of concrete and steel are shown in Table 2 and Table 3, respectively.

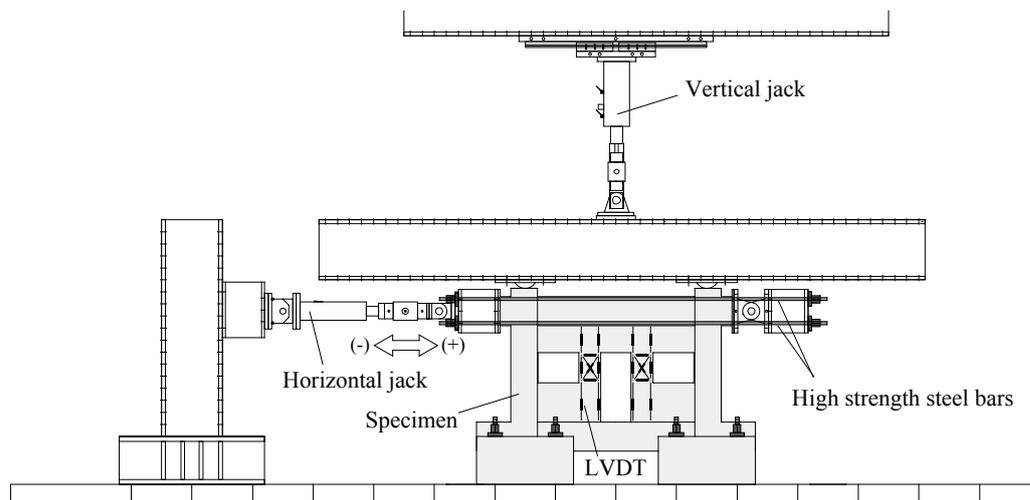
Figure 3. Test setup

Bi-directional single-curvature lateral cyclic loading tests were conducted using the test rig shown in Figure 3. Axial loads assigned by vertical jack through a rigid girder installed above specimen are applied to each column with pin and roller supports. A constant axial load, simulating gravity load which magnitude was equal to 20% of the gross area of column section times concrete compressive strength, was applied during testing. The cyclic lateral load was applied by horizontal jack installed on upper beam at only odd side. The plus and minus beside arrow symbol shown in Figure 3 represent loading direction of loadings. A pin support with reaction block at the end of opposite to horizontal jack is connected with four high tension steel bars in order to transmit

compression force to the specimen from the end of opposite to horizontal jack on loadings in negative direction. The lateral cyclic loading was applied to each specimen to drift levels of  $\pm 0.125\% \times 1$ ,  $\pm 0.25\% \times 2$ ,  $\pm 0.5\% \times 2$ ,  $\pm 1\% \times 2$ ,  $\pm 1.5\% \times 2$ , and  $\pm 2\% \times 1$ . The drift level is the relative displacement between the center of a beam height and base of a column divided by its height (1040 mm).

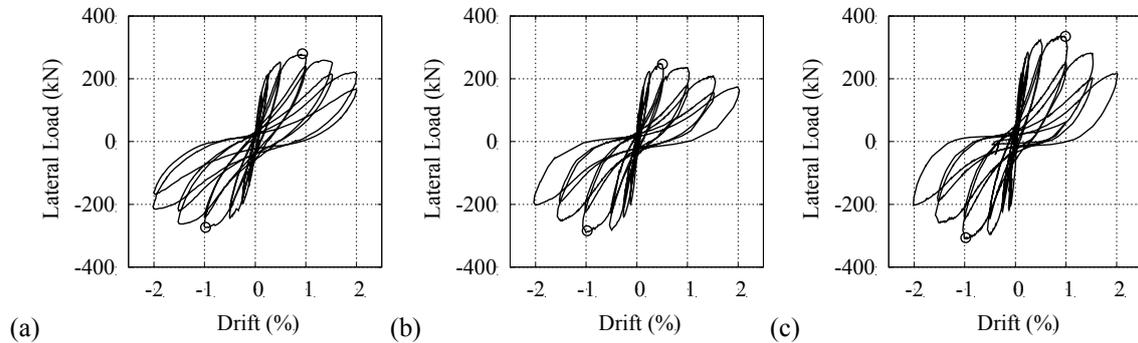
Figure 4. Lateral load-drift relationships: (a) B-WOA, (b) BH-WOA-V, (c) BH-WOA-VH

Figure 4 plots the lateral load-drift response of the specimens with maximum point indicated in the plots. The vertical axis represents the lateral load and horizontal axis represents the lateral drift. The maximum load, shown by open circle symbol, was observed at 1% drift for all specimens. Specimen BH-WOA-VH achieved a maximum load of 336kN which is approximately 120% of the maximum load of specimen B-WOA, which are summarized in Table 4 with average shear stress at ultimate strength  $\tau_u$  and normalized shear stress  $\tau_u/f_c$ . All specimens had shear failure of mullions and bond splitting failure of columns at a degraded strength. At 1.5% drift, yielding of longitudinal reinforcement of column was observed for specimen B-WOA due to normal strength of reinforcements, whereas no yielding of longitudinal reinforcement of both beams and columns were observed for specimens BH-WOA-V and BH-WOA-VH. The normalized shear stresses  $\tau_u/f_c$  for all specimens are equal to 0.12, which are smaller than typical normalized stress of reinforced concrete shear walls, in spite of difference of the amount of reinforcement and concrete compressive stress.

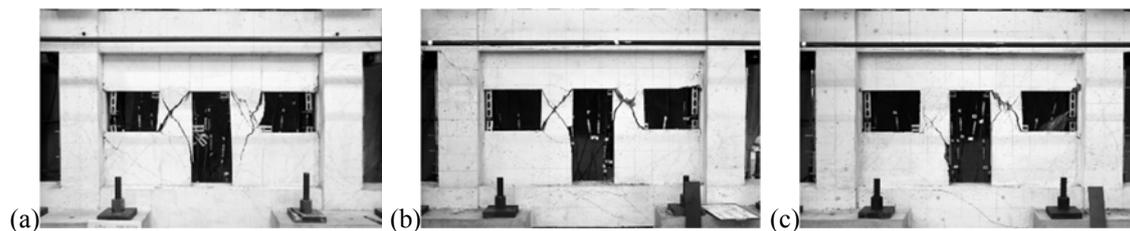
Figure 5. Crack patterns at first full cycle to 1% drift: (a) B-WOA; (b) BH-WOA-V, and (c) BH-WOA-VH

The crack patterns at the first full cycle to drift of 1% are shown in Figure 5. During testing, flexural cracks appeared on both mullions at first full cycle to 0.125 % drift, and diagonal shear cracks appeared on the right mullion only for specimens B-WOA and BH-WOA-VH. As the drift was increased further, shear cracks appeared on left mullion and extending to breast wall. Flexural cracks and shear cracks appeared on both mullions at first full cycle to 0.125 % drift for specimen BH-WOA-V. During drifts of 0.25% to 1%, large diagonal shear cracks developed and caused shear failure on both mullions for all specimens. At 0.5% drift, a lot of fine flexural cracks developed into inclined shear cracks on columns and conversely, small flexural cracks existed on the beams at 2% drift.

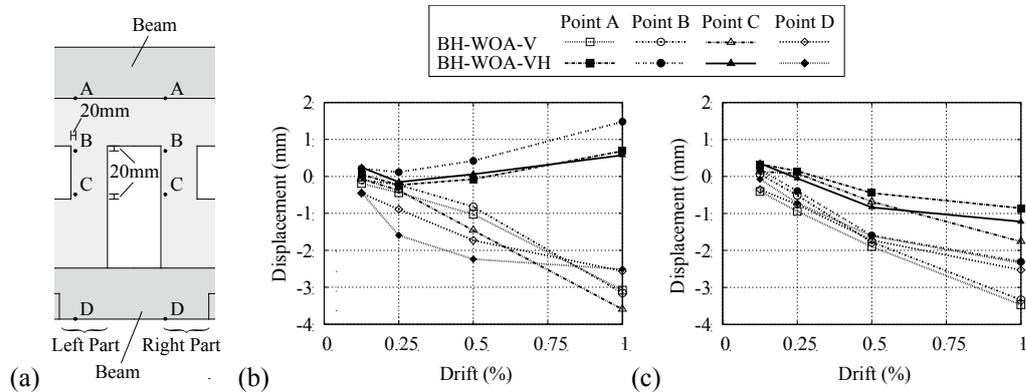
Figure 6. Vertical move displacement: (a) positions of measured point; (b) left part; and (c) right part

To investigate interaction of deformation between mullions and beams, vertical move displacement of characteristic points on the specimens BH-WOA-V and BH-WOA-VH, as shown in Figure 6(a), were measured by LVDTs. The LVDTs installed on mullions are displaced of 20 mm from the end of mullion and opening. The measured points (A to D) are classified into two parts: left and right part. Figure 6(b) and (c) show relationship between vertical move displacement at each point and lateral drift for left and right part, respectively, at drift in positive direction. The vertical axis represents the vertical move displacement and the horizontal axis represents story drift. The positive and negative values means upward and downward movement, respectively. All move displacements for both specimens on the right part decrease with a decrease of drift, whereas the move displacement except point D for specimen BH-WOA-VH increases with a decrease of drift on the left part. The mullion on the left side for specimen BH-WOA-VH moves upward by deformation. The amount of move displacements for specimen BH-WOA-VH are smaller than that of specimen BH-WOA-V on both parts, which represents that deformation of mullions are different between both specimens.

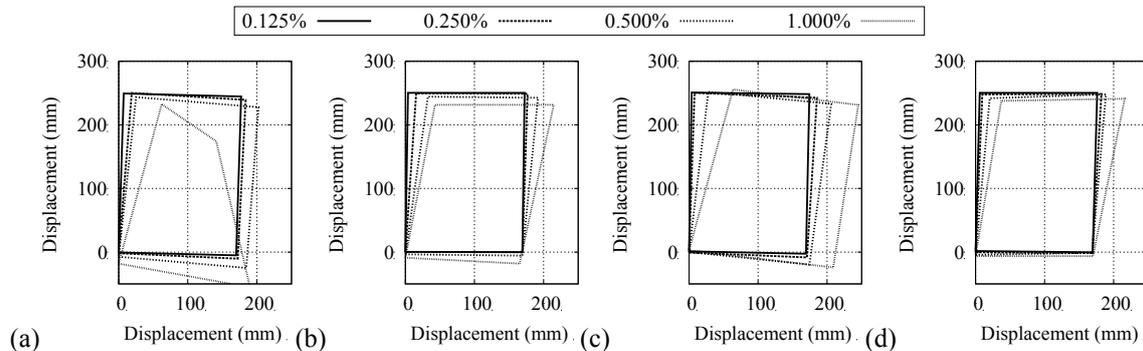
Figure 7. Deformation diagram: (a) and (b) are mullion on the left and right side, respectively, for specimen BH-WOA-V; (c) and (d) are mullion on the left side and right side, respectively, for specimen BH-WOA-VH

Deformation diagram of mullions for specimen BH-WOA-V and BH-WOA-VH at each drift in positive direction illustrated in Figure 7. The horizontal axis and vertical axis represent horizontal deformation and vertical deformation, respectively. The diagram are drawn with an assumption that the point at bottom left corner is fixed. Note that the load is applied from left to right, and the deformations are magnified by five times. Figure 7 shows that the estimated diagram of the left mullion rotates with increase of drift for both specimens, which represents that flexural deformation is dominant on the left mullion. On the other hand, shear deformation are dominant in the right mullion. These deformations are assumed to be given by deformation of frame: at drift in positive direction, the left mullion is subject to tension due to flexural bending of frame and both mullions are forced to deform by deflection of beam.
