Retrofit of shear deficient reinforced concrete beam-column joints

ABSTRACT: Many older reinforced concrete structures were built using inadequate construction practices with no consideration for lateral forces leading to their collapse in the case of a strong earthquake. Seismic vulnerability of these structures can be avoided if proper measures are taken in upgrading them. Fiber reinforced polymer (FRP) materials have proven to be effective for retrofit of substructure components. While many investigations have been conducted on retrofit of beams and columns, limited studies address the FRP retrofit of beam-column joints with insufficient and nonseismic internal reinforcement details. Furthermore, most of these studies concentrate on FRP strengthening of undamaged joints. The present study involves large-scale experimentation on shear deficient reinforced concrete (RC) beam-column joints under simulated earthquake loading. Carbon fiber-reinforced polymer (CFRP) sheets were used to strengthen the joints for pre- and post-damaged scenarios. The focus of this paper is to investigate the effect of repair materials on the response of the damaged, repaired and then strengthened specim

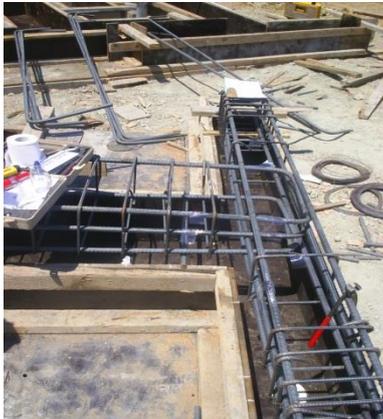
The main deficiencies which were studied for beam-column joints were widely spaced column ties that provide little confinement to the concrete, no transverse reinforcement in the joint region and construction joints below and above the beam column joint. All three specimens had 3 ϕ 20 longitudinal bars at the top of the beam and 2 ϕ 20 at the bottom. The column was reinforced with 6 ϕ 20 bars in longitudinal direction. ϕ 12 bars were used as ties for both column and beam with different spacing according to the previous code requirements. The support regions for beam and column were reinforced very dense in order to prevent possible failure in these regions. Figure 1 shows the internal reinforcement deficiencies for all three beam-column joint specimens identified as US-1 (control specimen), US-1 FRP (undamaged and FRP-strengthened specimen), and US1-R-FRP (damaged, repaired, and strengthened with identical FRP configuration as undamaged strengthened specimen).

Figure 1. Beam-column joint reinforcement arrangement.
