Structural health monitoring of offshore concrete structures using FBG sensors

E. Rizk¹, H. Marzouk², X. Gu³ and A. Hussein⁴

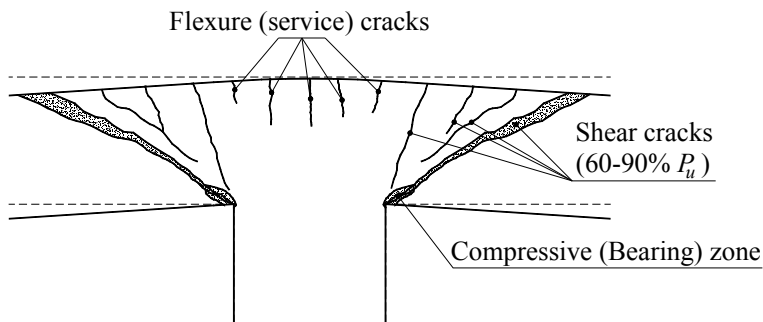
Figure 1 shows the general punching idealization of the shear behaviour of a uniformly loaded slab supported by a column. The inclined shear crack that develops from the top surface at an angle θ , and forming the critical section is shown. Damage could be detected in slab-column connections in three possible zones as shown in Figure 1. The first zone contains flexural (service) cracks that form in the tensile zone of the slab and have a wedge shape, with the maximum crack width at the tension face and zero width near the neutral plane. Flexural cracks begin to occur when concrete stress in the tension face of the slab reaches the tensile strength of concrete. Crack control is an important serviceability limit state. The second zone is the shear cracking zone. Cracking in this zone is dependent on the diagonal tensile strength of the concrete. In general, the inclined shear crack forms at a load level of 60-90% of the ultimate punching load. These cracks form at the critical section and completely surround the column. The slab at this level can be unloaded and reloaded without any decrease in the ultimate punching capacity. Although ultimate punching shear failure of the slab is not dependent on the shear crack zone, this zone is important in that the presence of cracking in this zone around the periphery of the column may be a warning sign, that the applied loads are nearing the ultimate punching shear level. In many structures, such as offshore structures, the presence of punching shear cracks is to be avoided and knowledge of the cracking mechanism behaviour is required. One of the major challenges in damage detection of civil structures is the capability to detect shear cracks that are very unpredictable. The third zone is the compressive (bearing) zone that exists at the column head. This zone extends from the slab neutral plane to the compression face of the slab. This zone is where the ultimate punching shear capacity of the slab is governed. Punching of the slab occurs when the concrete in this zone fails by a high concrete compression stress. This zone will be termed the ultimate failure zone. The zones in Figure 1 are shown in two-dimensional for simplicity; however, they are actually three-dimensional “cone-shaped” fields located around the perimeter of the column.

Figure 1. Punching failure mechanism of a concrete slab.

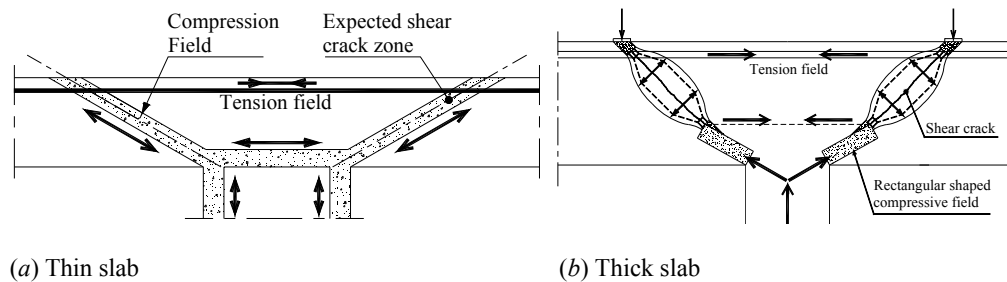
The complex internal flow of forces in a slab-column connection can be modeled using rational and simple strut-and-tie model. The strut-and-tie model considers the flow of forces within a structural element to consist of a series of compressive struts and tension ties joined at nodes. In this model, cracked concrete carries loads through sets of compressive fields that are distributed and interconnected by tension ties. The tension ties are reinforcing bars, prestressing tendons or concrete tensile stress fields. Muttoni and Schwartz (1991) found that the shear strength of concrete slabs is reduced by the presence of a critical shear crack that propagates through the slab into an inclined compression strut carrying the shear force to the column (Figure 2a). A

strut-and-tie model was recommended by Tiller (1995) to evaluate the punching shear capacity of concrete slabs. Marzouk et al. (2010) proposed an enhanced strut-and-tie model to evaluate the punching shear capacity of thick plates. The strut-and-tie model for symmetric punching consists of a “bottle-shaped” strut in the tension zone of the slab leading to a “rectangular-shaped” strut in the compressive zone. Inclined shear cracking develops in the bottle-shaped strut prior to failure in the compressive zone. Cracking in the bottle-shaped strut is related to the splitting tensile strength of the concrete. Ultimate punching failure occurs in the rectangular-stress zone by a high radial compressive stress failure (Figure 2b).

Figure 2. Flow of forces in a slab-column connection: (a) Thin slab; (b) Thick slab.

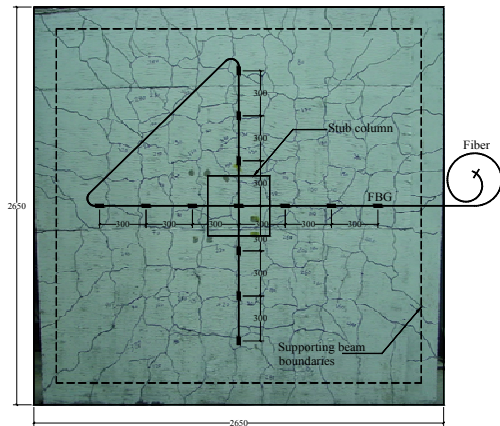
The first step in SHM process of two-way concrete slabs is to detect the location of first crack. The initiation of first crack is considered as the first warning sign that the concrete stresses reached the tensile strength of concrete. If the load is increased, new cracks form that result in reducing the spacing of cracks up to a certain limit “stabilized cracking stage”. In that case, crack formation stage is ended and no new cracks occur, but existing cracks widen. Long FBG sensors can be used to monitor the formation of first crack; this could be observed by a sudden increase in the strain magnitude. The sudden increase in strain could be converted into crack width by multiplying the strain by the sensor gauge length. The second step in SHM process is to localize and map crack patterns. Crack patterns for slabs provide insight into the failure mechanism and the rate of deterioration under loading. The prediction of crack patterns of a concrete slab; however, is a difficult problem. Crack patterns could be obtained using FBG sensors arrays. A less accurate but acceptable crack mapping could be obtained by assuming the crack to develop in a direction perpendicular to the FBG sensor array orientation (Figure 3). For the slabs having high reinforcement ratio that failing by punching, the first radial cracks were found to be more pronounced along the lines parallel to the reinforcement passing through the column stub. Orthogonal cracking was the most dominant crack pattern (Rizk & Marzouk 2009). The last step in SHM process is to detect the initiation of punching shear cracks and highly stressed compressive spots that exist near the column head. The presence of shear cracks is a warning sign that the applied loads are nearing the ultimate punching shear load. The initiation of shear cracks could be detected using a 3D configuration of FBG sensors arrays (Figure 4).

Figure 3. Crack pattern and schematic of FBG sensors arrays to map cracks

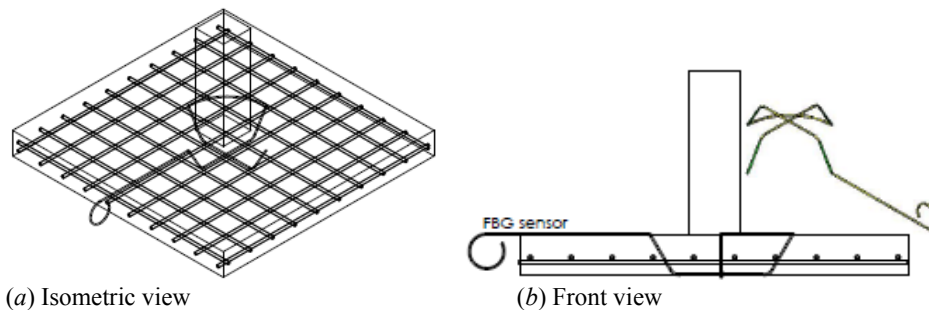
Figure 4. Schematic of FBG sensors arrays to detect shear cracks: (a) Isometric view; (b) Front view.

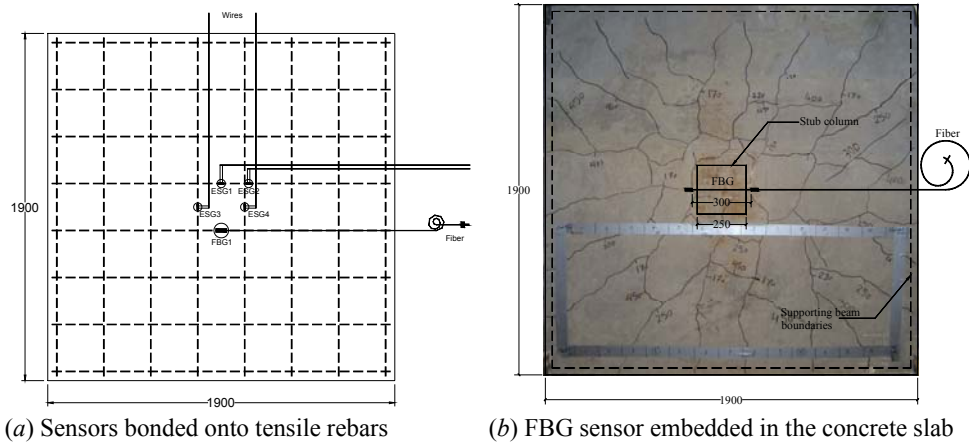
The first phase of the experimental program includes testing of a reinforced concrete two-way slab. The test slab had a side dimension of 1900 mm in both directions. The test slab had a total thickness of 200 mm and an effective depth of 140 mm. Reinforcement ratio of 0.90% was selected for flexural reinforcement. The high strength concrete (HSC) used in casting the test slab was supplied from a local batch plant. The concrete had a nominal compressive strength of 70 MPa after 28 days. Reinforcing bars consisted of grade 400 steel; conforming to CSA standards with actual tested yield strength of 440 MPa, and yield strain of about $2260 \mu\epsilon$ were used. The test specimen was simply supported along all four edges with the corners free to lift. A concentric load was applied on the slab through a 250×250 mm column stub. Two sets of FBG and ESG strain sensors were bonded onto tensile reinforcement (Figure 5a). A 20 mm gauge length FBG sensor was bonded onto a flattened surface at the middle of the reinforcement rebar. A different type of long FBG sensor (300 mm gauge length) was embedded in the tension side of the concrete slab (Figure 5b). The objective was to test the capability of long FBG strain sensors to capture the initiation of first crack within the column (loading) area. Conventional four electrical strain gauges (ESG) were bonded onto flattened surfaces of reinforcement bars, as shown in Figure 5a.

Figure 5. FBG and ESG sensors: (a) Sensors bonded onto tensile rebars; (b) FBG sensor embedded in the concrete slab.

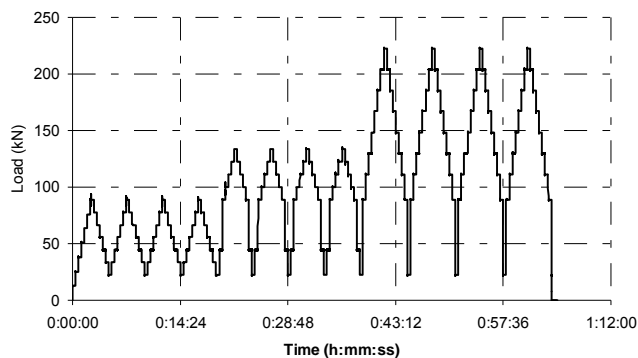
The slab was tested in a vertical position in order to detect and mark the cracks as it develops. The load was applied to the slab concentrically through the stub column. Rubber packing pieces were provided immediately under the slab surface to insure uniform contact along the supports. The test was carried out using a closed-loop (MTS) testing machine with a maximum capacity of 670 kN. The load was applied by means of a hydraulic actuator. During testing, the slab was carefully inspected and cracks were marked at each load increment. Deflection at the slab center was measured using an LVDT gage. The loading process involved a cycle test (serviceability limit state test) and a failure test. In the cycle test, a relatively small force was imposed on the slab of approximately 300 kN and then it was released after finishing the test. In this test, the concrete slab was loaded in three load-sets according to the CLT method as shown in Figure 6 and then it was loaded to failure, each load-set was repeated four times to allow enough time for monitoring and marking flexural cracks as it develops. The deformation experienced by the concrete slab was considered as elastic/linear. The maximum loading on the slab for it to be considered elastic is related to 50% of the steel reinforcement yield stress. The magnitude of the first load-set was chosen to represent 40% of service load level. Based on the loading configuration, this corresponded to a total applied load of 90 kN. The last load-set was up to 222 kN and it represented a value less than 50% of the ultimate failure load.

Figure 6. Loading profile for service loading test.

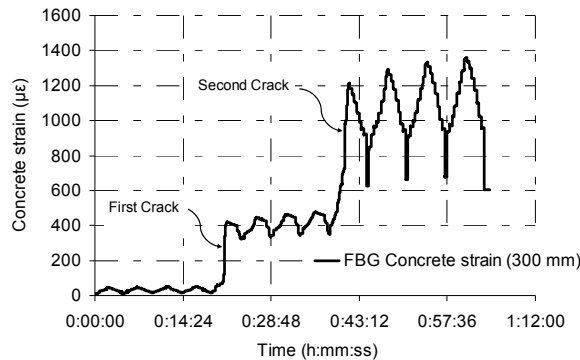
Concrete tensile strain was recorded using an embedded long FBG strain sensor with a gauge length equal to 300 mm. Based on a calibration test, the wavelength-strain coefficient for the FBG sensor was estimated to be approximately $0.95 \text{ pm}/\mu\epsilon$. Figure 7 shows the concrete tensile strain versus time curve. In general, the concrete strains indicated that as the load was increased, the concrete tensile strain increased gradually up to the initiation of first crack. The long FBG sensor was able to capture the initiation of the first and second transverse cracks; this is indicated by a sudden increase (shift) in the concrete tensile strain value. The first crack width could be calculated by multiplying the difference in the concrete tensile strain ($340 \mu\epsilon$) by the gauge length value (300 mm), and it is equal to 0.102 mm, using the same procedure, the width of the second crack could be calculated as well.

Figure 7. Concrete tensile strain versus time.

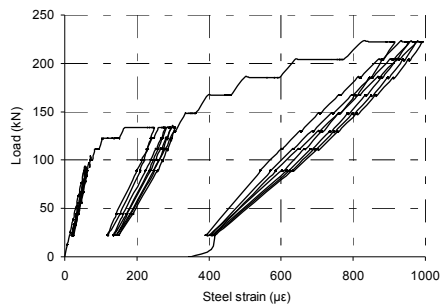
(a) Typical behaviour

Figure 8a shows a typical load versus steel strain behaviour for all load-sets before and after cracks initiation. Figure 8b shows the comparison between the tensile steel strain obtained using ESG and FBG sensors, under repeated cyclic loading conditions. Obviously, the structural response can be calculated according to the strain measurements shown in Figure 8a and 8b. The measured steel strains using FBG sensor (20 mm) are higher than the measured steel strains using ESG sensor (10 mm). The FBG sensor installed on the tensile rebar was working well as expected, and it did not show any significant reduction of sensing performance. However, two of the electrical strain gauges installed in the same location of the FBG sensor failed to operate after the strain reached a certain value of $4000 \mu\epsilon$. In this aspect, the FBG sensors demonstrated distinct advantage for long-term health monitoring of concrete structures because of their reliability, durability and accuracy.

Figure 8. Load vs. strain: (a) typical behaviour; (b) Strain response of cracked slab under cyclic loading
