## An Integrated Sensing System for Monitoring the Corrosion Activity in Concrete Blocks Exposed at Hangzhou Bay Bridge

**ABSTRACT:** This paper discusses the importance of integrated sensing systems comprising techniques that give different types of data from a structure exposed to the marine environment so that its service life could reliably be predicted. For this purpose, a novel sensor combination was designed and installed in concrete panels which were exposed to Hangzhou Bay Bridge in China. The integrated sensor probe was used to monitor the cover concrete as well as the reinforcement. The sensor probes were connected to a monitoring station, which enabled access and control of the data remotely from Belfast, UK. The initial data obtained from the monitoring station gives interesting information on the early age properties of concrete and distinct variations in these properties with different types of concrete. This paper also reports the variation in electrical properties of different concrete samples and environmental data in response to the marine exposure condition at Hangzhou bay bridge.

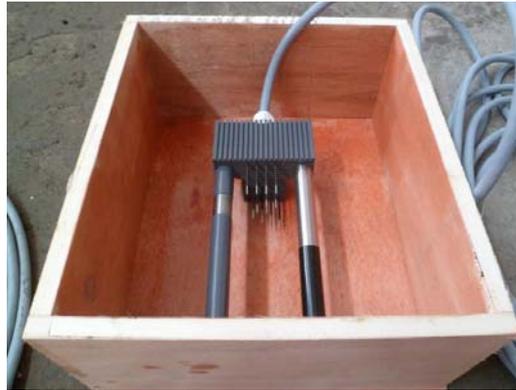
The integrated sensor system consisted of three different sensors, viz. array of 2-pin electrical resistance sensors, temperature sensors and a corrosion sensor. The sensor probe, as shown in Fig-1, consisted of an array of 2-pin electrical resistance sensors arranged in a staggered manner, electrical resistance based temperature sensors or thermistors and a galvanic cell corrosion sensor.

Fig-1: Sensor probe fixed in a wooden mould before pouring concrete

The concrete samples took the form of a slab of dimensions 350 x 300 x 150 mm. The sensor probe was fixed at the centre of the inside face of the mould, as shown in Fig-1, by means of a screw drilled through the plywood formwork from the outside. This method of emplacement of the multi-electrode sensors can easily be adapted for monitoring *in-situ* concrete by tying the two arms of the sensor probe, as shown in Fig-1, to the main reinforcement at the time of its construction. In this emplacement, the 2-pin electrode array would be in the cover zone of concrete and thus monitor the ingress of moisture or other ionic movements in the cover zone.

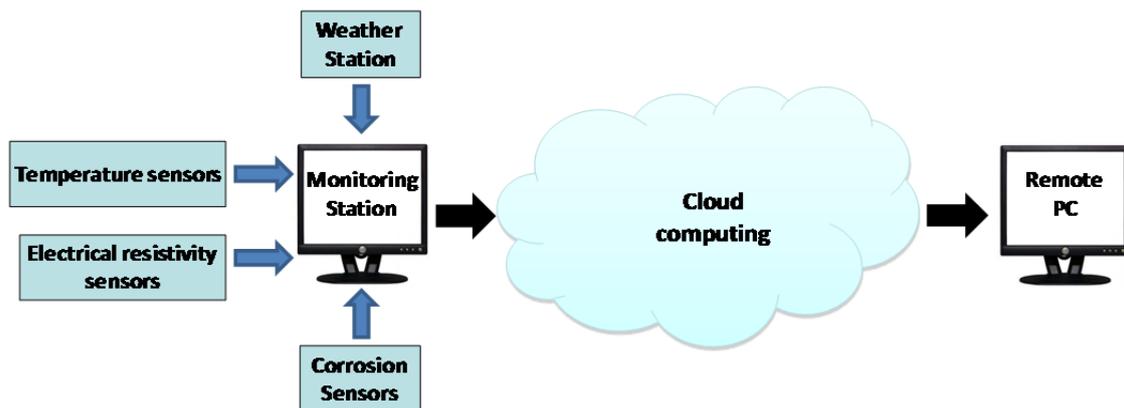
The monitoring system for the integrated sensor probe needs a robust data acquisition unit which is capable of handling different measurement systems, able to acquire data from multiple sensor probes and sustain the long-term monitoring needs for marine structures. A custom based control and monitoring station was designed to integrate the measurement devices. In addition to monitoring the changes in material properties and the corrosion activity in the cover zone of concrete, a weather station was installed near to the exposure site to monitor the environmental parameters such as temperature, relative humidity and wind speed. The monitoring of concrete cover zone in conjunction with the surrounding weather conditions would help in understanding the influence of environmental factors on the deterioration of concrete. The control unit for the weather station was integrated with the above mentioned custom based monitoring station such that all the sensing techniques were controlled and monitored simultaneously, as shown in the schematic in Fig-2.

Fig-2: Schematic of the concrete monitoring station

The data obtained from different sensing techniques at the monitoring station was transmitted to a remote PC using cloud computing, as depicted in Fig-2. In addition, using the cloud computing software and the internet, the data could easily be accessed from anywhere in the world.

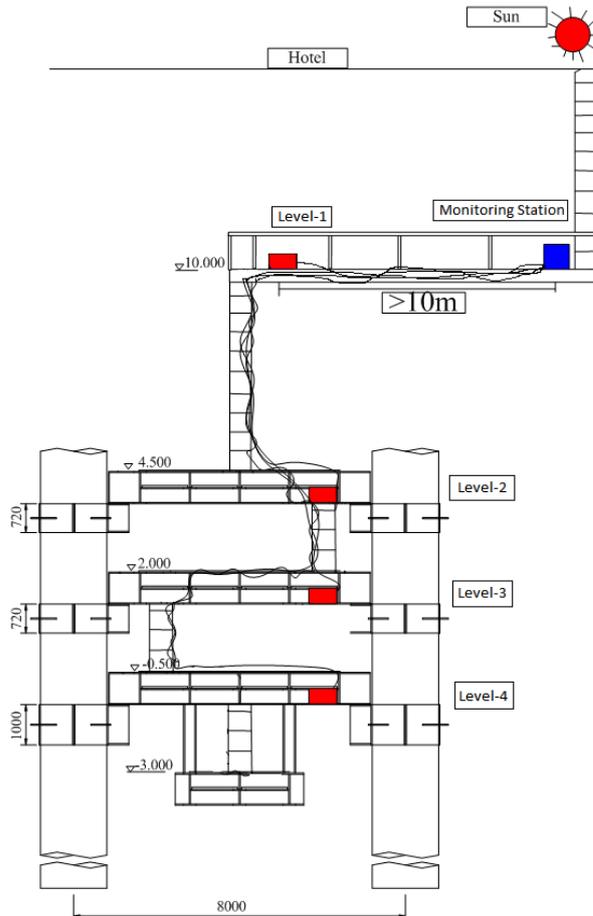
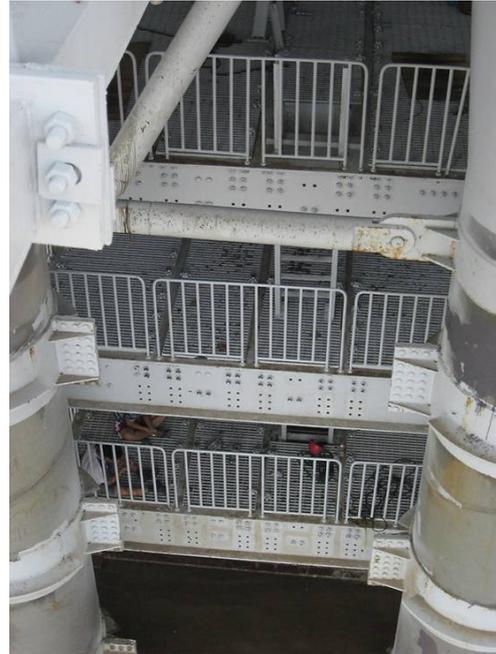
The concrete samples embedded with sensors were placed at four different levels, as shown in Fig-3. In each level one slab each of HPC, C40 and C30 concretes were placed. Therefore, the concrete samples at level-1 were in the atmosphere zone, those at level-2 were in the splash zone and those at levels 3 and 4 were in the tidal zone. The concrete samples were fixed by bolting them firmly to the platform so as to avoid any movement or abrasion caused by the waves and tidal variations. The cables coming out from the concrete samples were properly protected by encasing them in flexible PVC pipes and the cables tied to the structure at regular

intervals to avoid any movement due to tides. The tail ends of the cables were connected to the monitoring station placed at level-1, as shown in Fig-3. The weather station was placed close to the concrete samples at level-2 in the splash zone to record the temperature and moisture changes in the splash zone. The rain gauge of the weather station records the amount of sea water splash occurring at level-2. The control unit at the monitoring station was programmed to acquire data from different sensing techniques in the integrated sensor probes and transmit the data wirelessly to remote locations using cloud computing.

Atmospheric zone: above +10.210 m  
 Splash zone: +1.880~+10.210 m  
 Tide zone: -4.560~+1.880 m  
 Underwater zone: below -4.560 m

Fig-3: Schematic representation and photograph of the marine exposure site at Hangzhou Bay Bridge

After the concrete samples were cured in the laboratory for initial 4 days the samples were transported to the exposure site at Hangzhou Bay Bridge. All the concrete samples were initially placed in level-2 of the exposure platform (Fig-3) and the cables were connected to the monitoring station installed at Level-1. When the concrete was 7 days of age, one concrete block in each concrete type was installed at four levels of the exposure platform (Fig-3). Fig-8 shows the variations in electrical resistance ratio,  $\rho_t/\rho_{28}$ , which is the ratio of electrical resistivity of concrete measured at time 't' to electrical resistivity measured at 28 days. Presented in Figs-8a, 8b and 8c are the electrical resistance data obtained from three different concrete blocks placed at level-1 (atmosphere zone). It can be seen from Fig-8a that the electrical resistivity ratio at different depths for C30 concrete increased with time, which was higher at the 10mm depth in comparison to measurement made at 30, 50 and 80mm depths. The latter trend can be attributed to the drying or evaporation of moisture at surface due to surrounding environmental conditions at level-1.

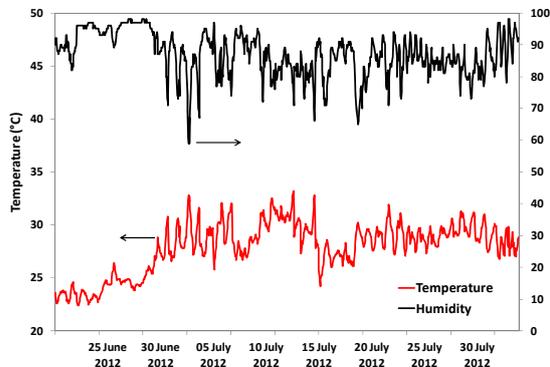
Fig-4a: Variations in Temperature and Humidity at the Hangzhou Bay bridge exposure site

The weather data obtained from the marine exposure site has been programmed to display the weather conditions live on a web page. The recent data obtained from the weather station placed at the exposure site is shown in Figs- 4a & 4b. It can be observed from the weather monitoring during Jun – Aug'12 period that there existed cyclic variations in temperature and humidity at the exposure site. The daily maximum wind speeds data shown in Fig-4b also indicate a similar trend.

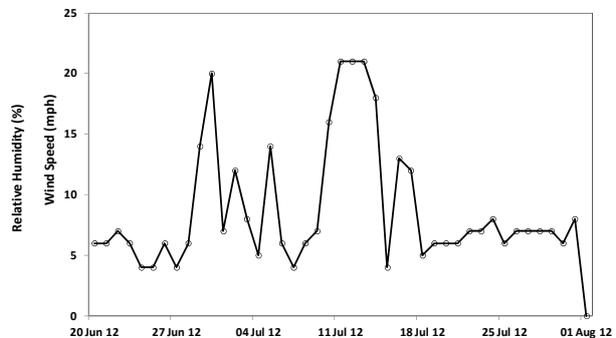
Fig-4b: Variations in daily maximum wind speed at the Hangzhou Bay bridge exposure site

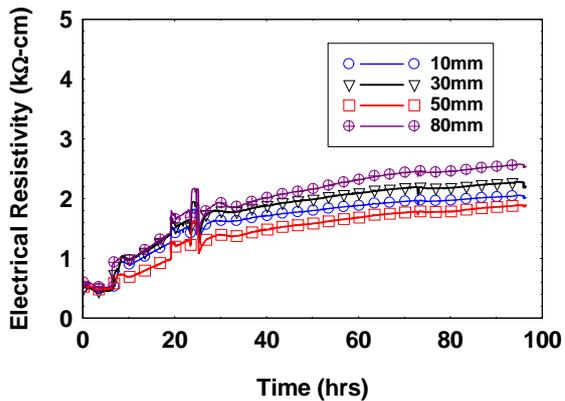
In this investigation three different concrete mixes with different water-binder ratios were tested. The changes in electrical resistivity at different depths with time for the C30 concrete during the first four days of curing are shown in Fig-5a. It may be noted that these data were collected at Belfast from the slabs manufactured in China using the remote monitoring set up described in section 3

Based on the trend observed in Fig-5a the graph can be divided into three phases, the first phase is the initial 3 hrs of hydration, the second phase is from 3-24 hrs of hydration and the third phase is from 24-100 hrs of hydration. It can be observed from Fig-5a that during the first phase there is not much change in electrical resistivity values as the ions which conduct electricity between the electrodes are readily available due to the fresh state of concrete. In the second phase, as the concrete begins to set and changes into a semi-solid state the resistivity values increase rapidly with time. The changes in resistivity of concrete in the second phase mainly depend on the pore structure formation. In the third phase, as the concrete hardens completely the electrical resistivity measured at different depths tends to stabilise with time and the value at

Fig-5a: Changes in electrical resistance at different depths with time for C30 Concrete

The electrical resistivity values for fresh concrete were generally low (Figs. 5a, 6a and 7a) due to the high conduction through dissolved ions in the fresh state of concretes. As the cement in the concrete hydrates with time the concrete hardens slowly depending on the cement content, water-binder ratio and the content of the supplementary cementitious materials in the concrete mix, which in turn increases the electrical resistivity measured at different depths in the concrete. At the hardened phase of concrete the electrical resistivity values depends on the pore structure formation, pore connectivity and constituents of the pore solution in the concrete. Both the temperature and the electrical resistivity data obtained from the sensors were useful to differentiate the mixes.

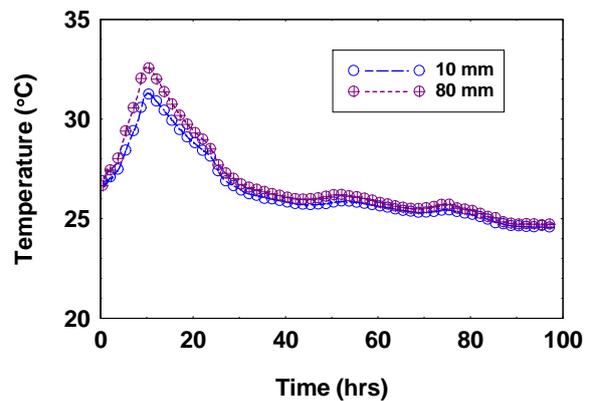
Fig-5b shows the temperature changes at both 10 mm and 80 mm depths for C30 concrete. It is evident from this figure that the temperature in concrete increased with time for the initial 12 hours due to the exothermic hydration reactions. In addition, the temperature values at 80 mm depth are marginally greater than the temperature measured at 10 mm depth initially, but both were similar after around 2 days, which is mainly due to the influence of ambient room temperature at shallow depths.

Fig-5b: Changes in temperature at different depths with time for C30 concrete

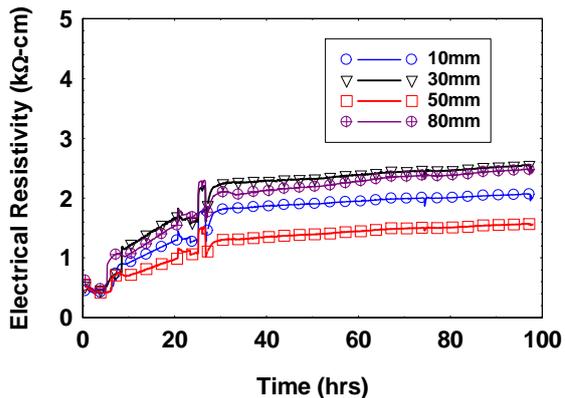
The changes in electrical resistivity and temperature for the C40 concrete are shown in Fig-6a and 6b respectively. The trend in the changes in resistivity values observed for the C40 concrete is similar to that for the C30 concrete. The rate of changes in resistivity observed in the initial part of the second phase is greater for the C40 concrete when compared to the C30 concrete. The increase in temperature in Fig. 6b for the C40 concrete is slightly greater than that for the C30 concrete in Fig. 5b. This is considered to be due to increased degree of hydration of cement because the C40 concrete had more cement content compared to the C30 mix.

Fig-6a: Changes in electrical resistance at different depths with time for C40 Concrete

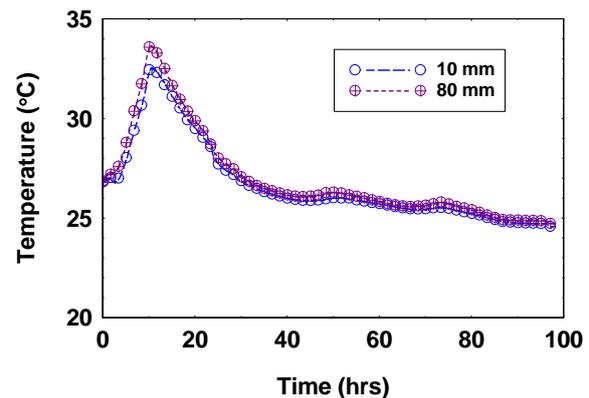
Fig-6b: Changes in temperature at different depths with time for C40 concrete

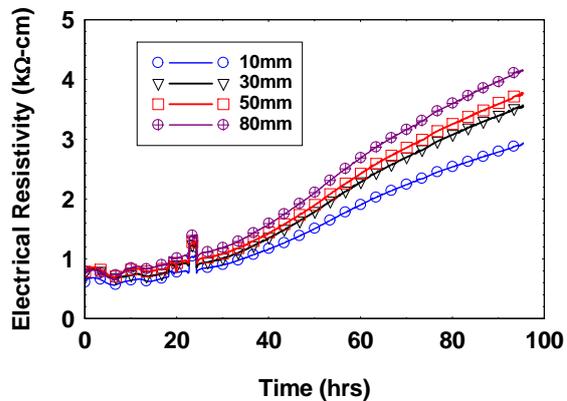
Fig-7a: Changes in electrical resistance at different depths with time for HPC

The resistivity and temperature plots for the HPC are shown in Fig-7a and 7b respectively. The resistivity changes observed for HPC clearly show a distinct feature of prolonged increase in the third phase when compared to both C30 and C40 concretes. This increase in electrical resistivity at different depths is attributed to the slow pozzolanic reaction and better pore structure in the HPC. Moreover, the rapid increase of resistivity in the second phase is not observed in the case of the HPC due to the slow pozzolanic reaction of fly ash and GGBS in the concrete. The increase in temperature for the HPC as shown in Fig-7b is low in comparison to that for both C30 and C40 concretes. This is attributed to the low heat of hydration of HPC containing supplementary cementitious materials in the concrete mix.

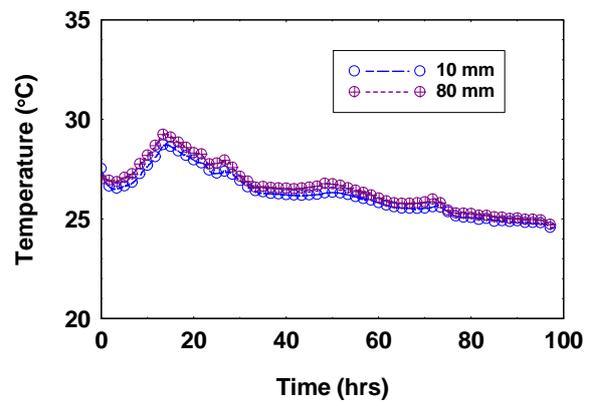
Fig-7b: Changes in temperature at different depths with time for HPC

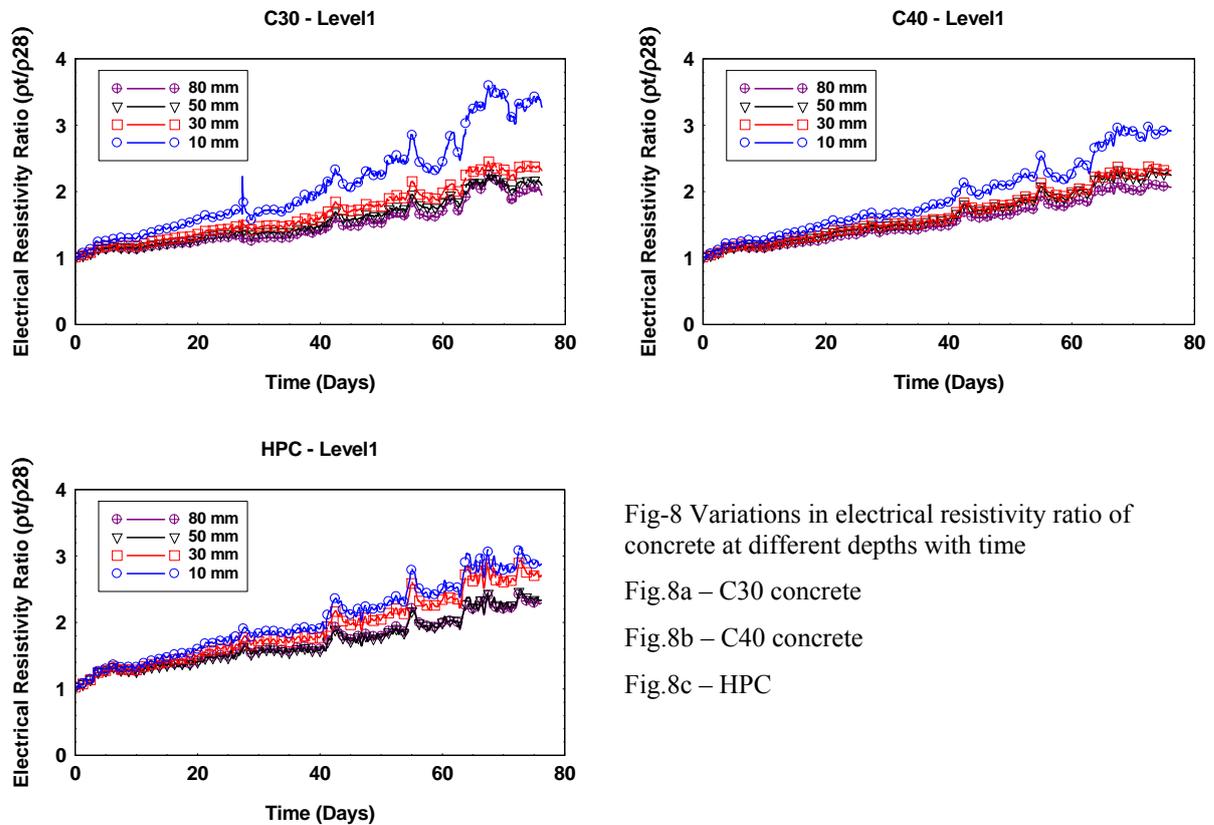
Fig-8 Variations in electrical resistivity ratio of concrete at different depths with time

Fig.8a – C30 concrete

Fig.8b – C40 concrete

Fig.8c – HPC

The results in Figs-8b and 8c also show an increase in the resistivity ratio with time for the C40 concrete and HPC respectively. The larger increase in electrical resistivity ratio at 10mm depth for the C30 concrete compared to both C40 concrete and HPC would suggest that there was higher rate of drying at surface for the former compared to the other two. The increased rate of drying at surface for C30 concrete is mainly due to high W/C ratio for C30 concrete, resulting in relatively high porosity and thus facilitating easy evaporation of moisture at surface.
